Bexley City School District

FACILITY ASSESSMENT REPORT

Montrose Elementary School

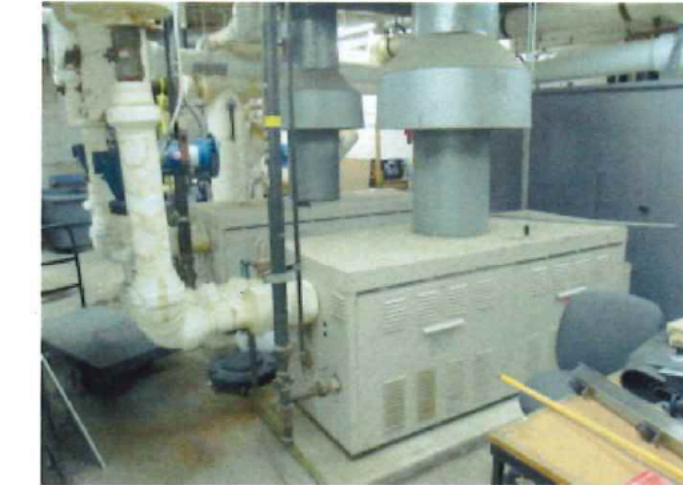
Description: The existing system for the overall facility is a gas fired heating hot water system, installed in 1993, and is in poor condition. The heating and chilled water system in the overall facility is a 2-pipe system, without a capacity for simultaneous heating and cooling operation, which is not compliant with the OSDM requirements for basic system type. The 2 gas fired boilers, manufactured by Raypak, were installed in 1993 and are in poor condition. Heating water is distributed to terminal units consisting of cabinet heaters and air handlers. The terminal equipment was installed in 1993 and is in poor condition. The system does not comply with the 15 CFM per person fresh air requirements of the Ohio Building Code mechanical code and Ohio School Design Manual. The DDC type system temperature controls are in fair condition. The system does feature individual temperature controls in all spaces required by the OSDM. The overall system does not feature any central energy recovery systems. The facility is not equipped with louvered interior doors to facilitate Corridor utilization as return air plenums. The existing system is ducted, but the ductwork cannot be integrated into a possible future system due to arrangement, air volume, and routing of existing ductwork. The overall heating system is evaluated as being in safe but inefficient working order, and long-term life expectancy of the existing system is not anticipated. The structure is equipped with central air conditioning. The site does not contain underground fuel tanks.

Rating: 3 Needs Replacement

Gas Fired Boilers

Recommendations: Provide new overall heating, ventilating, and air conditioning system to achieve compliance with Ohio Building Code and Ohio School Design Manual standards. Replace existing ductwork to facilitate efficient exchange of conditioned air.

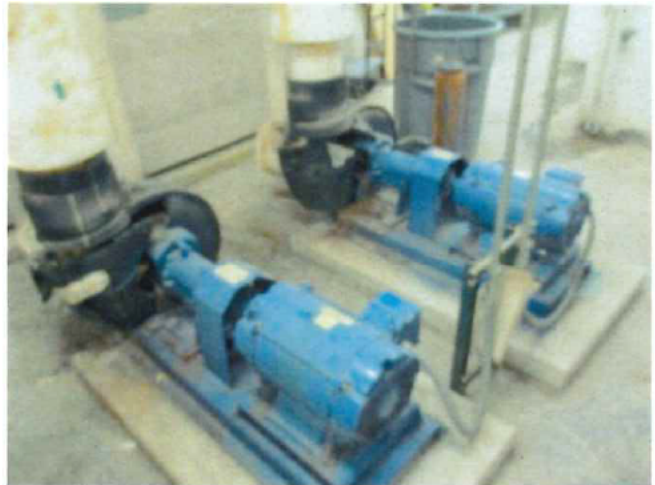
Heating Hot Water Pumps

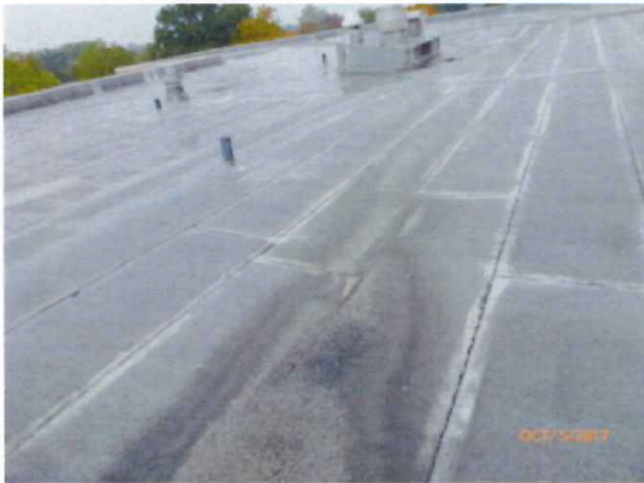
Description: The roof over the 1922 Original Construction and 1993 Addition is a build-up system that was installed in over 15 years ago, and is in fair condition. There are no District reports of current leaking. Signs of past leaking were observed during the physical assessment. Access to the 2nd level roof was gained by a window 8' above the floor that is in good condition and a 10' ladder to the 3rd level roof. Fall safety protection cages are not required. There were observations of standing water on the roof. Metal cap flashings are in fair condition. Roof storm drainage is addressed through a system of roof drains, which are properly located, and in fair condition. The roof is not equipped with overflow roof drains though they are needed on this building. No problems requiring attention were encountered with any roof penetrations. There are not any covered walkways attached to this structure.

Rating: 3 Needs Replacement

Ponding water

Recommendations: Provide replace roofing material. Provide replace coping and flashing. Provide additional overflow drains. Provide access ladders. Correct ponding water.

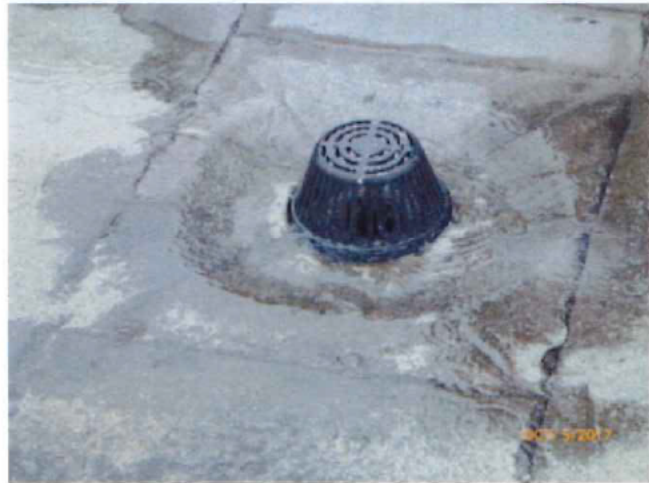
Roof drain

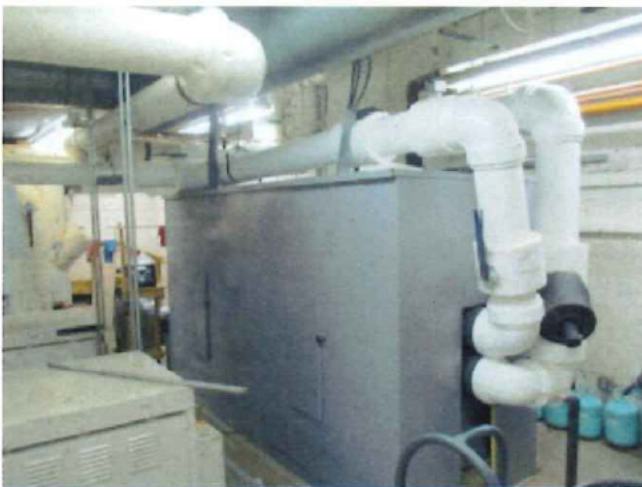
Description: The overall facility is equipped with a chilled water central air conditioning system, which is in good condition. An air-cooled condenser provides refrigerant to a chiller, installed in 2015, and in good condition, providing chilled water to air handling units. The ventilation system in the overall facility consists of air handlers, in poor condition, providing fresh air to Classrooms, and air handlers, in poor condition, providing fresh air to other miscellaneous spaces such as Gymnasiums, Student Dining, and Media Center. Relief air venting is provided by ceiling plenums. The ventilation system does not meet the Ohio Building Code 15 CFM per occupant fresh air requirement. The overall system is not compliant with Ohio Building Code and Ohio School Design Manual requirements. Dust collection systems are not required in this facility. The Art program is equipped with a kiln, and existing kiln ventilation is inadequate, and in poor condition. General building exhaust systems for Restrooms are adequately placed, and in fair condition.

Chiller

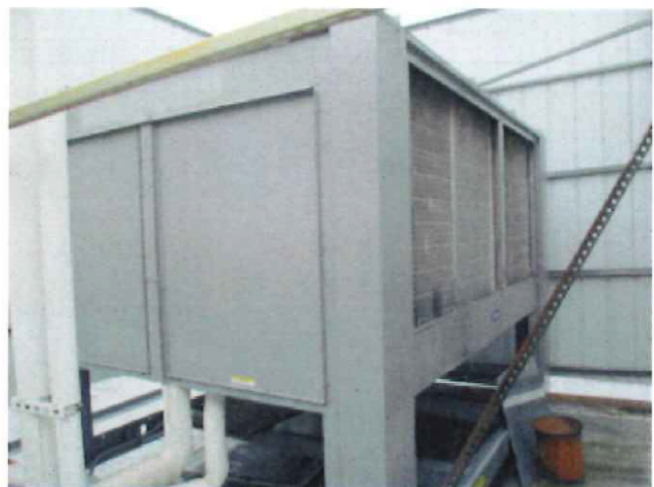
Air Cooled Condenser

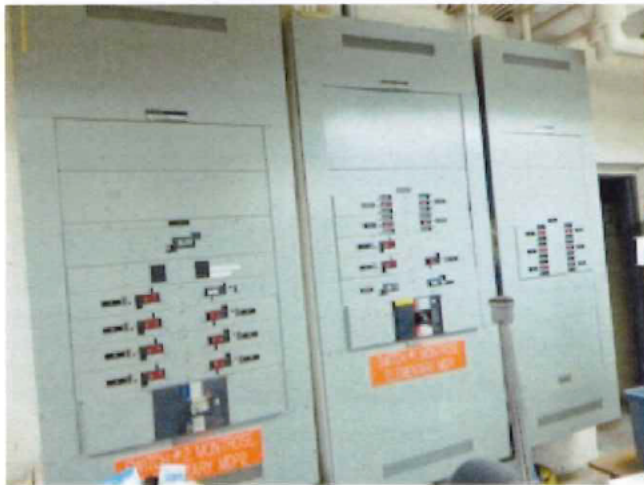
Description: The electrical system provided to the overall facility is a dual 1000A, 480/277V, 3PH, 4W and 800A, 208/120V, 3PH, 4W system installed in 1993 and is in fair condition. Power is provided to the school by two utility owned, pad-mounted transformers located in the boiler room and in fair condition. The panel system is in fair condition and cannot be expanded to add additional capacity. The Classrooms are equipped with adequate electrical outlets. The typical Classroom contains 8 general purpose outlets. There are not any spaces that have no electrical outlets. The Corridors are equipped with adequate electrical outlets for servicing. Adequate GFI protected exterior outlets are not provided around the perimeter of the building. The facility is not equipped with an emergency generator. Adequate lightning protection safeguards are not provided. The existing facility is not equipped with a Stage. The overall electrical system does not meet Ohio School Design Manual requirements in supporting the current needs of the school, and will be inadequate to meet the facility's future needs.

Rating: 3 Needs Replacement

Main Distribution Panelboards

Recommendations: The entire electrical system requires replacement to meet Ohio School Design Manual guidelines for overall capacity, due to condition and age, and lack of OSDM-required features.

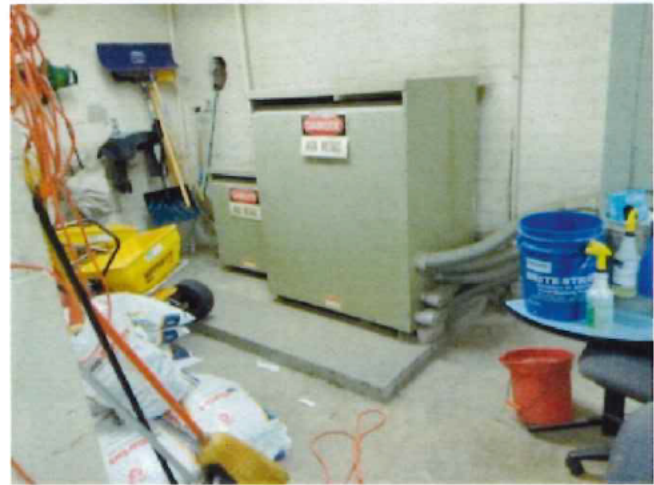
Indoor Utility Transformers

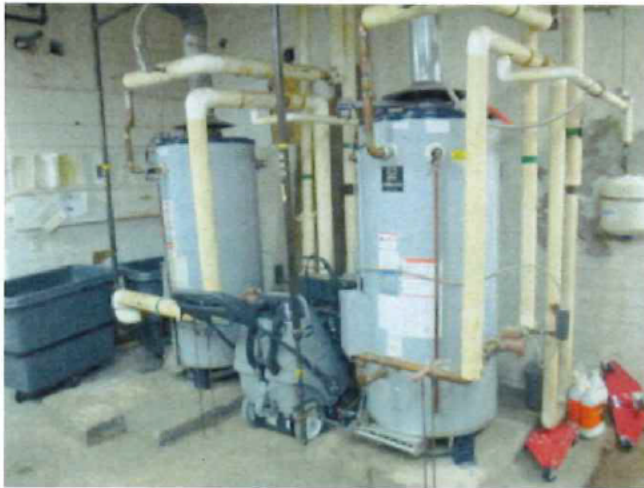
Domestic Hot Water Heaters

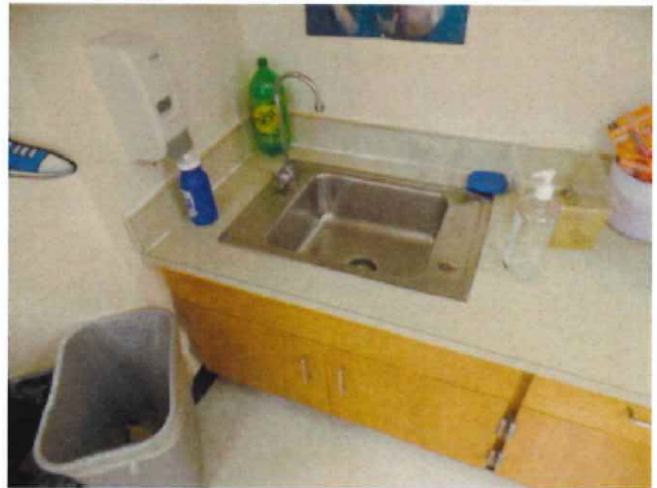
Description: The service entrance is equipped with a reduced pressure backflow preventer in fair condition. A water treatment system is not provided. The domestic water supply piping in the overall facility is copper and PVC, and is in fair condition. The waste piping in the overall facility is cast iron and PVC, and is in fair condition. The facility is equipped with (2) 100-gallon gas water heaters in good condition. The school contains 4 Large Group Restrooms for boys, 4 Large Group Restrooms for girls, Restrooms associated with specialty Classrooms, and 4 Restrooms for staff. Boys' Large Group Restrooms contain 0 ADA and 8 non-ADA floor mounted flush valve toilets, no ADA and 4 non-ADA wall mounted flush valve urinals, as well as 0 ADA and 14 non-ADA countertop mounted lavatories. Girls' Large Group Restrooms contain 0 ADA and 14 non-ADA floor mounted flush valve toilets, as well as 0 ADA and 14 non-ADA countertop lavatories. Staff Restrooms contain 2 ADA and 4 non-ADA floor mounted flush valve toilets, 0 ADA and 4 non-ADA floor mounted urinals, as well as 2 ADA and 4 non-ADA countertop lavatories. Condition of fixtures is good. The facility is equipped with 0 ADA and 0 non-ADA drinking fountains, as well as 2 ADA and 2 non-ADA electric water coolers, in fair condition. The 25 Elementary Classrooms are not equipped with sink mounted type drinking fountains. Special Education Classroom is not equipped with the required Restroom facilities, and fixtures are in good condition. Kitchen is not equipped with the required Restroom. Health Clinic is equipped with the required Restroom, and fixtures are in good condition. Kindergarten Classrooms are not equipped with Restroom facilities, and fixtures are in good condition. Kitchen fixtures consist of 1 hand sink and 1 triple-compartment sink, which are in fair condition. The Kitchen is equipped with an unsatisfactory grease interceptor due to insufficient capacity and condition. The Kitchen is provided the required 140-degree hot water supply via an Insta Hot type water heater, which is in good condition. The school does not meet the OBC requirements for fixtures. Relative to LEED requirements, the school is not equipped with low flow type fixtures. Per OBC and OSDM requirements this facility should be equipped with 35 toilets, 8 urinals, 35 lavatories, 25 Classroom sink mounted drinking fountains, and 17 electric water coolers. Observations revealed that the school is currently equipped with 32 toilets, 11 urinals, 28 lavatories, 0 Classroom sink mounted drinking fountains, and 4 electric water coolers. ADA requirements are not met for fixtures and drinking fountains (see Item O). Custodial Closets are not properly located and are not adequately provided with required service sinks or floor drain sinks, which are in fair. Science Classroom and Lab utility sinks, gas connections, compressed air connections, and safety shower and eyewash are not provided, but are not required due to existing grade configuration. Due to existing grade configuration, no Biology or Chemistry Classroom acid waste systems are required. Adequate exterior wall hydrants are not provided.

Classroom sink without fountain

Recommendations: Provide required sink mounted type drinking fountains in Elementary Classroom spaces. Provide 4 exterior wall hydrants. Replace the existing grease interceptor due to condition. See Item O for replacement and addition of fixtures related to ADA requirements.

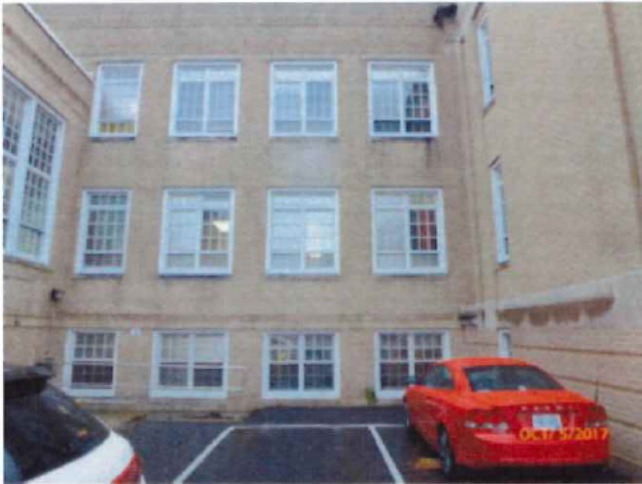
Description: The overall facility is equipped with wood, double glazed insulated glazing type window system, the installation date is unknown, and is in poor condition. The window system features operable windows throughout of the building, and operable windows are not equipped with opening limiters, most insect screens are missing, and in poor condition. Window system seals are in poor condition, with frequent air infiltration being experienced. Window system hardware is in poor condition. The window system features integral blinds, which are in fair condition. This facility does not feature any glass block windows. The exterior doors in the overall facility hollow metal are equipped with steel frames and no glazing, in poor condition and aluminum doors with single pane glazing, in fair condition. The school does not contain skylights. The school does not contain any clerestories. Interior glass is not OSDM-compliant due to it being wire glass. Window security grilles are not provided for ground floor windows. There is no a Greenhouse associated with this school.

Rating: 3 Needs Replacement

Exterior aluminum clad windows

Recommendations: Provide a new insulated window system with integral blinds to meet with Ohio School Design Manual requirements. Provide sidelights and transom panels. Provide interior door lights. Provide aluminum storefront type doors, refer to Item S. Provide exterior hollow metal doors, frames and hardware, refer to Item S.

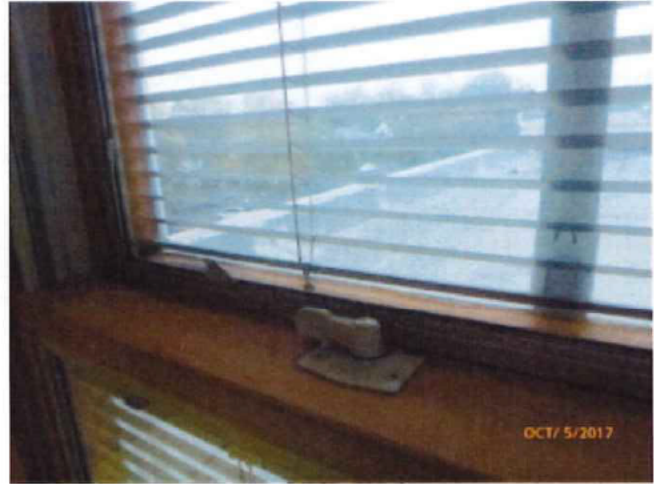
Interior of windows

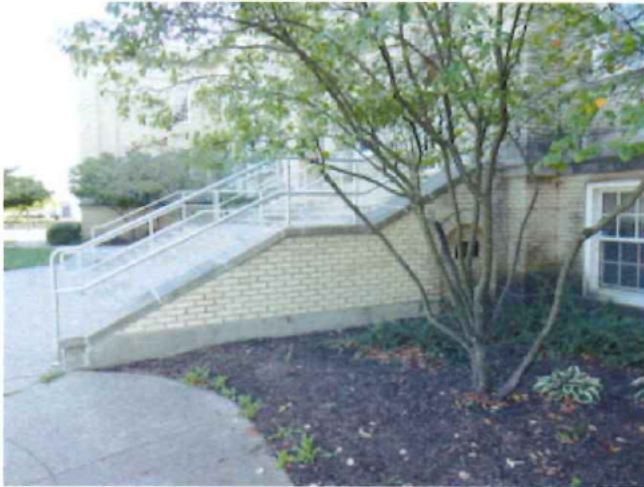
Description: The overall facility is equipped with masonry foundation walls on concrete footings, and are in good condition. No significant issues related to foundation cracking or spalling were encountered. The District reports that there has been no past leaking

foundation wall at steps

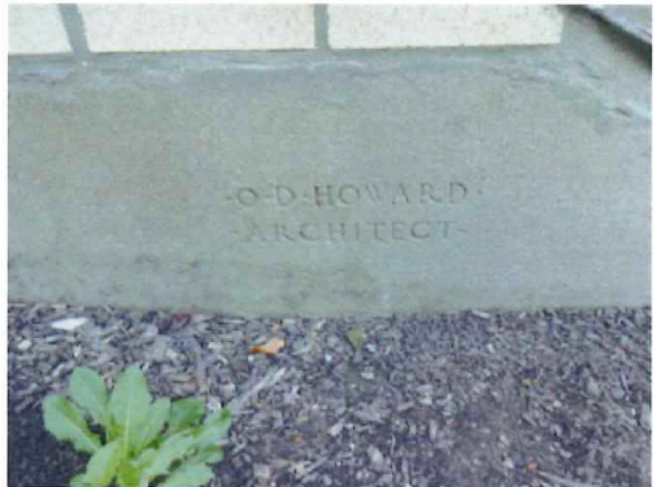
Foundation Stone

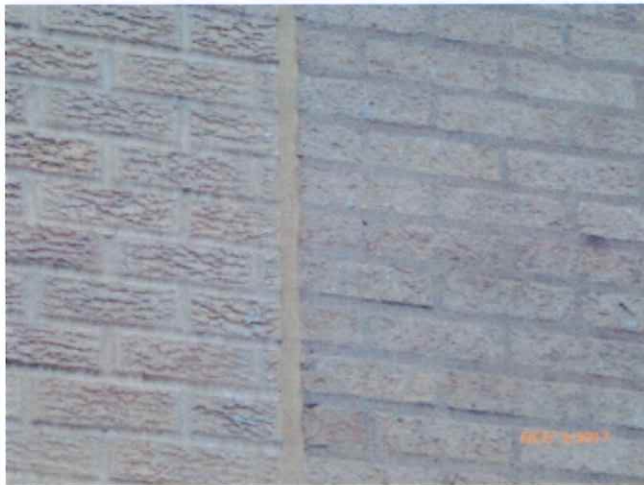
Description: The overall facility has a brick veneer on load bearing brick wall system, which displayed no locations of deterioration, and is in good condition. The 1993 gymnasium addition has a brick veneer on load bearing masonry walls, which displayed no locations of deterioration, and are in good condition. The 1993 exterior masonry appears to have appropriately spaced and adequately caulked control joints in fair condition. Control joints are provided at lintel locations, at doors, building corners, and wall offsets and are in fair condition. The 1922 school contains expansion joints in the corners only and no other expansion joints are needed, as there is no indication of exterior masonry cracking or separation. Exterior walls in the 1922 facility are inadequately insulated. Brick veneer masonry walls are not cavity walls. Exterior walls in the 1993 Addition are adequately insulated. Brick veneer masonry walls are cavity walls. Weep holes are not provided in sufficient quantity at lintels, below sills. The exterior masonry has not yet needed to be cleaned and sealed, showing no evidence of mortar deterioration. Architectural exterior accent materials consist of stone is in good condition. Exterior building fenestration in the overall facility exceeds 12.50% of the exterior surfaces. Interior Corridor and demising walls are concrete masonry units with, project do project full height from floor to bottom of deck, and are in good condition. Interior masonry appears to have adequately spaced and caulked control joints in good condition. Interior soffits are of metal stud and gypsum type construction, and in good condition. The window sills are stone, and are in good condition. The exterior lintels are steel, and are in fair condition. Chimneys are in fair condition. Exterior soffits are of metal stud and gypsum type construction, and in good condition. The school is not equipped with a loading dock.

Recommendations: Provide masonry cleaning, sealing, caulking as required through the overall facility. Add weeps to lintel and below sills. Exterior wall insulation deficiencies are addressed in Item J.

Re-caulk expansion joints

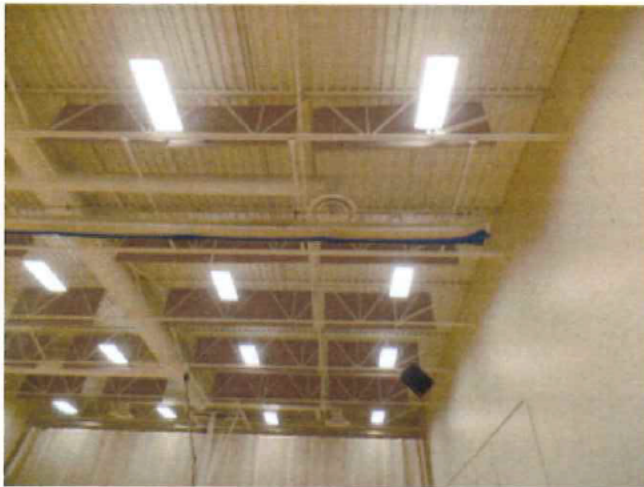
Description: The floor construction of the base floor of the overall facility is concrete slab on grade) type construction, and is in good condition. There is no crawl space. The floor construction of the intermediate floors of the 1922 facility are precast concrete planks with concrete topping type construction, and is in good condition. Ceiling to structural deck spaces are sufficient to accommodate HVAC, electrical, and plumbing scopes of work in required renovations. The roof construction of the 1922 is concrete plank type construction, and is in good condition. The roof construction above the 1922 entrance is coffered cast in place concrete, and is in good condition. The roof construction of the 1993 Addition is steel deck on steel trusses type construction, and is in good condition.

Metal roof deck

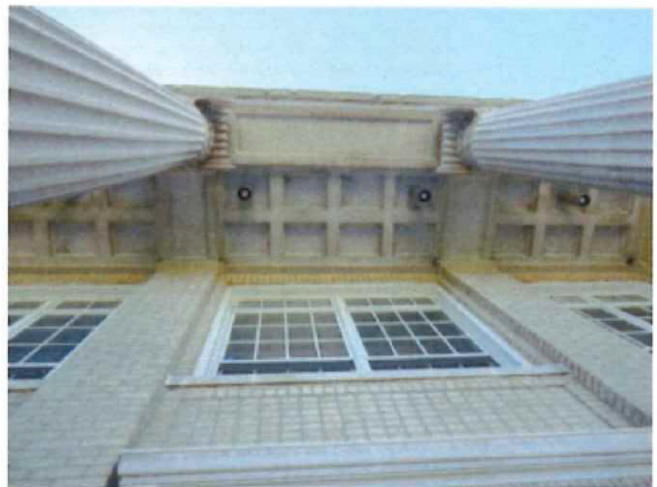
Cast in place concrete at roof level

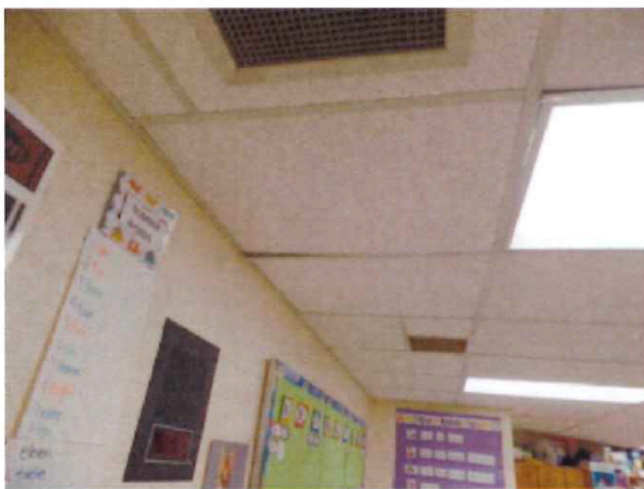
The overall facility features conventionally partitioned Classrooms with VCT type flooring, acoustical ceiling tile type ceilings, as well as painted type wall finishes, and they are in fair condition. The overall facility has Corridors with terrazzo type flooring, acoustical ceiling tile type ceilings, as well as painted type wall finishes, and they are in fair condition. The overall facility has Restrooms with ceramic tile type flooring, acoustical ceiling tile type ceilings, as well as ceramic tile and gypsum type wall finishes, and they are in fair condition. Toilet partitions are metal or plastic laminate, metal is in good condition, plastic laminate is in poor condition. Classroom casework in the overall facility is wood type construction with plastic laminate tops, is adequately provided, cabinets are in fair conditions and countertops are in poor condition. The typical Classroom contains 24 lineal feet of casework, and Classroom casework provided ranges from 17 to 27 feet. Classrooms are provided adequate chalkboards, markerboards, tack boards which are in fair condition. The Classroom storage cubbies, located in the Classrooms, are adequately provided, and in fair condition. The Art program is equipped with a kiln. The facility is equipped with wood non-louvered interior doors that are both flush mounted and recessed with proper ADA hardware and clearances, and in fair condition. The Gymnasium space has VCT type flooring, open to metal deck type ceilings, as well as painted type wall finishes, and they are in fair condition. There is no indication of Tartan flooring. Gymnasium does not have seating or stands. Gymnasium basketball backboards are both fixed and electrically operated type, and are in fair condition. The Media Center, located in the 1922 building, has carpet type flooring, acoustical ceiling tile type ceilings, as well as painted type wall finishes, and they are in fair condition. Student Dining, located in the original facility, has terrazzo type flooring, acoustic ceiling tile type ceilings, as well as painted type wall finishes, and they are in fair condition. The facility does not have a Stage. Existing Gymnasium, Student Dining spaces are adequately provided with appropriate sound attenuation acoustical surface treatments. The Media Center and Music spaces are not provided with appropriate sound attenuation acoustical surface treatments. The existing Kitchen is a Warming Kitchen only, is undersized based on current enrollment, the existing Kitchen equipment is over 20 years old, installation date is unknown, is in fair condition. The Kitchen hood is in fair condition, and is equipped with the required UL 300 compliant wet chemical fire suppression system. The required 6" overhang on all three exposed sides of the cooking equipment is provided by the hood. Kitchen hood exhaust ductwork is of proper construction. Reach-in coolers and freezers are located within the Kitchen spaces, and are accessed by kitchen staff, and are in fair condition.

Acoustical ceiling tile

Provide complete replacement of warming kitchen equipment due to age and condition. Replace carpet in media center and offices. Provide insulation of exterior walls Replace laminate countertops in classrooms and restrooms including removal and reinstallation of existing sinks. Provide sound attenuation acoustical surface treatments. Replace all acoustical ceiling systems due to lighting replacement. Refer to Item K Replace plastic laminate toilet partitions, refer to Item O. Replace toilet accessories, refer to Item O. Replace interior doors is provided in Item O.

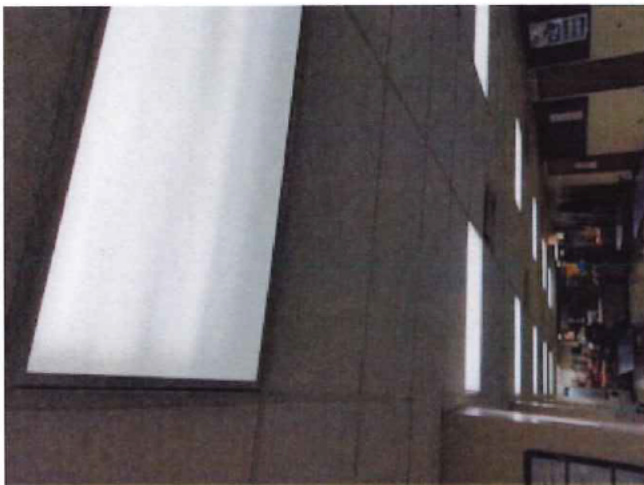
The typical Classrooms in the overall facility are equipped with T-8 lay-in 2x4 fluorescent fixtures with dual level switching. Classroom fixtures are in good condition, providing an average illumination of 62 FC, thus complying with the 50 FC recommended by the OSDM. The typical Corridors in the overall facility are equipped with T-8 lay-in 2x4 fluorescent fixtures with single level switching. Corridor fixtures are in good condition, providing an average illumination of 42 FC, thus complying with the 20 FC recommended by the OSDM. The Gymnasium spaces are equipped with T-8 suspended 2x4 fluorescent fixtures in good condition, providing an average illumination of 65 FC, thus complying with the 50 ES / MS FC recommended by the OSDM. The Media Center is equipped with T-8 lay-in 2x4 fluorescent fixture type lighting in good condition, providing an average illumination of 44 FC, which is less than the 50 FC recommended by the OSDM. The Student Dining spaces are equipped with T-8 lay-in fluorescent fixture type lighting with single level switching. Student Dining fixtures are in good condition, providing an average illumination of 57 FC, thus complying with the 50 FC recommended by the OSDM. The Kitchen spaces are equipped with T-8 lay-in 2x4 fluorescent fixture type lighting with single level switching. Kitchen fixtures are in good condition, providing an average illumination of 70 FC, which is less than the 75-80 FC recommended by the OSDM. The Service Areas in the overall facility are equipped with 1x4 suspended T-8 fluorescent fixture type lighting in fair condition. The typical Administrative spaces in the overall facility are equipped with T-8 lay-in 2x4 fluorescent fixture type lighting in good condition, providing adequate illumination based on OSDM requirements. The overall lighting systems of the facility are not fully compliant with Ohio School Design Manual requirements due to inadequate lighting levels in some locations.

Typical Lighting

Provide complete replacement of lighting system to facilitate work done in Items A and U.

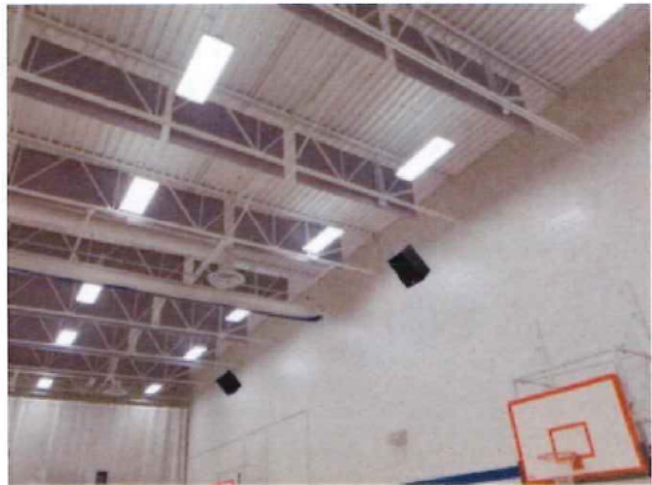
Gymnasium Lighting

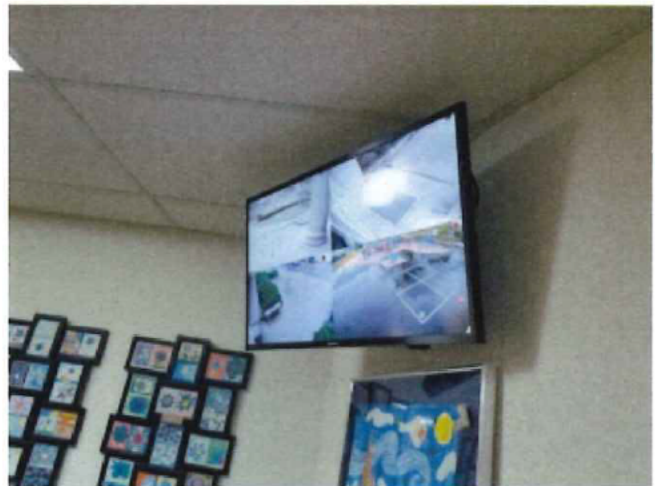
CCTV Monitor with All Zones Shown

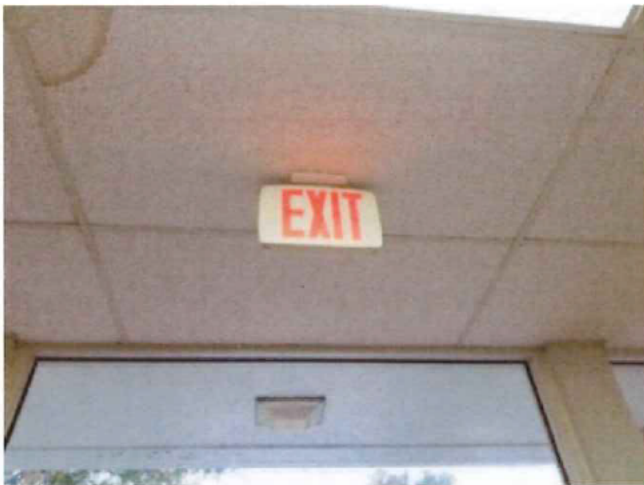
Description: The overall facility is equipped with an emergency egress lighting system consisting of non compliant plastic construction and the system is in good condition. The facility is equipped with emergency egress floodlighting and the system is in good condition. The system is provided with appropriate battery backup. The system is adequately provided throughout, and meets Ohio School Design Manual and Ohio Building Code requirements.

Noncompliant Exit Sign

Recommendations: Provide complete replacement of emergency / egress lighting system to facilitate work in Items A, K, and U.

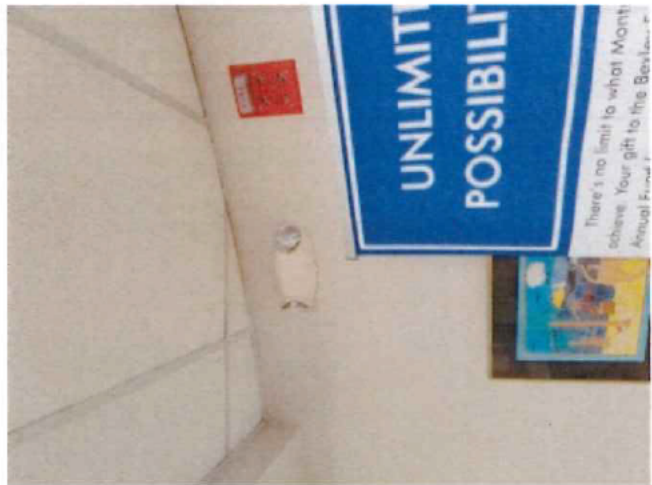
Typical Egress Light

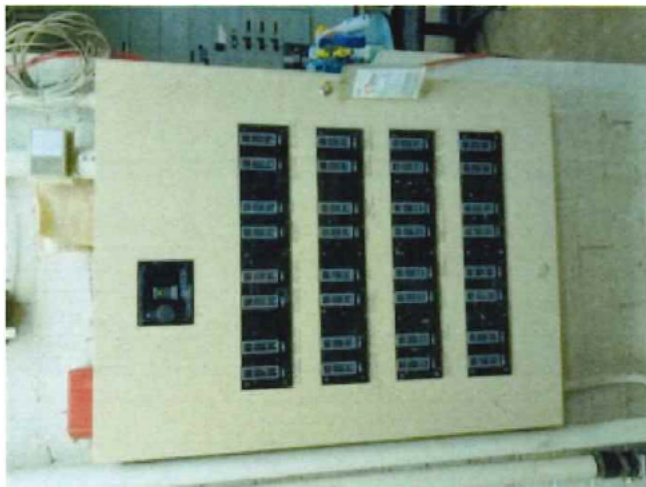
Description: The overall facility is equipped with a Johnson Controls panel type fire alarm system in fair condition, consisting of manual pull stations, horn and strobe indicating devices. The system is automatic and is not monitored by a third party. The system is equipped with sufficient audible horns / strobe indicating devices and smoke detectors. The system thus will not support future fire suppression systems. The system is not adequately provided throughout, and does not have additional zone capabilities. The system is not compliant with Ohio Building Code, NFPA, and Ohio School Design Manual requirements.

Fire Alarm Control Panel

Recommendations: Provide complete replacement of fire alarm system to meet OBC, NFPA, and Ohio School Design Manual guidelines.

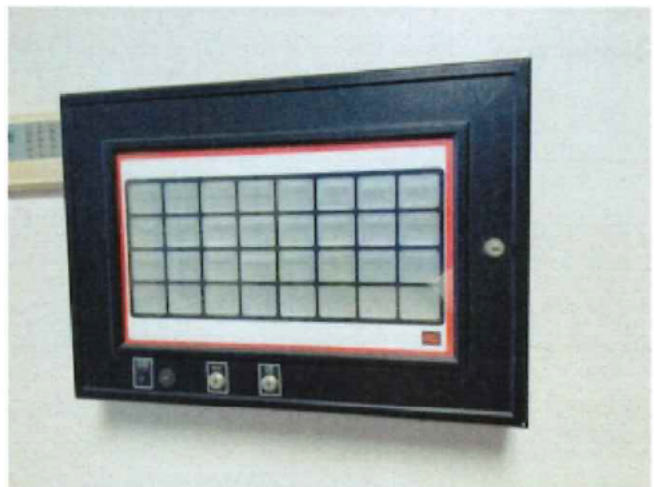
Remote Annunciator

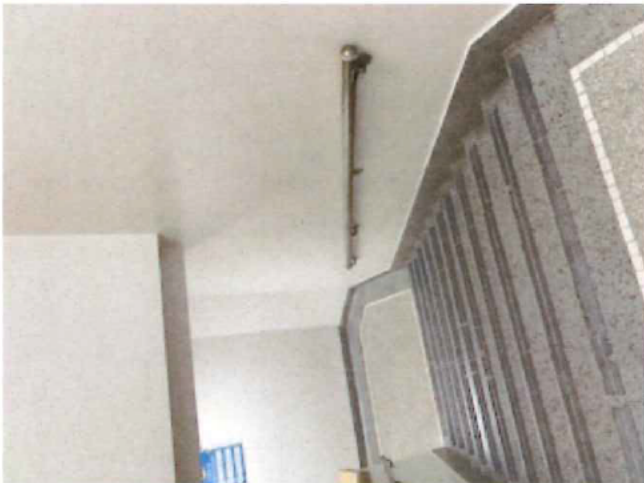
Non-compliant handrails

Recommendations: Provide ADA-compliant power assist door opener, electric water coolers, classroom drinking fountains, toilets, sinks, urinals, toilet partitions, toilet accessories, in the 1922 facility to facilitate the school's meeting of ADA requirements. Provide ADA handrails in stairwells. Provide replacement interior doors. Remount restroom mirrors to ADA height. Provide ADA drinking fountains and sinks in the classrooms. Refer to Item J for casework.

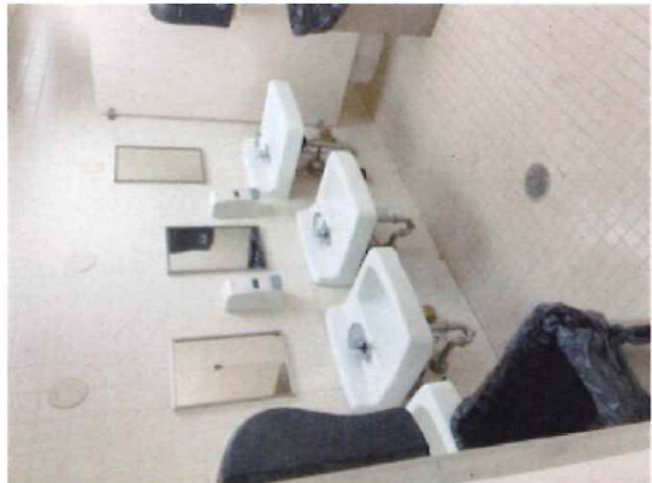
Non-compliant fixtures and mirrors

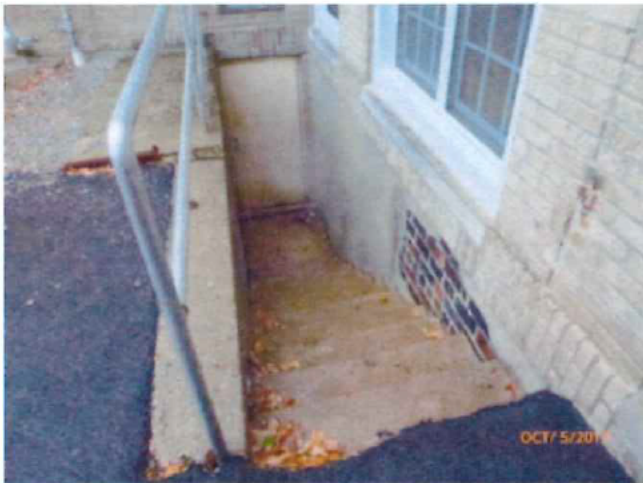
Stairwell missing handrails

Provide railings and handrails at the rear stairwell parking lot to ground level

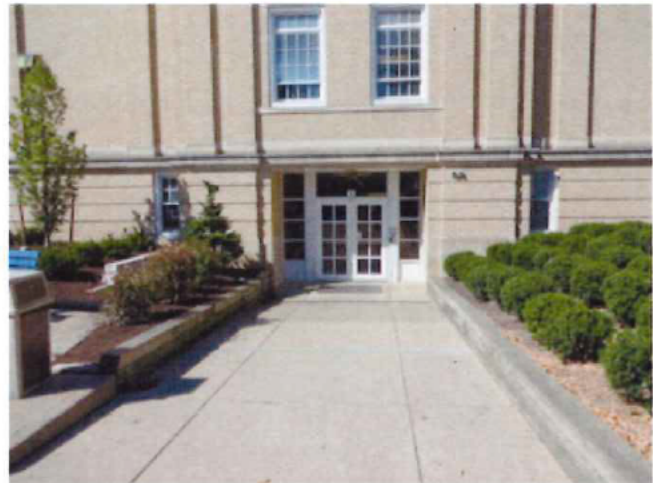
ADA compliant ramp and entrance

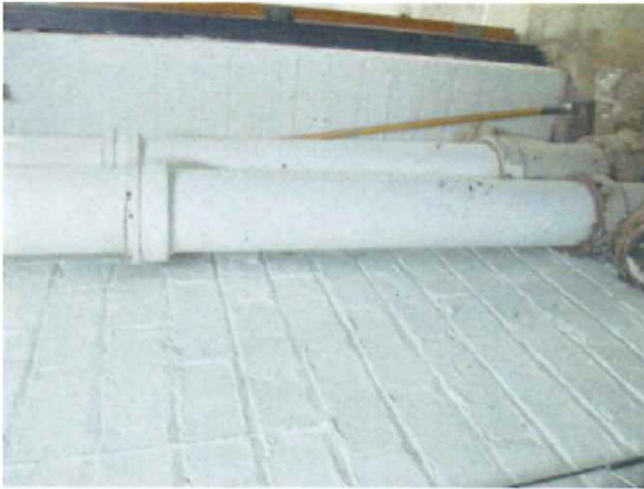
Description: The sanitary sewer system is tied in to the city system, and is in good condition. No significant system deficiencies were reported by the school district or noted during the physical assessment.

Exposed Waste Pipe in Boiler Room

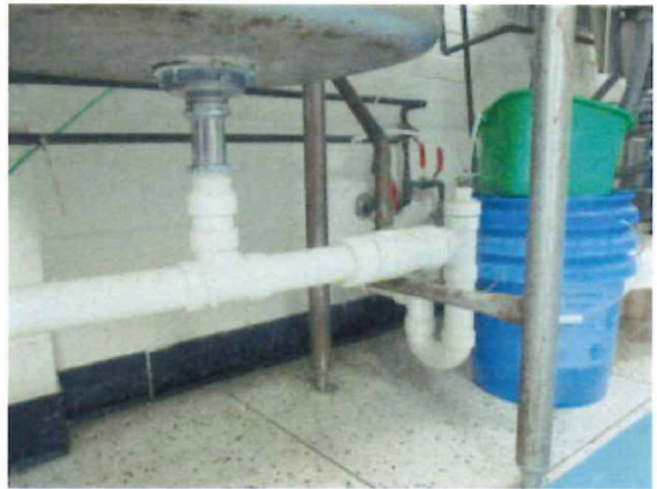
Kitchen Sink Waste

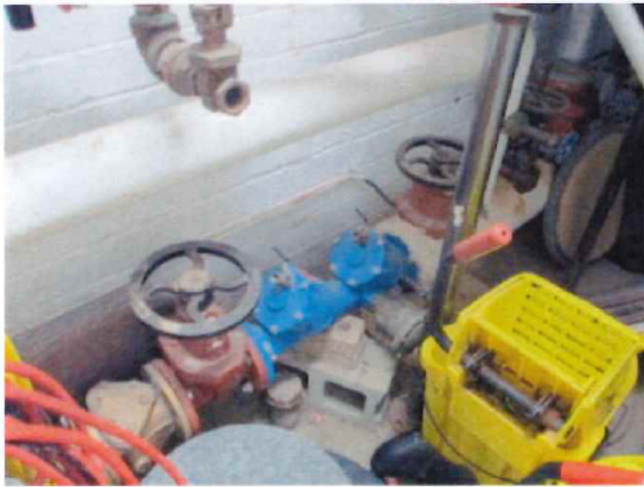
Description: The domestic water supply system is tied in to the city system, features 3" service and 3" water meter, and is in fair condition. The District was not able to provide water supply flow test data. The existing domestic water service appears to meet the facility's current needs. The facility is not equipped with an automated fire suppression system, and the existing water supply will not provide adequate support for a future system. The domestic water service is not equipped with a water booster pump. The system provides adequate pressure for the future needs of the school.

Backflow Preventer

Recommendations: Provide a new city water supply line of adequate capacity to support the existing needs of the facility, as well as a future automated fire suppression system. Funding provided in Item U.

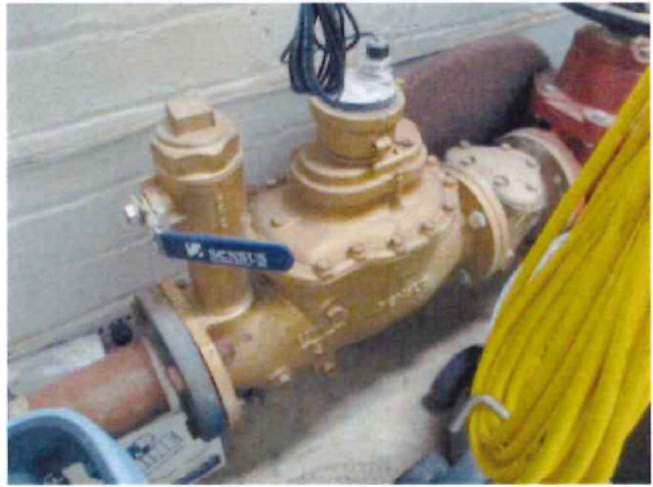
Water Meter

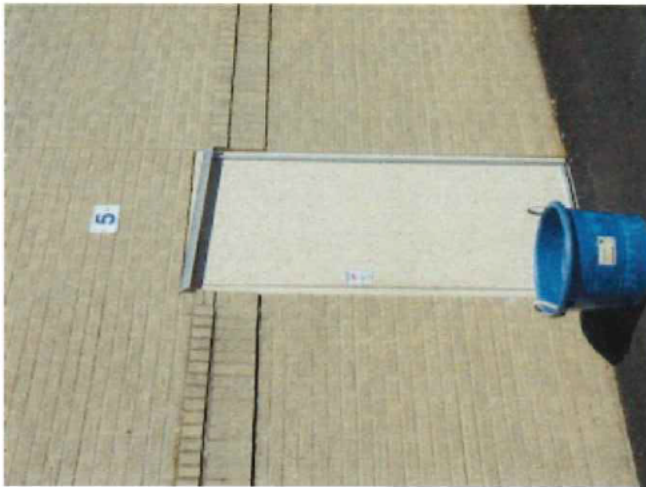
Description: Typical exterior doors in the overall facility hollow metal type construction, installed on hollow metal frames, and in poor condition. Typical exterior doors feature no vision panels, and appropriate hardware. Entrance doors in the 1922 facility are aluminum type construction, installed on aluminum frames, and in fair condition. Entrance doors feature single glazed vision panels and insulated transoms and sidelights, and appropriate hardware. The facility is not equipped with roof access doors. There are no overhead doors in the facility.

Hollow Metal Door

Recommendations: Replace all hollow metal and aluminum exterior doors, due to poor condition.

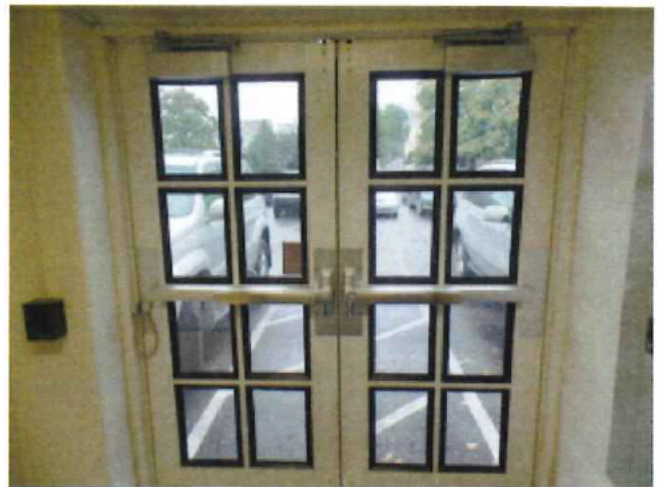
Aluminum Doors

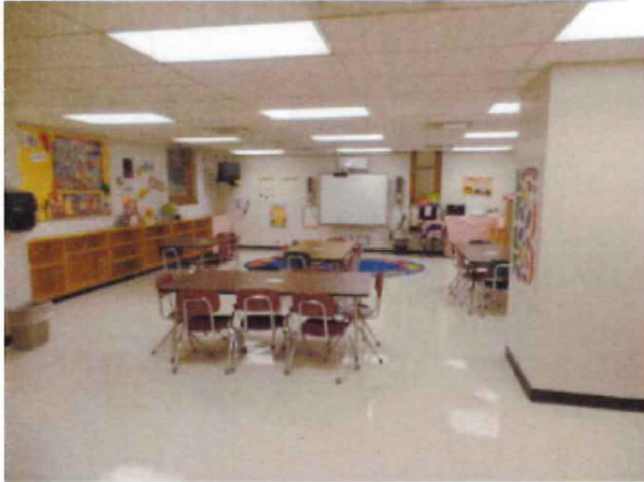
Fluorescent tubes to be removed

Recommendations: Due to the construction date, there is a potential for lead based paint. Fluorescent lighting will require special disposal.

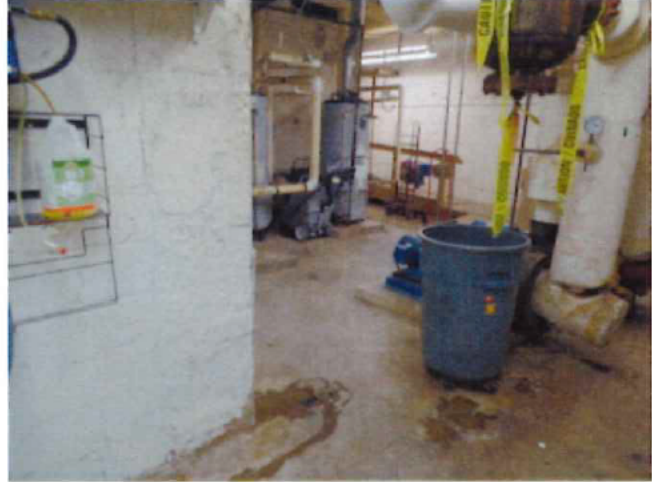
Test for lead paint

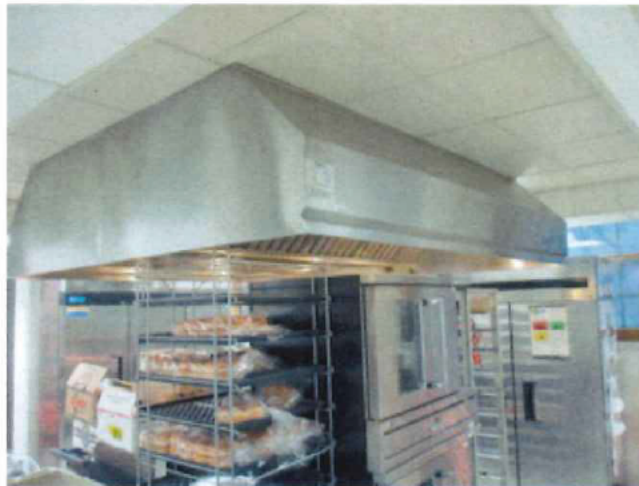
Kitchen Hood

Recommendations: Provide new automated fire suppression system to meet Ohio School Design Manual guidelines. Provide increased water service of a capacity sufficient to support the fire suppression system, funding included in fire suppression funding. Provide new emergency generator, with funding provided via complete replacement of electrical system in Item D. Provide interlock to de-energize cooking equipment upon discharge of the Kitchen hood fire suppression system.

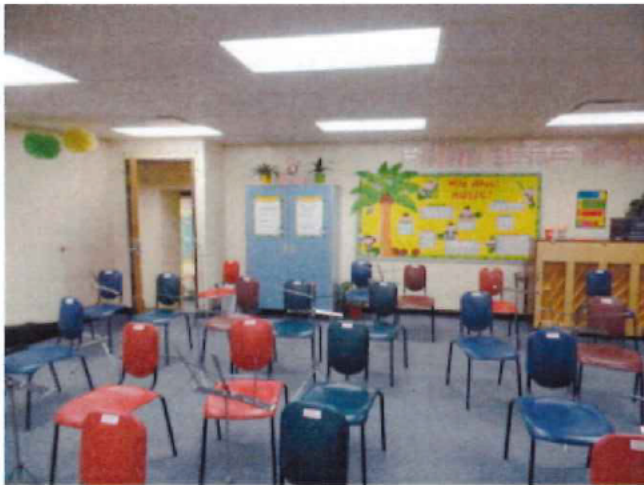
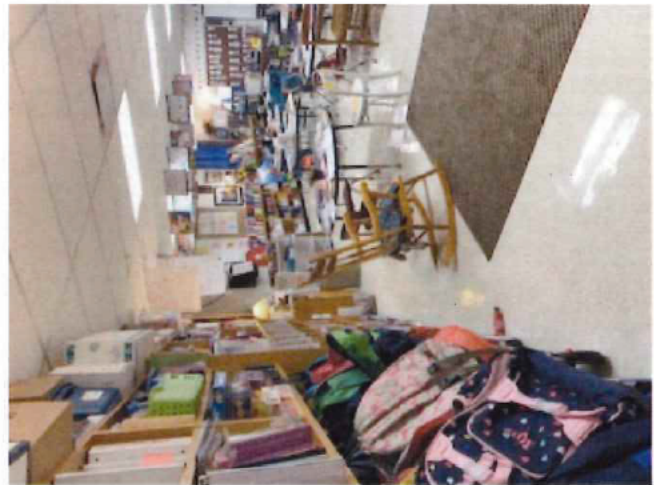
Mismatched loose furnishings

Recommendations: Provide for replacement of outdated or inadequate furnishings.

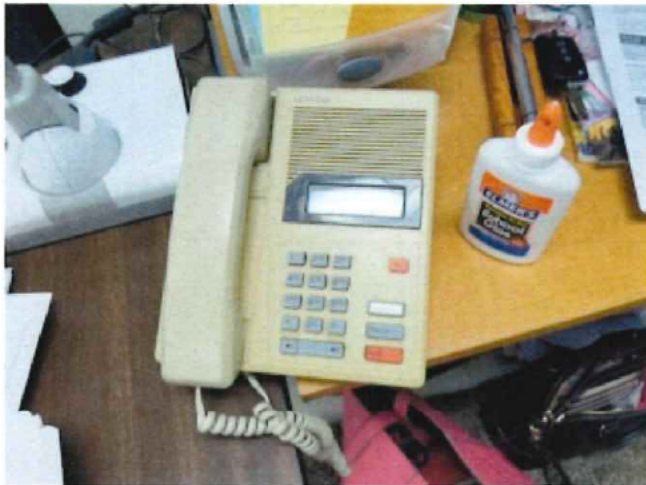
Typical Classroom Phone

Recommendations: Provide complete replacement of technology systems to meet Ohio School Design Manual requirements, and to sustain the capacity to keep pace with technological development.

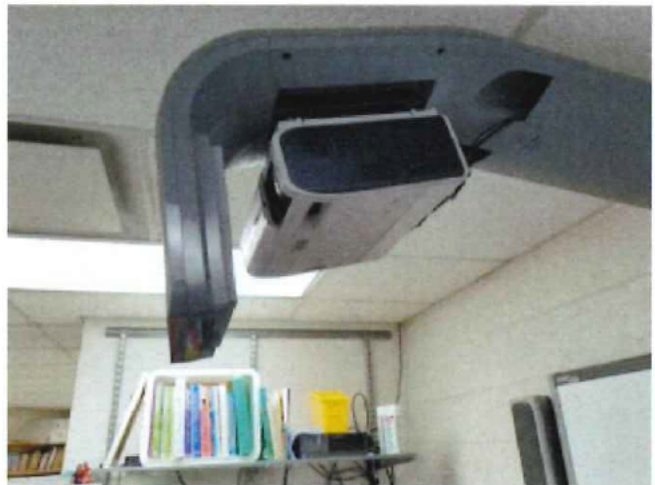
Classroom Smart Board Projector
