Bexley City School District

FACILITY ASSESSMENT REPORT

Bexley Middle School & High School

Building Information - Bexley City (43620) - Bexley High

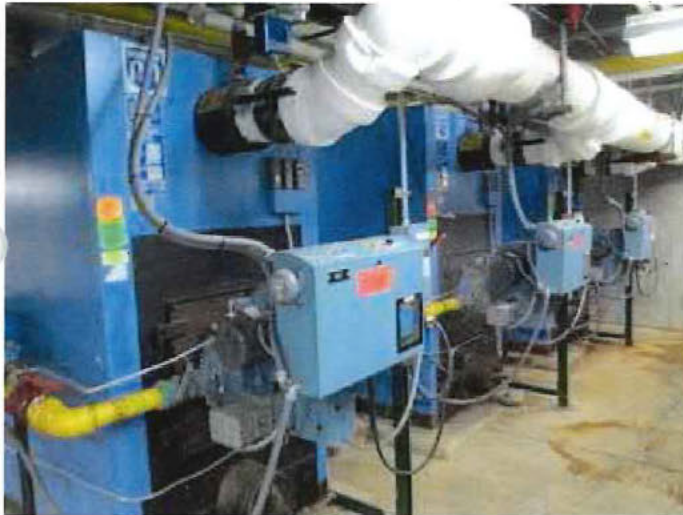
The existing system for the overall facility is a gas fired heating hot water system, installed in 2001, and is in good condition. The heating and chilled water system in the overall facility is a 4-pipe system, with a capacity for simultaneous heating and cooling operation, which is compliant with the OSDM requirements for basic system type. The 3 gas fired boilers, manufactured by Unilux, were installed in 2001 and are in fair condition. A gas fired boiler, manufactured by Thermal Solutions, was installed in 2008, and is in good condition. Heating water is distributed to terminal units consisting of cabinet heaters, unit heaters, air handlers, and VAV boxes. The terminal equipment was installed in 2001 and is in good condition. The system does comply with the 15 CFM per person fresh air requirements of the Ohio Building Code mechanical code and Ohio School Design Manual. The DDC type system temperature controls were installed in 2001 and are in good condition. The system does feature individual temperature controls in all spaces required by the OSDM. The overall system does not feature any central energy recovery systems. The facility is not equipped with louvered interior doors to facilitate Corridor utilization as return air plenums. The existing system is ducted, though lack of need for HVAC system replacement at this time negates any need to evaluate the potential integration of existing ductwork into a new system. The overall heating system is evaluated as being in safe and efficient working order, and long-term life expectancy of the existing system is anticipated. The structure is equipped with central air conditioning. The site does not contain underground fuel tanks.

Rating: 3 Needs Replacement

Gas Fired Boilers

Recommendations: Replace the existing roof mounted air handlers due to age and condition on the original construction.

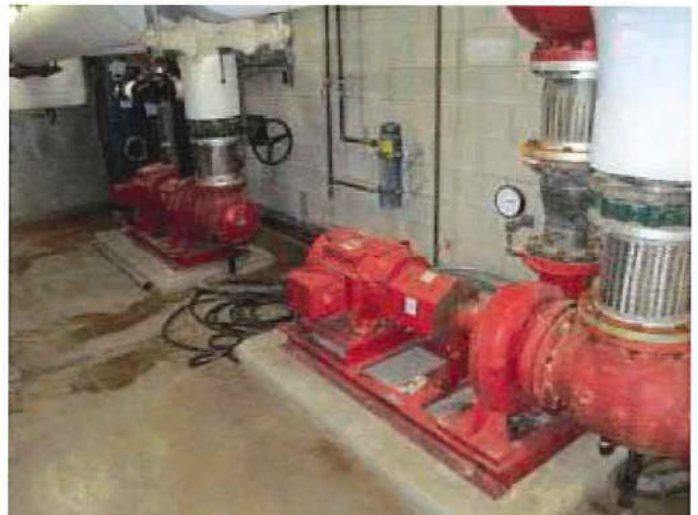
Heating Hot Water Pumps

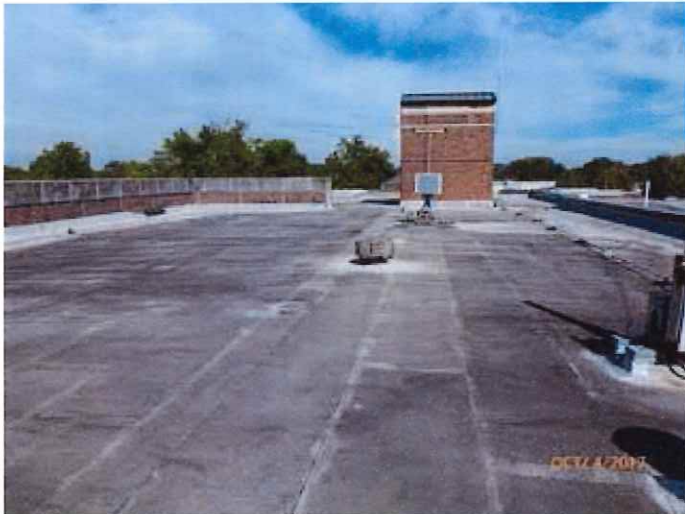
Description: The roof over the overall facility is a built-up asphalt system that was installed over 20 years ago with additional build-up layers added between 2000 and 2016, and is good to poor condition. There are no District reports of current leaking. Few signs of past leaking were observed during the physical assessment. Access to the roof was gained by access door that is in good condition. Fall safety protection cages are not required. There were no observations of standing water on the roof. Metal cap flashings and stone copings are in fair condition. Roof storm drainage is addressed through roof drains and low gravel stops, which are properly located, and in fair condition. The roof is not equipped with overflow roof drains though they will be required in areas of roof replacement. No problems requiring attention were encountered with any roof penetrations. There are not any covered walkways attached to this structure.

Rating: 3 Needs Replacement

Built up roofing

Recommendations: Replace build up roofing due to age and condition. Replace the cap flashing and gravel stops on the overall facility due to condition. Add overflow drains in areas surrounded by parapets.

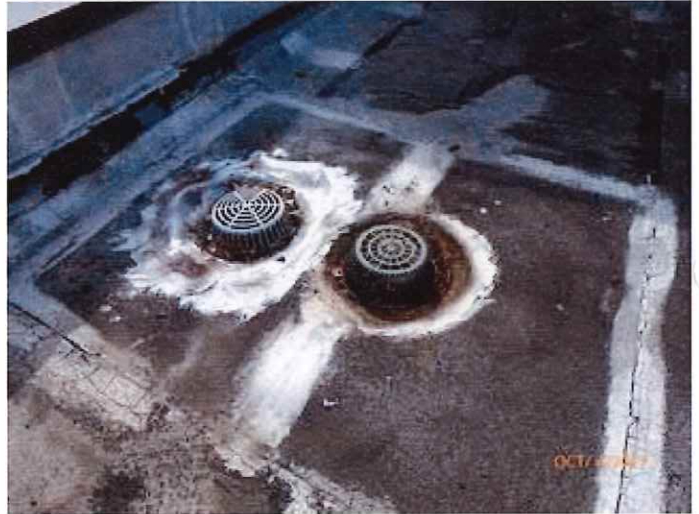
Roof drain and overflow drain

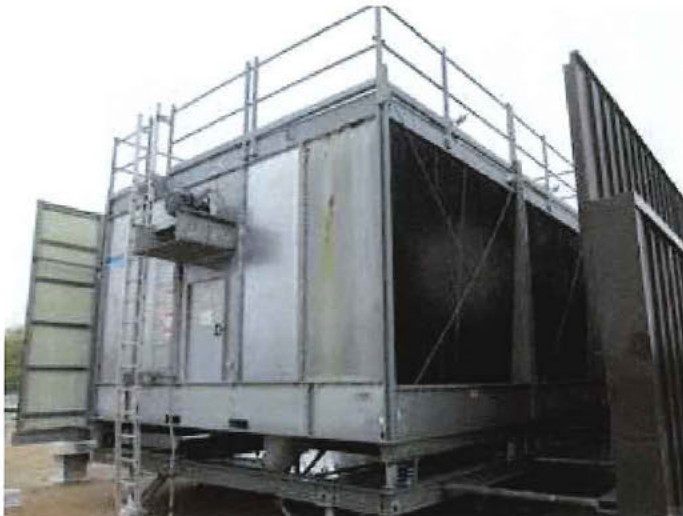
Description: The overall facility is equipped with a chilled water central air conditioning system, which is in fair condition. A cooling tower, manufactured by Harley, was installed in 2001, and is in poor condition. Cooling water is distributed to a chiller. The chiller, manufactured by McQuay, was installed in 2001, and is in fair condition. Chilled water is distributed to terminal units consisting of air handlers. The terminal equipment was installed in 2001 and is in good condition. The ventilation system in the overall facility consists of air handlers, installed in 2001 and in poor to good condition, providing fresh air to Classrooms, and air handlers, installed in 2001 and in good condition, providing fresh air to other miscellaneous spaces such as Gymnasiums, Student Dining, and Media Center. Relief air venting is provided by ceiling plenums. The ventilation system does meet the Ohio Building Code 15 CFM per occupant fresh air requirement. The overall system is compliant with Ohio Building Code and Ohio School Design Manual requirements. Dust collection systems are required in this facility to support the Carpentry Program. The Art program is equipped with a kiln, and existing kiln ventilation is adequate, and in fair condition. General building exhaust systems for Restrooms and Custodial Closets are adequately placed, and in fair condition.

Rating: 3 Needs Replacement

Cooling Tower

Recommendations: Replace the existing cooling tower due to age and condition. Replace the existing roof mounted air handlers due to age and condition on the original construction. Cost included in Item A.

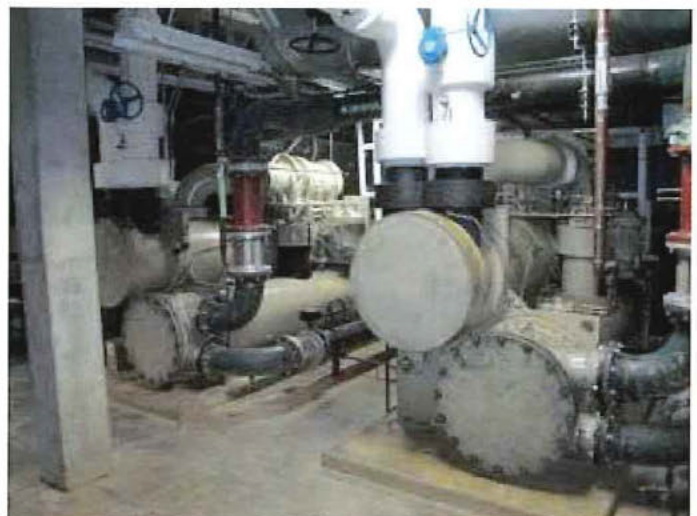
Chillers

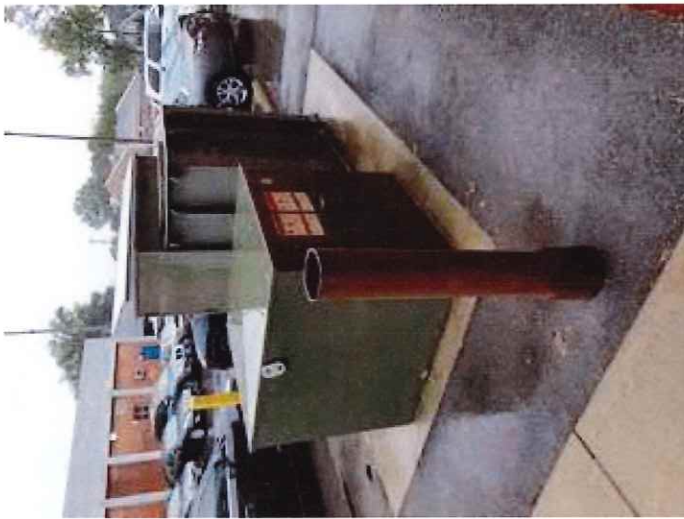
Description: The electrical system provided to the high school is an 800A, 480/277V, 3PH, 4W; 1600A, 480/277V, 3PH, 4W; and a 2500A, 480/277V, 3PH, 4W equipment system installed in 2001 and is in good condition. The electrical system provided to the middle school is an 2500A, 480/277V, 3PH, 4W system installed in 2001 and is in good condition. The panel system is in good condition, and can be expanded to add additional capacity. Power is provided to the school by two utility owned pad-mounted transformers in good condition. The panel system is in good condition, and can be expanded to add additional capacity. The Classrooms are equipped with adequate electrical outlets. The typical Classroom contains 6 general purpose outlets and 1 dedicated outlet for each Classroom television. There are not any spaces that have no electrical outlets. The Corridors are equipped with adequate electrical outlets for servicing. Adequate GFI protected exterior outlets are provided around the perimeter of the building. The facility is equipped with suitable emergency generators. Adequate lightning protection safeguards are not provided. Stage lighting power system including control panel, breakers, and dimmers is adequately provided, in good condition and does meet OSDM requirements. The overall electrical system meets Ohio School Design Manual requirements in supporting the current needs of the school, and will be adequate to meet the facility's future needs.

Rating: 2 Needs Repair

Utility Transformers

Recommendations: Provide adequate lightning protection safeguards. Replace emergency generators as detailed in Item U.

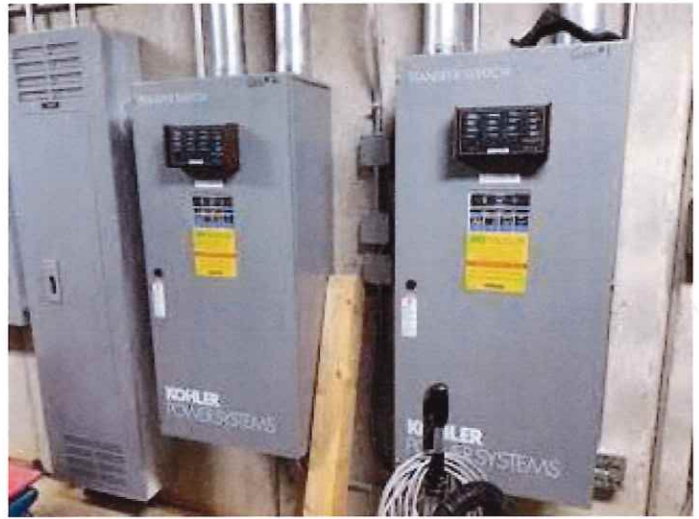
Facility Transfer Switches

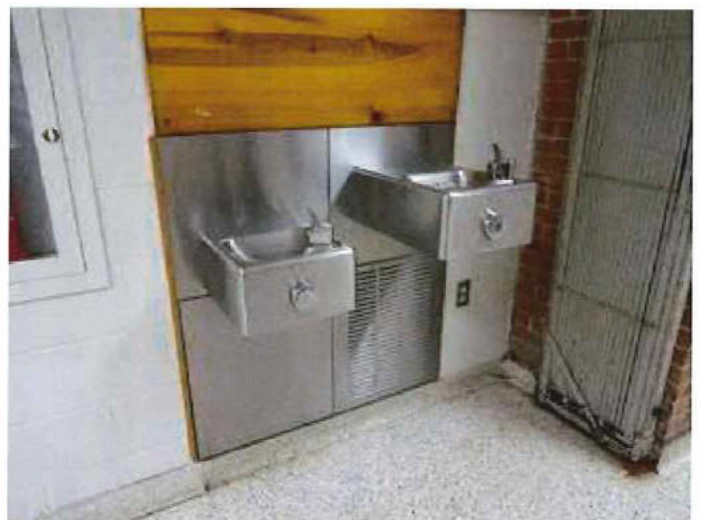
ADA Electric Water Coolers

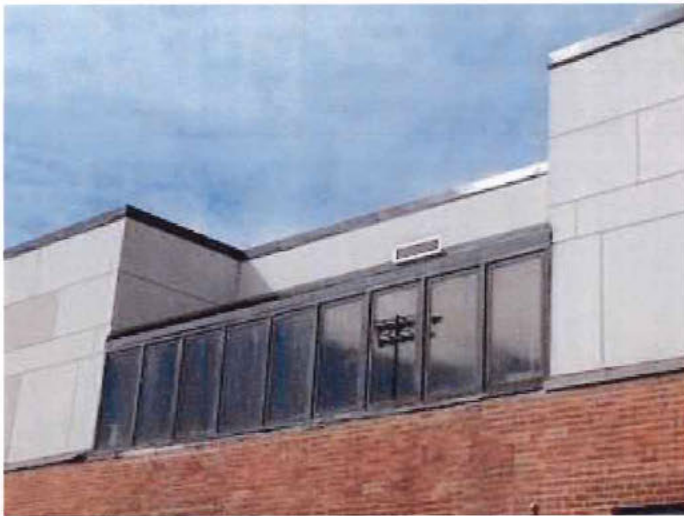
Description: The 1932 facility is equipped double glazed insulated glazing type window system, the installation date is not known, and is in fair condition. The windows on the east side 3rd floor are in poor condition. The 1969 addition is equipped double glazed insulated glazing type window system, the installation date is unknown, and are in fair condition. The 2001 addition is equipped with double glazed insulated type window system, and is in good condition. The window system features operable windows throughout the building, and operable windows are not equipped with opening limiters, not all have insect screens. Window system seals in the 1932 facility and 1969 addition are in fair condition, with minimal air and water infiltration being experienced. Windows and window hardware in the 2001 addition are in good condition. Other window system hardware is in fair condition. The window system features surface mounted blinds, which are in fair condition or no blinds. This facility is equipped with a curtain wall systems. There are glass block windows in the 1969 addition, in fair condition. The exterior doors in the overall facility are equipped with aluminum frame sidelights and transoms with double glazing, in good condition. Exterior door vision panels are double glazed. The school does contain 8 aluminum skylights in fair condition. Interior glass is not OSDM-compliant in the 1932 building and 1969 addition due to it not being tempered. Window security grilles are not provided for ground floor windows. There is greenhouse area in the 1932 facility, and it is in poor condition.

Rating: 3 Needs Replacement

Greenhouse

Recommendations: Replace windows 1932 3rd floor. Replace interior glazing. Replace storefront type greenhouse system. Replace skylights. Replace glass block.

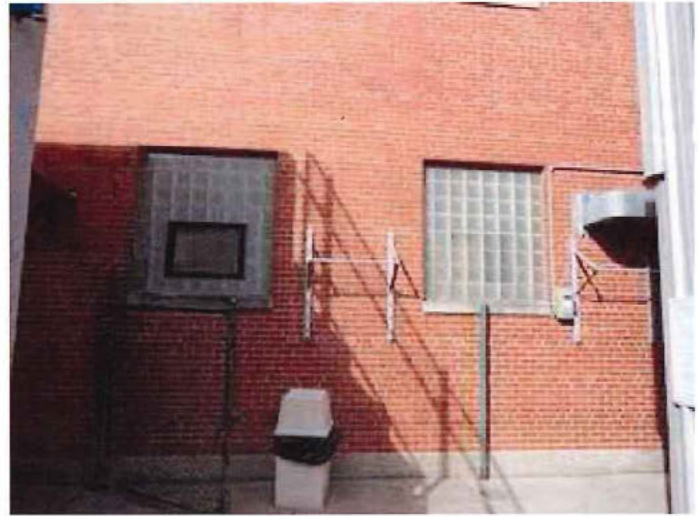
Glass block window

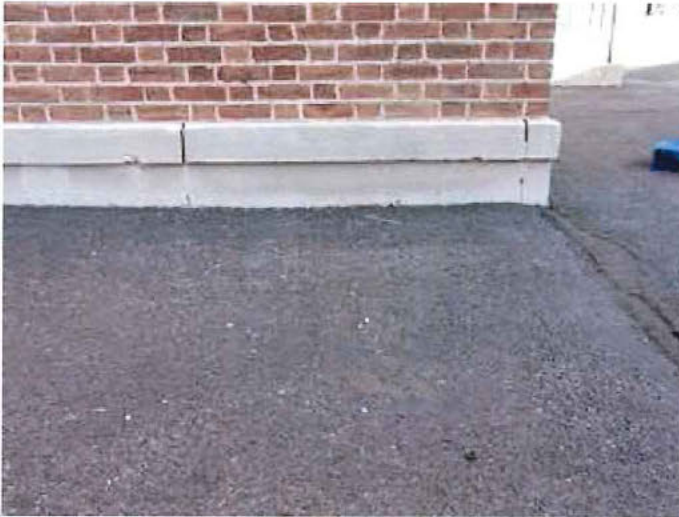
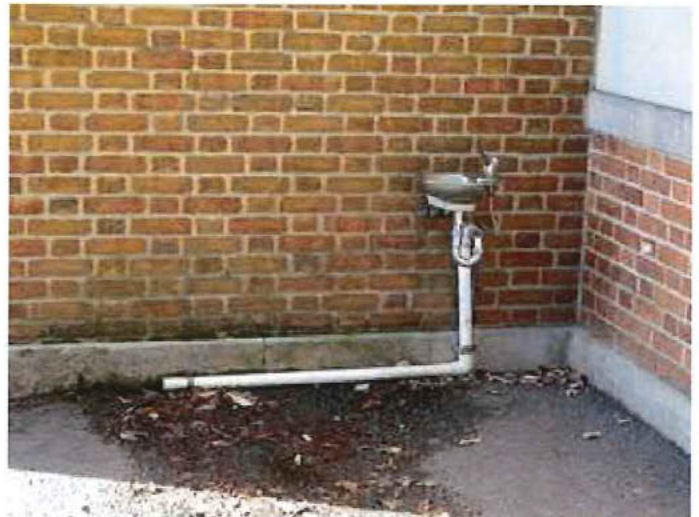
Description: The overall facility is equipped with concrete foundation walls on concrete spread footings, which displayed no locations of significant differential settlement, cracking, or leaking, and are in good condition. No significant issues related to foundation cracking or spalling were encountered. The District reports that there has been no past leaking. No grading or site drainage deficiencies were noted around the perimeter of the structure that are contributing or could contribute to foundation wall structural deterioration.

Exposed foundation

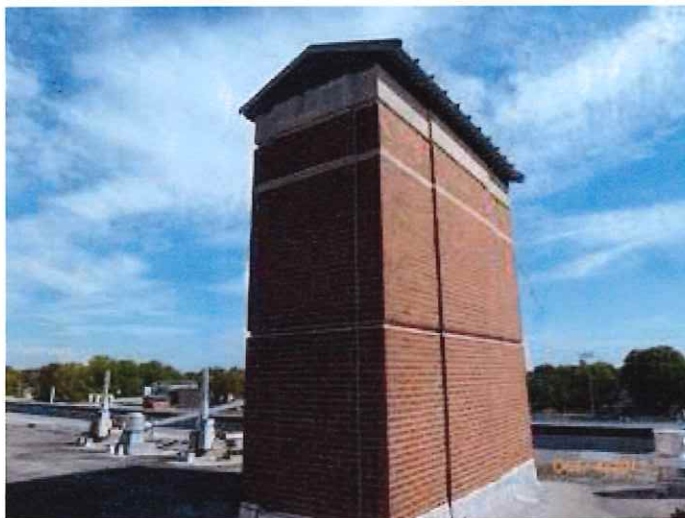
Description: The 1932 facility and 1969 addition has a brick veneer on load bearing masonry wall system, which displayed locations very limited mortar deterioration, and is in good condition. Control joints are not provided at lintel locations, at doors and windows, and building corners though are not needed. They are provided at offsets. The school has added expansion joints as needed in the past, are very limited areas of exterior masonry cracking or separation. The 1969 and 2001 additions have a brick veneer on load bearing masonry, which displayed some locations of deterioration, and is in good condition. The exterior masonry appears to have appropriately spaced and adequately caulked control joints in good condition. Control joints are provided in walls. The school does have sufficient expansion joints, and they are in good condition. Exterior walls in the 1932 facility and 1969 additions are inadequately insulated. Brick veneer masonry walls are not cavity walls. Exterior walls in the 2001 addition are adequately insulated. Brick veneer masonry walls are cavity walls. Weep holes and vents are not provided or required on the 1932 and 1969 addition. Weep holes are not provided in sufficient quantity at the base of masonry cavity walls in the 2001 addition. The exterior masonry on the facility has not been cleaned and sealed in recent years, showing small areas of mortar deterioration. Architectural exterior accent materials consist of stone which is in good condition. Exterior building fenestration in the overall facility represents over 12.50% of the exterior surfaces. Interior Corridor and demising walls are concrete masonry units, glazed block and metal stud framed partitions with gypsum board, project full height from floor to bottom of deck, and are in good condition. Interior masonry appears to have inadequately spaced control joints. Interior soffits are of metal stud with gypsum board type construction, and in good condition. The window sills are in good condition. The exterior lintels are steel, and most are in good condition. Lintel at the 3rd floor rear side windows should be replaced. Chimneys are in fair condition and need to be repointed. Canopies over entrances are integral to the building, and are in good condition. Exterior soffits are of metal stud and gypsum type construction, and in good condition. The school is not equipped with a loading dock.

Rating: 3 Needs Replacement

chimney to be tuckpointed

Recommendations: Provide tuckpointing of chimneys. Provide tuckpointing on stone wall cap. Provide masonry cleaning and sealing as required through the overall facility. Replace lintels. Provide weeps. Caulk window on east side.

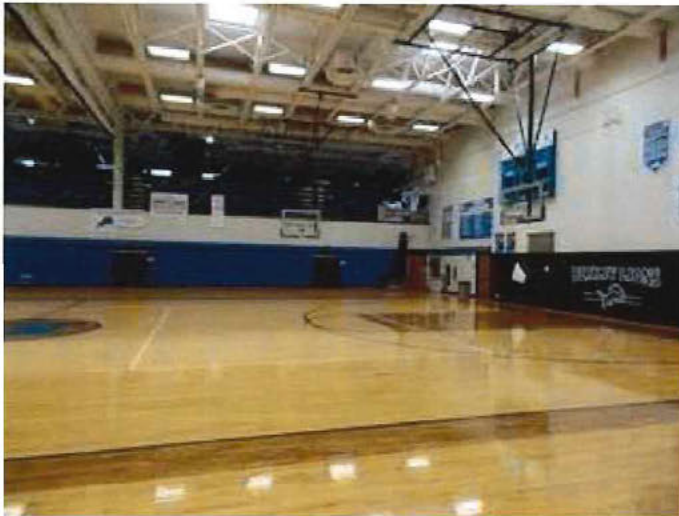
Description: The floor construction of the base floor of the overall facility is concrete slab on grade type construction, and is in good condition. The floor construction of the intermediate floors of the 1932 facility and 1969 addition are cast-in-place concrete type construction, and is in good condition. Intermediate floors on the 2001 addition is concrete filled metal deck on bar joists. Ceiling to structural deck spaces are sufficient to accommodate HVAC, electrical, and plumbing scopes of work in required renovations. The roof construction of the 1932 facility and 1969 additions is cast-in-place concrete type construction, and is in good condition. The roof construction of the 1932 gymnasium and auditorium and 2001 addition is metal deck on steel joist type construction, and is in good condition.

Steel Trusses

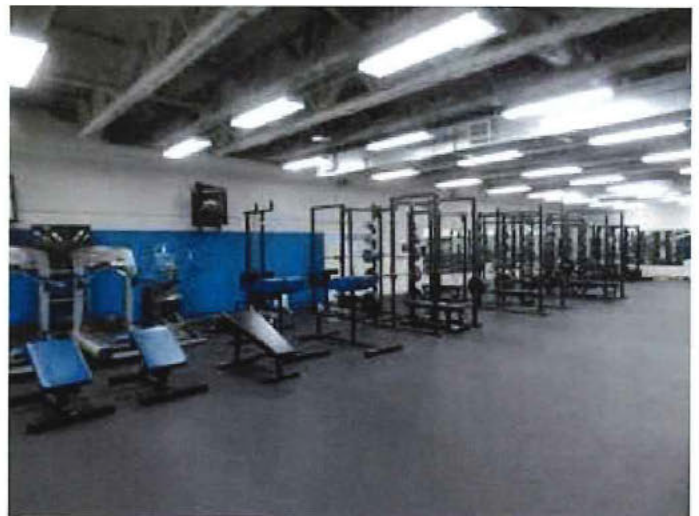
Steel bar joist with spray on fire proofing

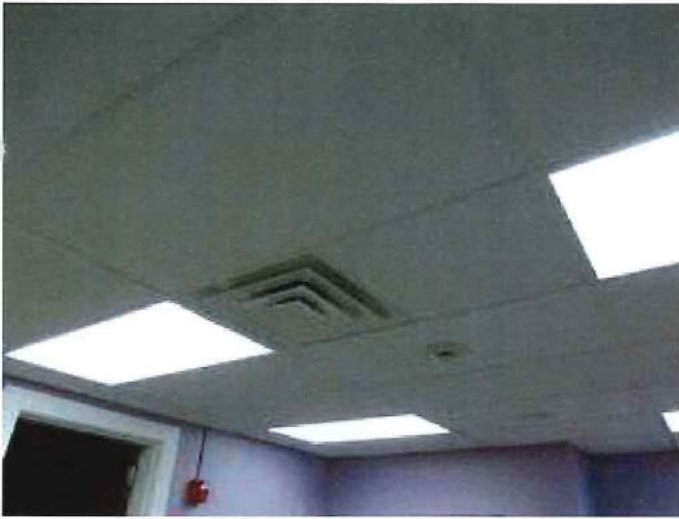
The 1932 facility and 1969 addition features conventionally partitioned Classrooms with VCT, carpet or wood type flooring, acoustical ceiling tile, as well as painted type wall finishes, and the floors condition varies from good to poor condition and acoustical ceilings are in poor condition. The overall facility has Corridors with VCT or terrazzo type flooring, acoustical ceiling tile type ceilings, as well as painted type wall finishes, and the floors are in good condition with the ceilings in poor condition. The overall facility has Restrooms with terrazzo or ceramic type flooring, gypsum type ceilings, as well as ceramic tile, glazed block and cement block type wall finishes, and they are in good or fair condition. Toilet partitions are plastic and are in good condition. The overall 2001 addition is in good condition. Classroom casework in the 1932 facility and 1969 addition is wood type built into the walls construction, is inadequately provided, and in poor condition. Not all classrooms have casework. The typical casework provided ranges from 0 to 18 feet. Classrooms are provided adequate chalkboards, tackboards and markerboards which are in fair condition. The lockers located in corridors, are adequately provided, and in fair condition. The Art program is equipped with a kiln in good condition, and existing kiln ventilation is adequate. The facility is equipped with wood non-louvered interior doors that are flush mounted recessed with proper ADA hardware and clearances, and in good condition. The Gymnasium spaces have wood type flooring, exposed metal deck type ceilings, as well as painted type wall finishes, and they are in good condition. Wood Gymnasium flooring has been well maintained, will accommodate one future sanding and refinishing, and is rated at a median stage of its product lifecycle. There is no evidence of Tartan flooring. Gymnasium telescoping stands are metal framed with plastic top type construction in good condition. Gymnasium basketball backboards are electrically operated type, and are in good condition. The Media Centers, located in the 1932 facility and the 1969 addition, have carpet type flooring, acoustical ceiling tile type ceilings, as well as painted type wall finishes, and they are in poor condition. Student Dining, located in the 1969 addition, has VCT type flooring in good condition, acoustical ceiling tile in poor condition, as well as painted type wall finishes in good condition. OSDM-required fixed equipment for Stage is adequately provided, and in good condition. Existing Gymnasium, Student Dining, Media Center and Music spaces are inadequately provided with appropriate sound attenuation acoustical surface treatments. The existing Kitchen is full service facility, is undersized based on current enrollment, and the existing Kitchen equipment, installation date is unknown, is in good condition. The Kitchen hood is in good condition, and is equipped with the required UL 300 compliant wet chemical fire suppression system. The required 6" overhang on all three exposed sides of the cooking equipment is provided by the hood. Kitchen hood exhaust ductwork is of proper construction material installed as required by the OSDM and OBCMC. Walk-in and Reach-in coolers and freezers are located within the Kitchen spaces, and are in good condition.

3 Needs Replacement

Replace acoustical ceilings

Provide complete replace acoustical ceilings due to Item K lighting replacement. Replace flooring. Provide casework in classrooms. Provide acoustical wall panels. Provide replacement of gypsum board removed in Item T abatement.

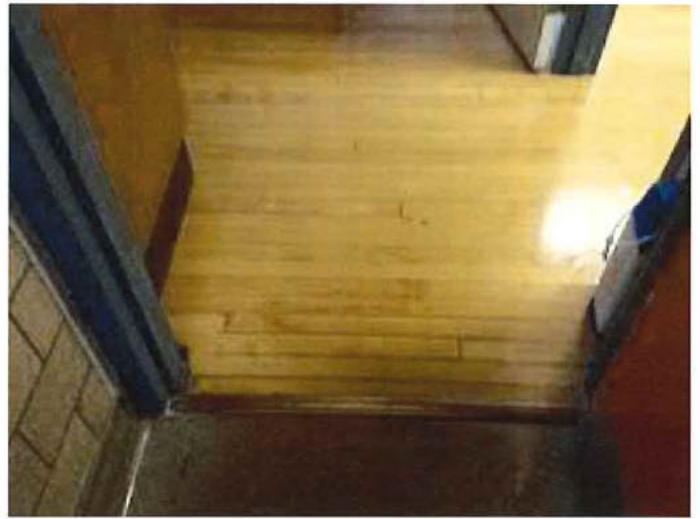
Wood floors in classrooms

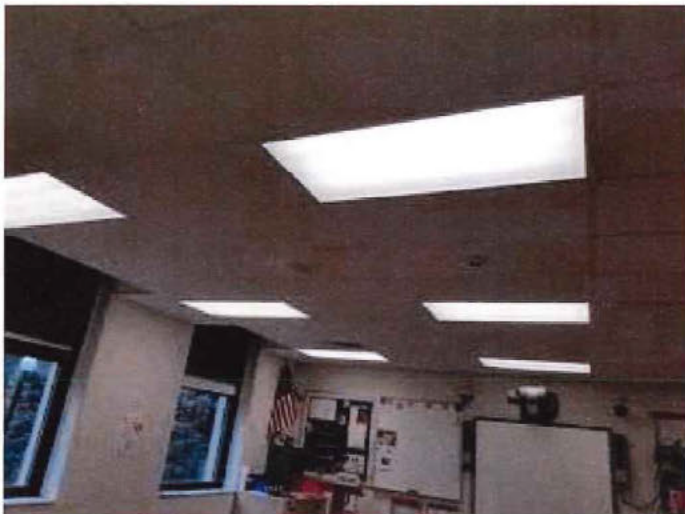
Rating: 3 Needs Replacement

Typical Lighting

Recommendations: Provide complete replacement of lighting system due to installation of systems outlined in Item U.

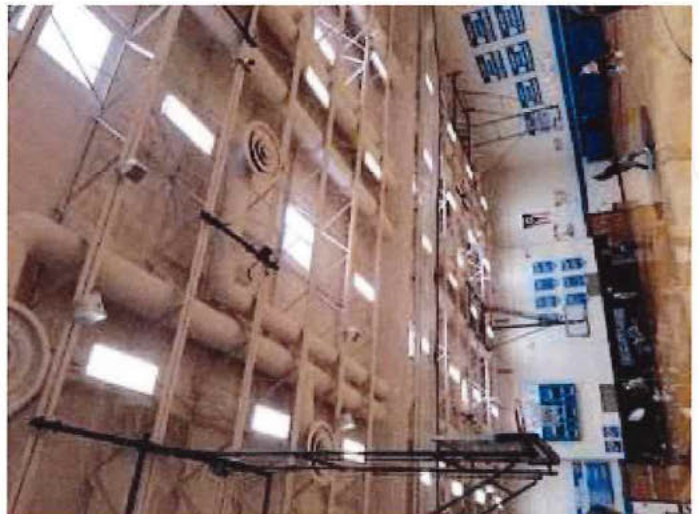
High School Gymnasium Lighting

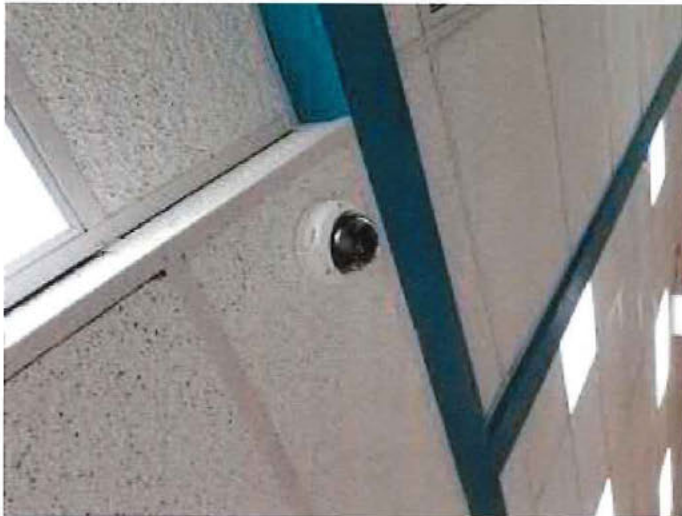
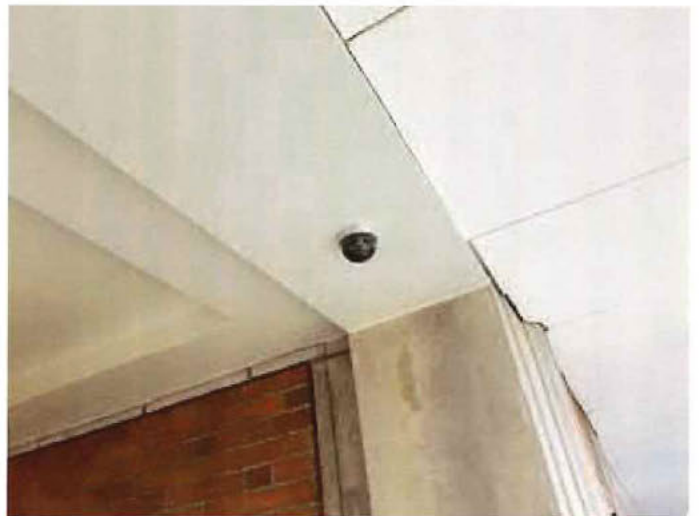
Rating: 3 Needs Replacement

Typical CCTV Camera

Recommendations: Provide new security system to meet Ohio School Design Manual guidelines.

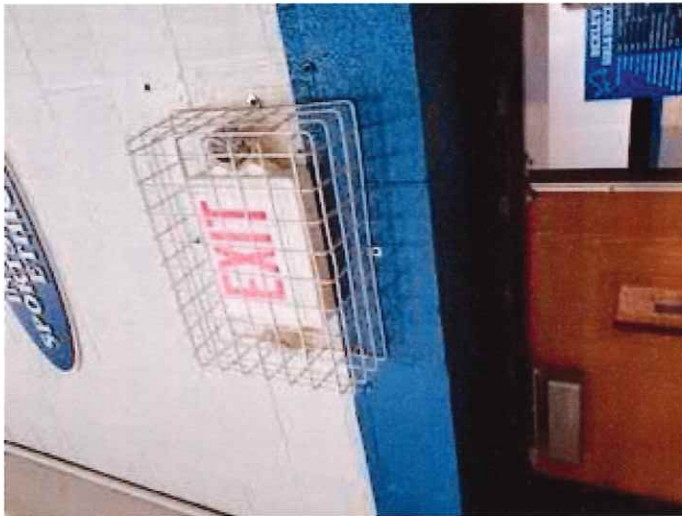
Rating: 3 Needs Replacement

Gymnasium Exit Sign with Egress Floods

Recommendations: Provide complete replacement of emergency / egress lighting system to meet Ohio School Design Manual and Ohio Building Code guidelines and to facilitate work in Item U.

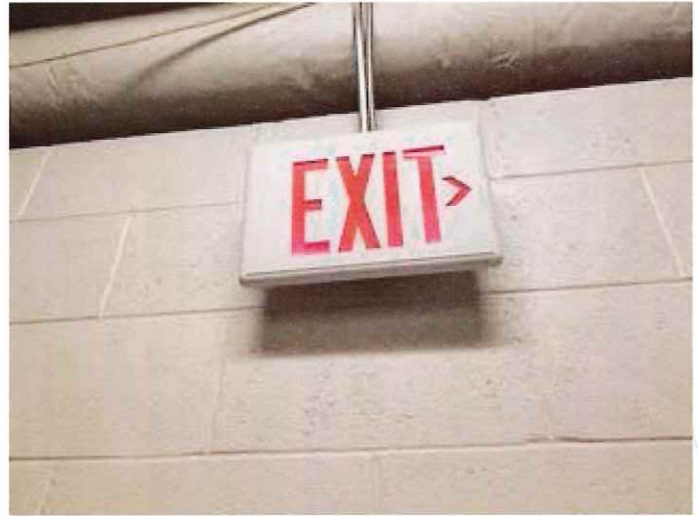
Noncompliant Exit Sign

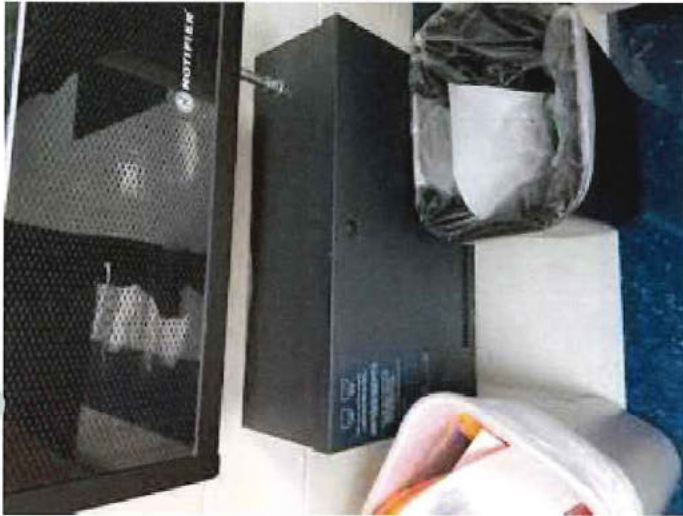
Middle School FACP

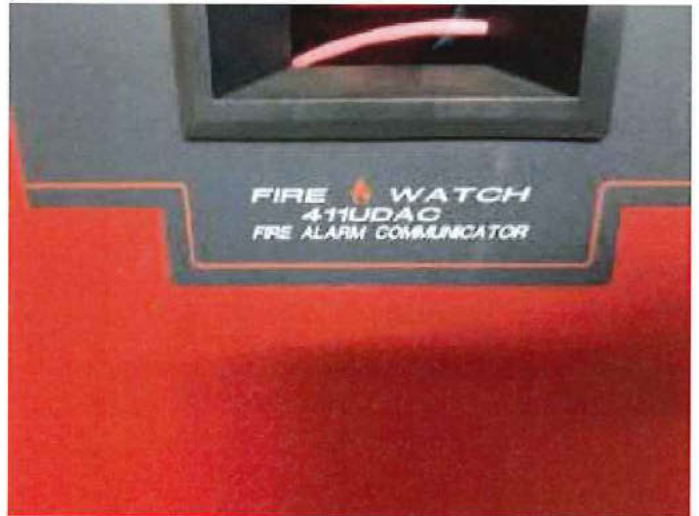
High School FACP

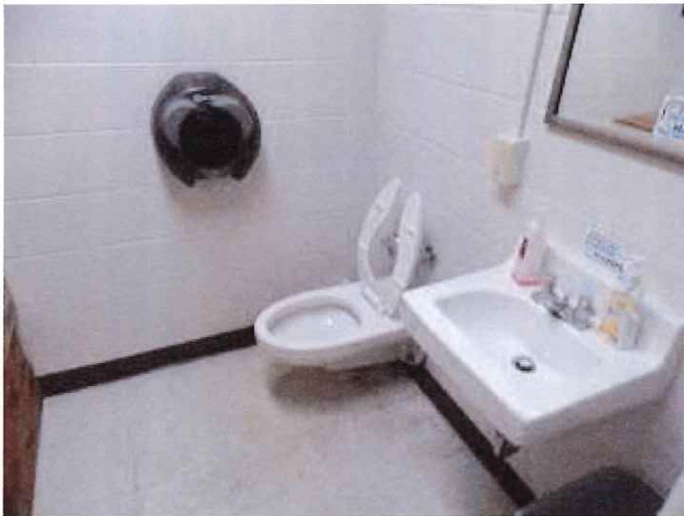
Rating: 3 Needs Replacement

Non-compliant restroom

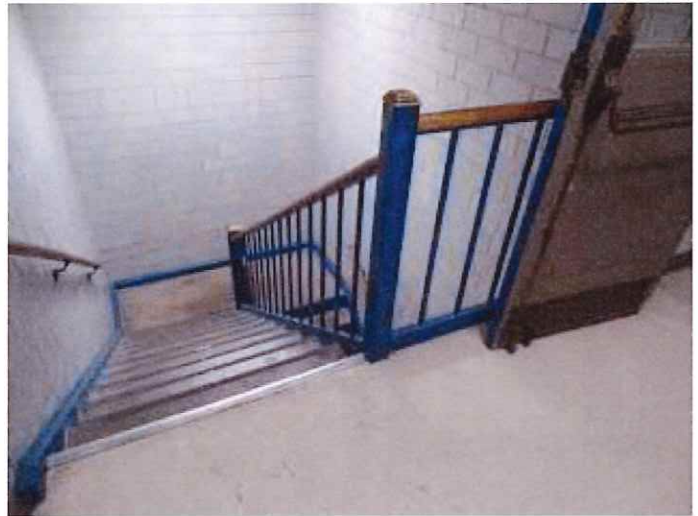
Non-compliant handrails

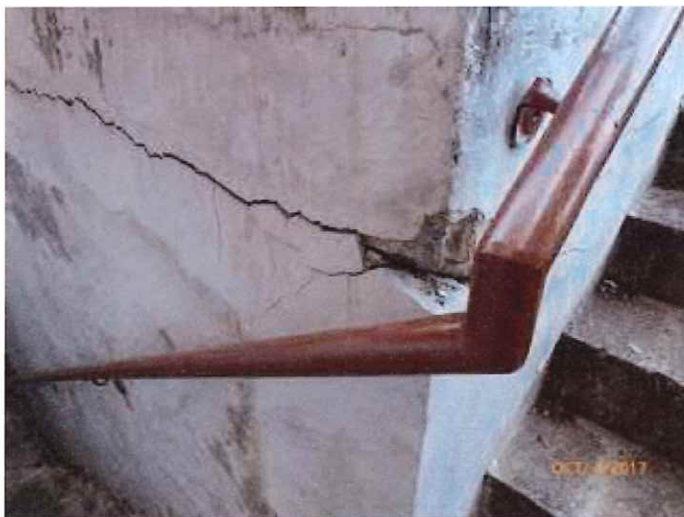
Rating: 3 Needs Replacement

Stairwell that needs repaired

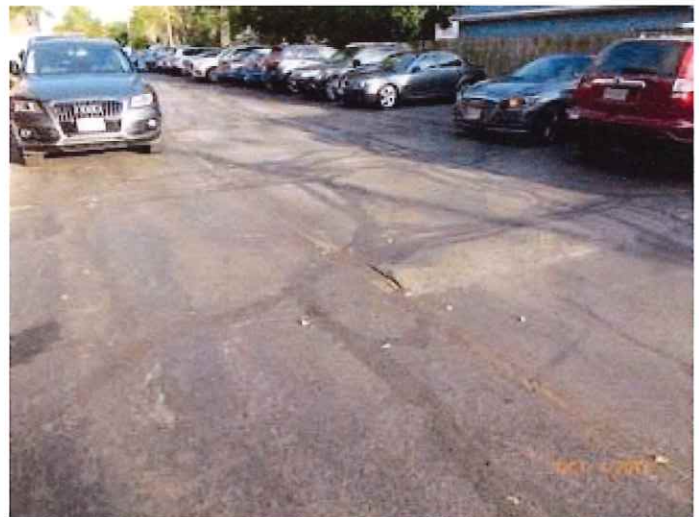
Limited parking between the school and residential properties

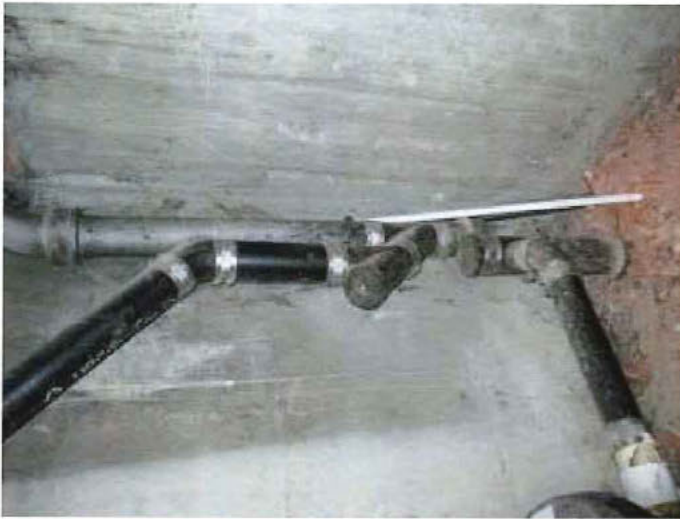
Exposed Waste

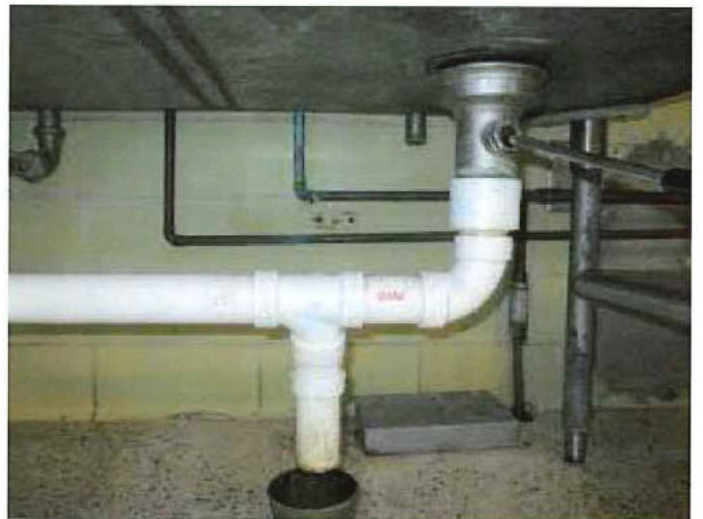
Kitchen Sink Waste

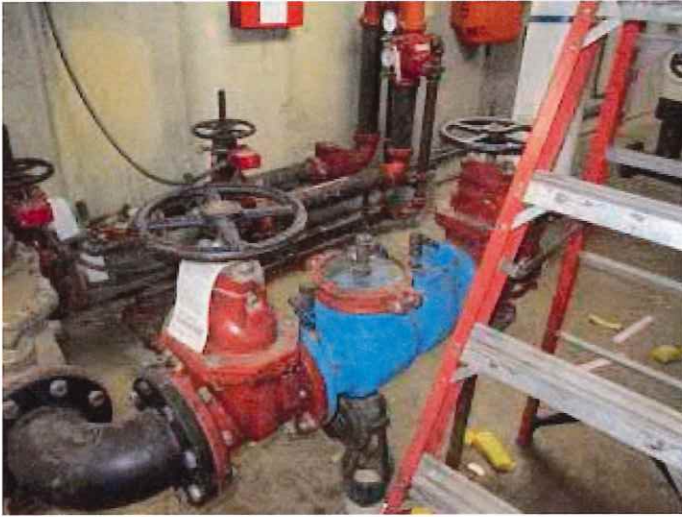
Backflow Preventer

Recommendations: Provide a new city water supply line of adequate capacity to support the existing needs of the facility, as well as a future automated fire suppression system. Funding provided in Item U.

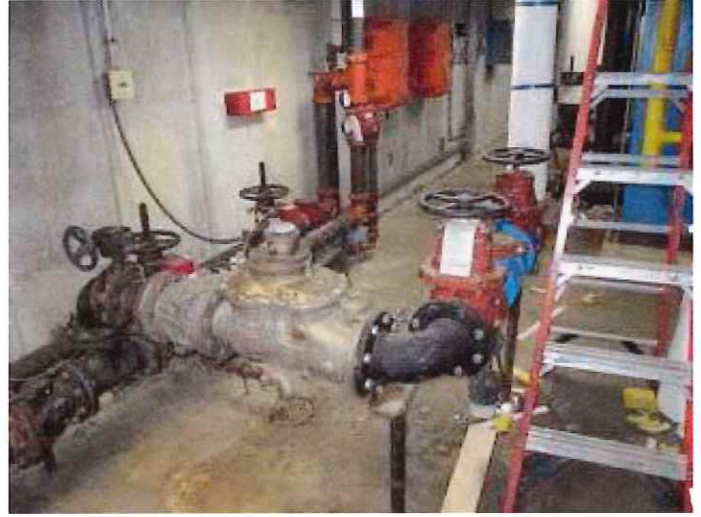
Water Meter

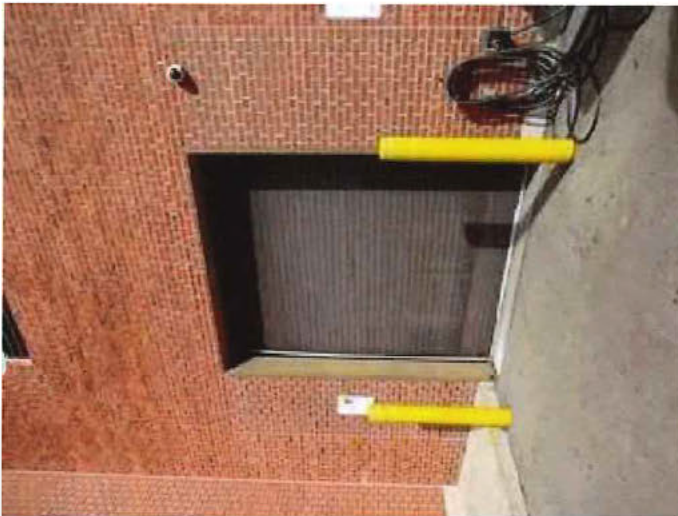
3 Needs Replacement

Coiling door to be replaced

Replace hollow metal doors and frames on 1932 facility Replace hollow metal doors and frames and one single glazed aluminum doors on 1969 addition. Replace overhead coiling door

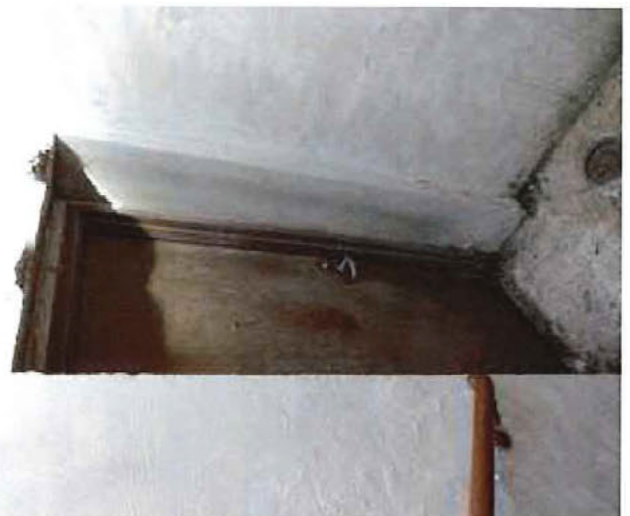
Exterior door to be replaced

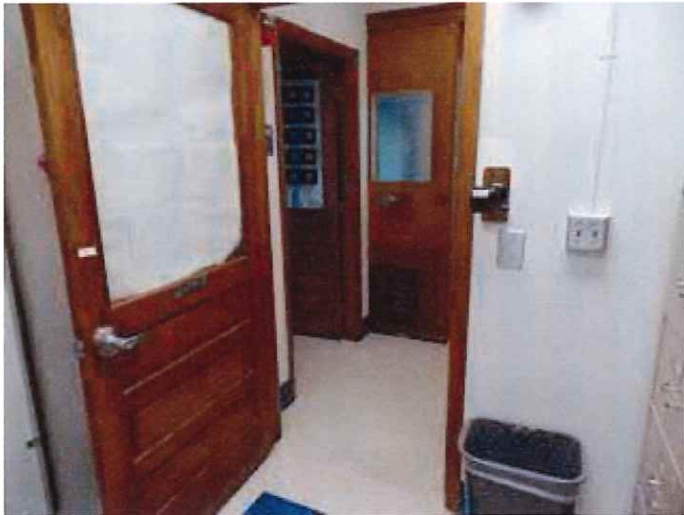
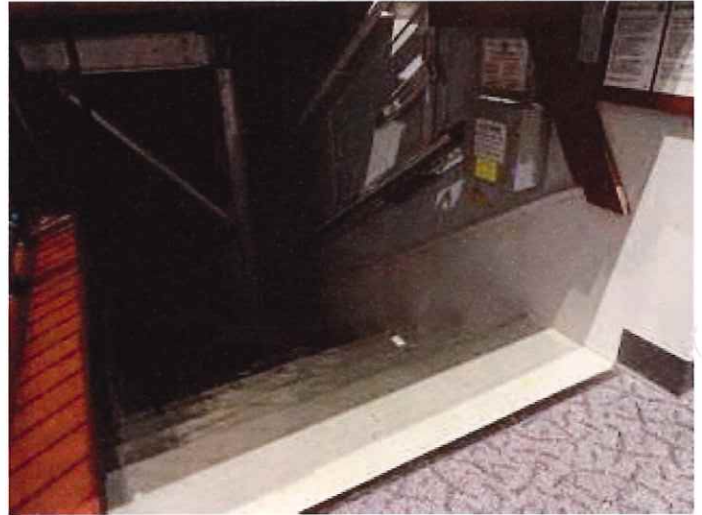
Plaster walls

Recommendations: Remove all hazardous materials, inclusive of asbestos-containing materials in the 1932 facility and 1969 addition, as noted in the attached Environmental Hazards Assessment. Provide for the testing of paint that has the potential of being lead-based. Replacement of gypsum board is in Item J.

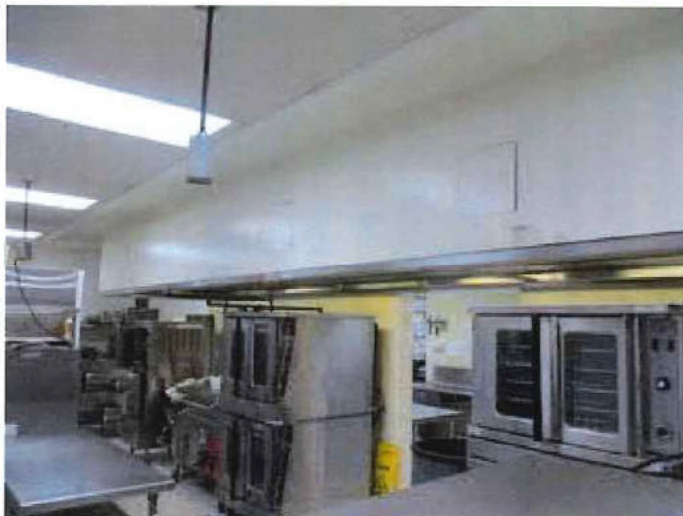
Kitchen Hood

Recommendations: Provide new automated fire suppression system to meet Ohio School Design Manual guidelines. Provide increased water service of a capacity sufficient to support the fire suppression system, funding included in fire suppression funding. Replace the existing emergency generators due to condition.

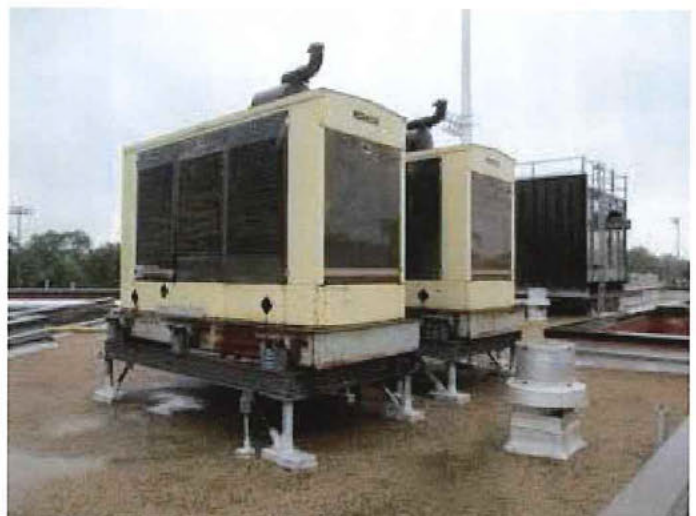
Generators

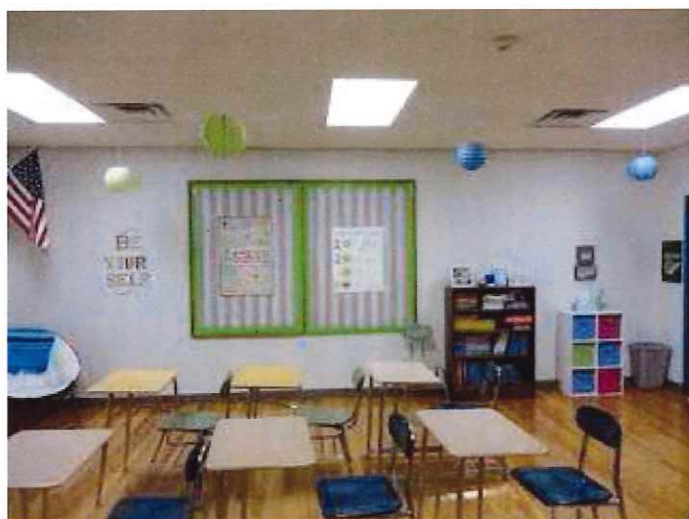
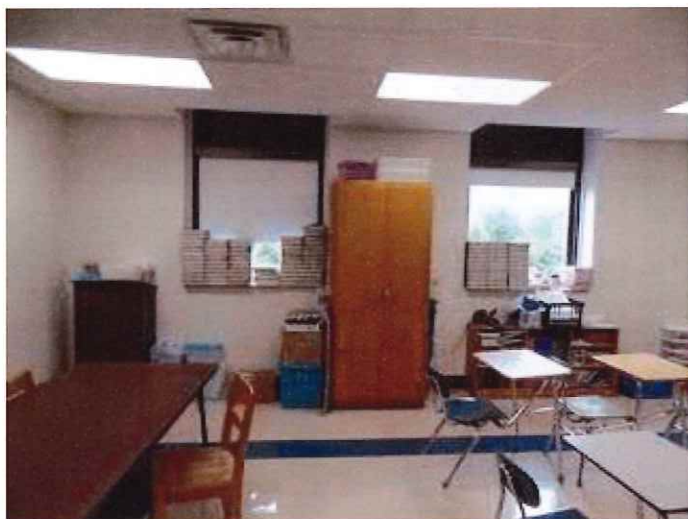
Mismatched furnishings

Recommendations: Provide for replacement of outdated or inadequate furnishings in 1932 facility.

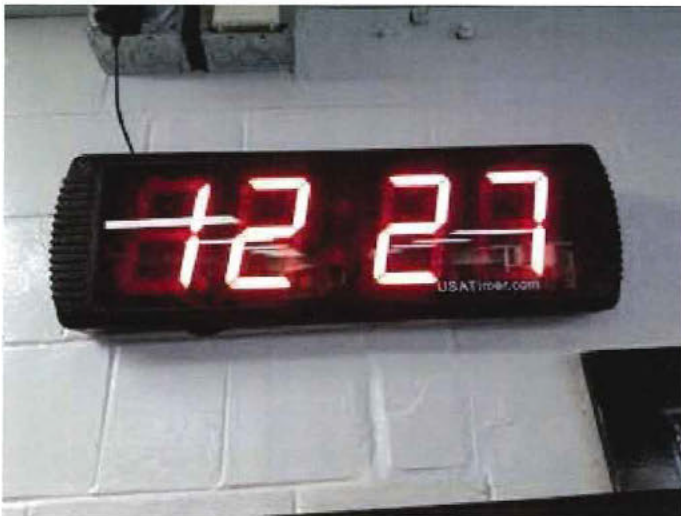
Typical Facility Clock

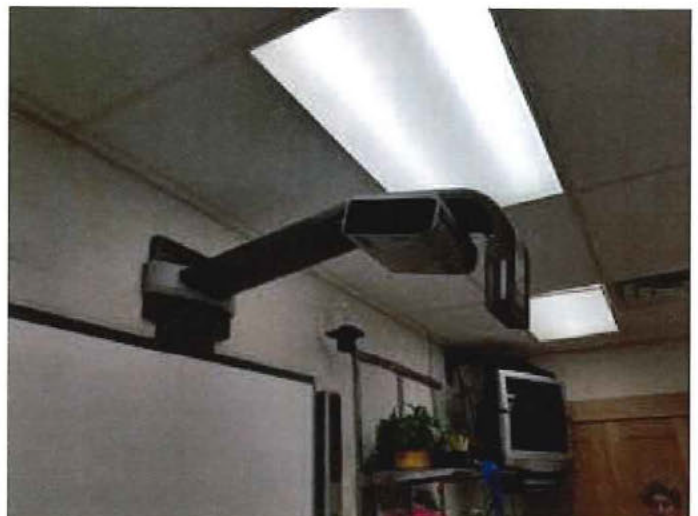
Typical Classroom Smart Board
