Bexley City School District

FACILITY ASSESSMENT REPORT

Cassingham Elementary School

Building Information - Bexley City (43620) - Cassingham Elem

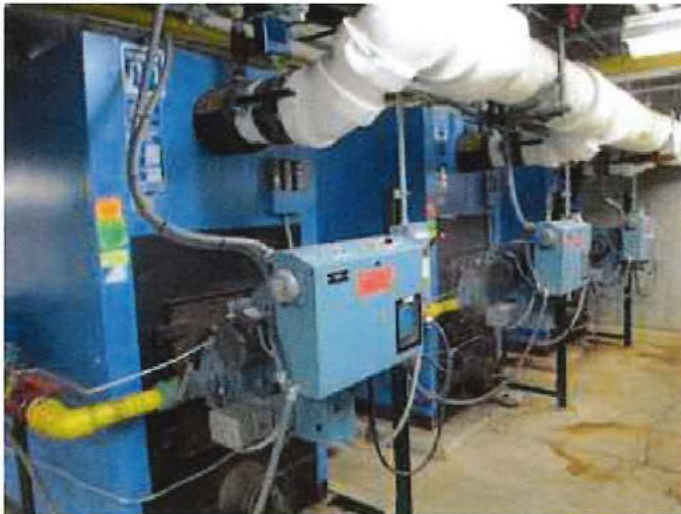
The existing system for the overall facility is a gas fired heating hot water system, installed in 2001, and is in good condition. The heating and chilled water system in the overall facility is a 4-pipe system, with a capacity for simultaneous heating and cooling operation, which is compliant with the OSDM requirements for basic system type. The 3 gas fired boilers, manufactured by Unilux, were installed in 2001 and are in fair condition. A gas fired boiler, manufactured by Thermal Solutions, was installed in 2008, and is in good condition. The boilers are shared with the middle/high school and are located in the middle/high school. Heating water is distributed to terminal units consisting of cabinet heaters, unit heaters, air handlers, and VAV boxes. The terminal equipment was installed in 2001 and is in good condition. The system does comply with the 15 CFM per person fresh air requirements of the Ohio Building Code mechanical code and Ohio School Design Manual. The DDC type system temperature controls were installed in 2001 and are in good condition. The system does feature individual temperature controls in all spaces required by the OSDM. The overall system does not feature any central energy recovery systems. The facility is not equipped with louvered interior doors to facilitate Corridor utilization as return air plenums. The existing system is ducted, though lack of need for HVAC system replacement at this time negates any need to evaluate the potential integration of existing ductwork into a new system. The overall heating system is evaluated as being in safe and efficient working order, and long-term life expectancy of the existing system is anticipated. The structure is equipped with central air conditioning. The site does not contain underground fuel tanks.

Gas Fired Boilers

Replace the existing roof mounted air handlers due to age and condition.

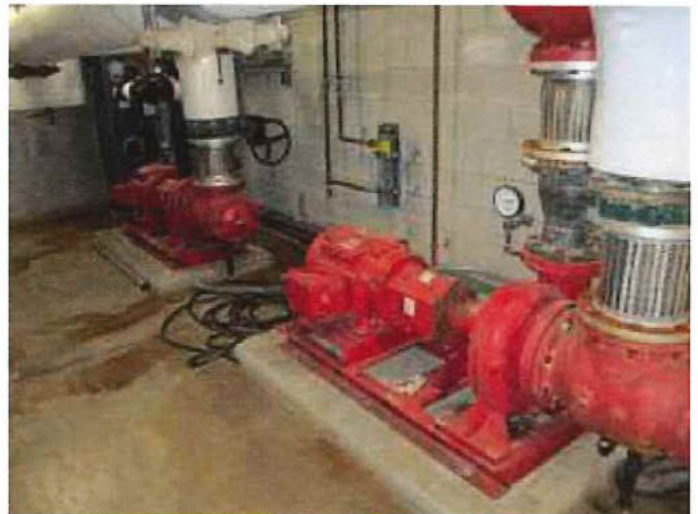
Heating Hot Water Pumps

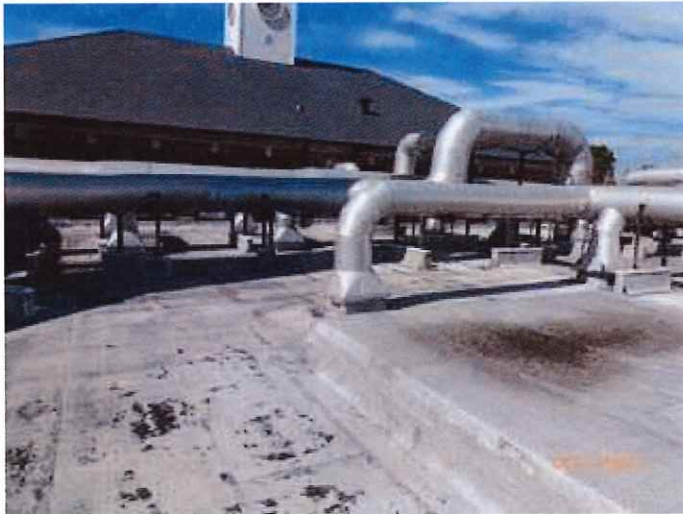
The roof over the overall facility is a built-up asphalt system that was installed over 20 years ago with additional build-up layers added between 2000 and 2016, and is in fair condition. There are no District reports of current leaking. No signs of past leaking were observed during the physical assessment. Access to the roof was gained by access hatch that is in fair condition. Fall safety protection cages are not required, have been not provided to the slope roof area. There were no observations of standing water on the roof. Metal cap flashings and stone copings are in fair condition. Roof storm drainage is addressed through a system of gutters and downspouts as well as roof drains and thru-wall scuppers, which are properly located, and in fair condition. The roof is not equipped with overflow roof drains though they will be required in areas of roof replacement. No problems requiring attention were encountered with any roof penetrations. There are not any covered walkways attached to this structure.

Built up roofing

The roof over the overall facility requires replacement to meet Ohio School Design Manual guidelines due to age of system and projected lifecycle. Replace the cap flashing and gravel stops on the overall facility due to condition. Add overflow drains in areas surrounded by parapets.

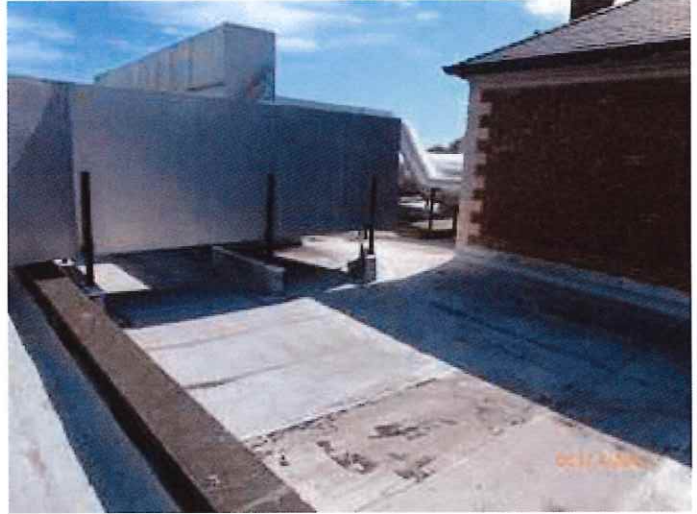
Coping

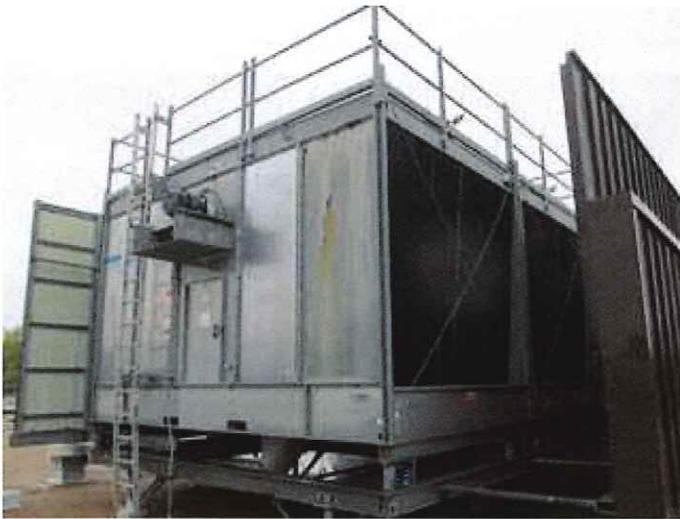
Description: The overall facility is equipped with a chilled water central air conditioning system, which is in fair condition. A cooling tower, manufactured by Harley, was installed in 2001, and is in poor condition. Cooling water is distributed to a chiller. The chiller, manufactured by McQuay, was installed in 2001, and is in poor condition. The chiller and cooling tower is shared with the middle/high school and are located in the middle/high school. Chilled water is distributed to terminal units consisting of air handlers. The terminal equipment was installed in 2001 and is in good condition. The ventilation system in the overall facility consists of air handlers, installed in 2001 and in poor condition, providing fresh air to Classrooms, and air handlers, installed in 2001 and in poor condition, providing fresh air to other miscellaneous spaces such as Gymnasiums, Student Dining, and Media Center. Relief air venting is provided by ceiling plenums. The ventilation system does meet the Ohio Building Code 15 CFM per occupant fresh air requirement. The overall system is compliant with Ohio Building Code and Ohio School Design Manual requirements. The Art program is equipped with a kiln, and existing kiln ventilation is adequate, and in fair condition. General building exhaust systems for Restrooms and Custodial Closets are adequately placed, and in fair condition.

Cooling Tower

Recommendations: Replace the existing cooling tower due to age and condition. Cost included in the Bexley Middle/High school assessment. The cooling tower sets on the Middle/High school building and provides cooling to Cassingham as well as the MS/HS. It is not practical to split the cost between 2 assessments. Replace the existing roof mounted air handlers due to age and condition. Cost included in Item A.

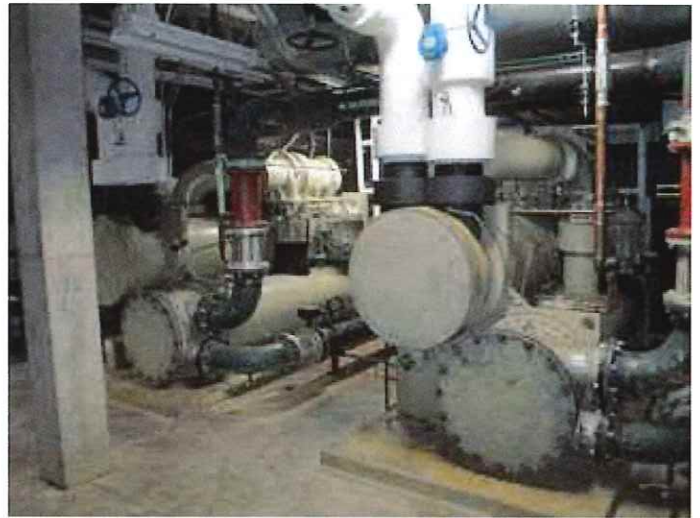
Chillers

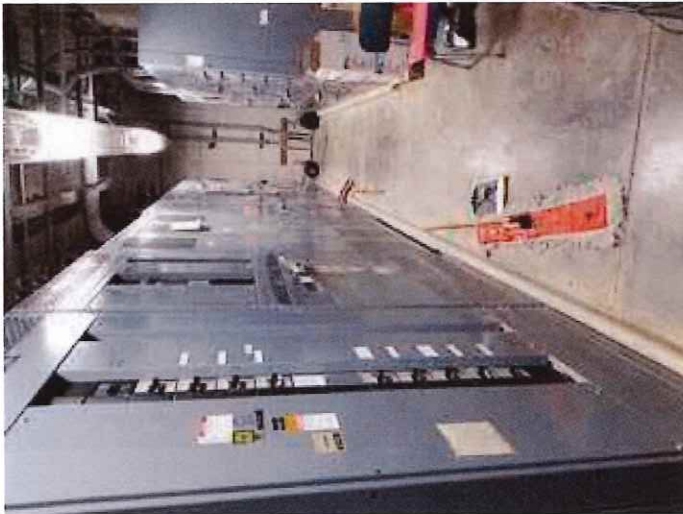
Description: The electrical system provided to the overall facility is an 2000A, 208/120V, 3PH, 4W and a shared 1200A, 480/277V, 3PH, 4W system installed in 2002 and is in good condition. The panel system is in good condition, and can be expanded to add additional capacity. The Classrooms are equipped with adequate electrical outlets. The typical Classroom contains 7 general purpose outlets. There are not any spaces that have no electrical outlets. The Corridors are equipped with adequate electrical outlets for servicing. Adequate GFI protected exterior outlets are provided around the perimeter of the building. The facility is equipped with suitable emergency generators. Adequate lightning protection safeguards are not provided. Stage lighting power system including control panel, breakers, and dimmers is adequately provided, in fair condition and does meet OSDM requirements. The overall electrical system does not meet Ohio School Design Manual requirements in supporting the current needs of the school, and will not be adequate to meet the facility's future needs.

Main Distribution Switchgear

Recommendations: The entire electrical system requires replacement to meet Ohio School Design Manual guidelines for overall capacity.

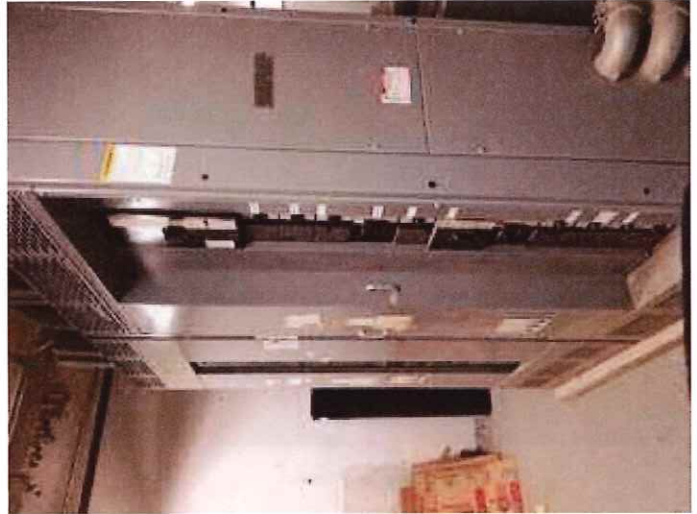
Elementary School Subdistribution

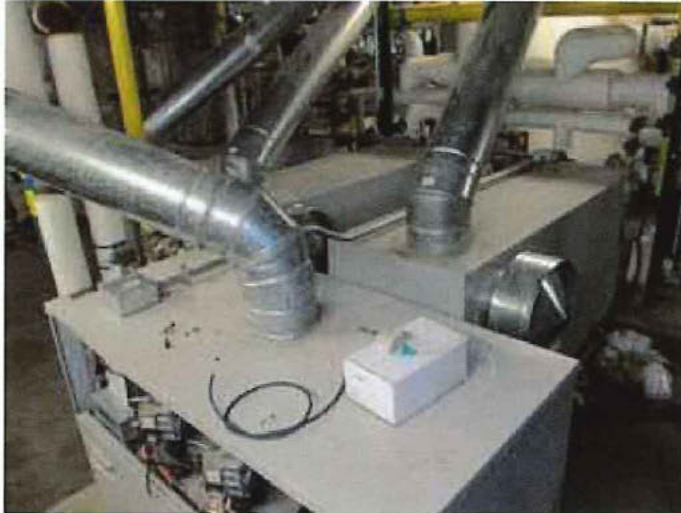
Gas Fired Water Heater

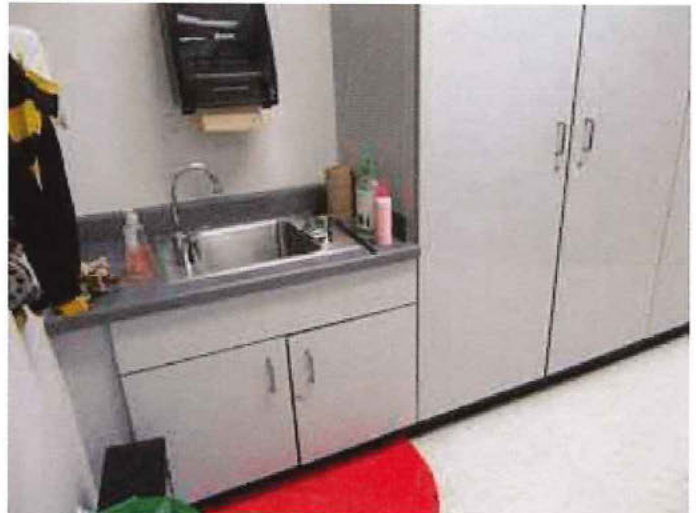
Classroom sink with fountain

To facilitate the school's compliance with OBC and OSFC fixture requirements Due to age, condition, LEED, and OSFC requirements, provide 2 new toilets, 9 new lavatories, 0 new electric water coolers. See Item O for the replacement of fixtures related to ADA requirements that are not included in this fixture count. Replace faucets and flush valves on fixtures that don't already have them. Provide 2 exterior wall hydrants.

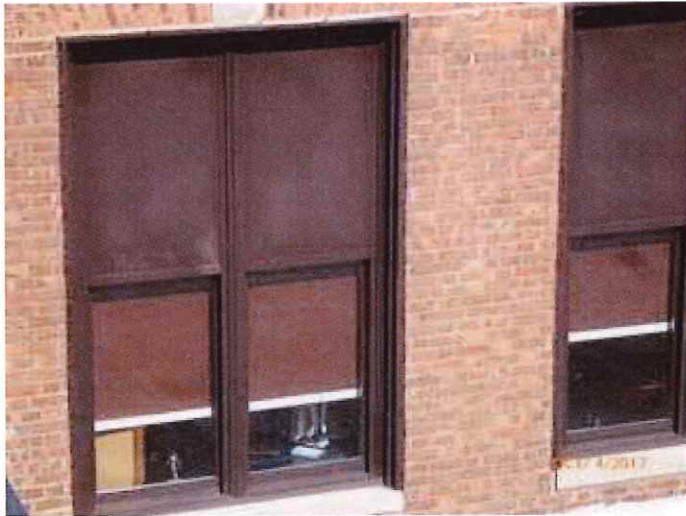
The 1927 facility is equipped double glazed insulated glazing type window system, the installation date is not known, and is in poor condition. The 1993 addition is equipped double glazed insulated glazing type window system, the installation date is assumed to be 1993, and are in fair condition. The 2001 addition is equipped with double glazed insulated type window system, and is in good condition. The window system features operable windows throughout the building, and operable windows are not equipped with opening limiters or and insect screens. Window system seals in the 1927 facility and 1993 addition are in fair condition, with minimal air and water infiltration being experienced. Window system hardware is in fair condition. The window system features surface mounted blinds, which are in fair condition or no blinds. This facility is not equipped with any curtain wall systems. This facility does not feature any glass block windows. The exterior doors in the overall facility are equipped with aluminum frame sidelights and transoms with double glazing, in good condition. Exterior door vision panels are double glazed. The school does not contain skylights. The school does not contain clerestories. Interior glass is not OSDM-compliant in the 1927 building due to it not being tempered. Window security grilles are not provided for ground floor windows. There is not Greenhouse associated with this school.

Double hung windows

Provide a new insulated window system with integral blinds to meet with Ohio School Design Manual requirements. Replace interior glazing. Replace exterior sidelights and transom glass panels.

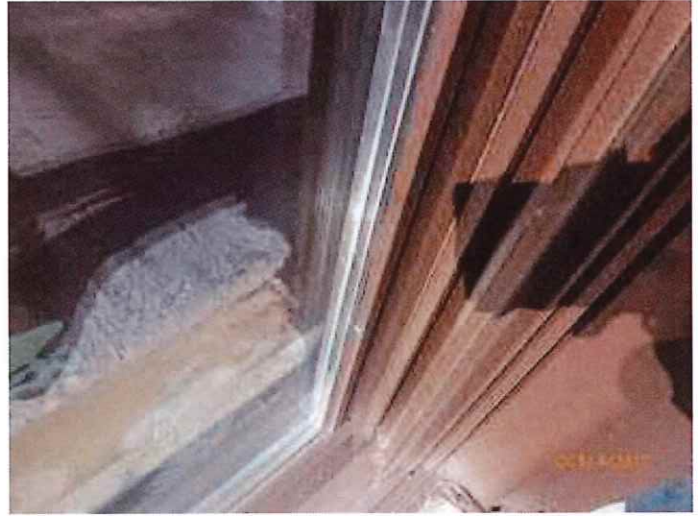
Window frame and glazing

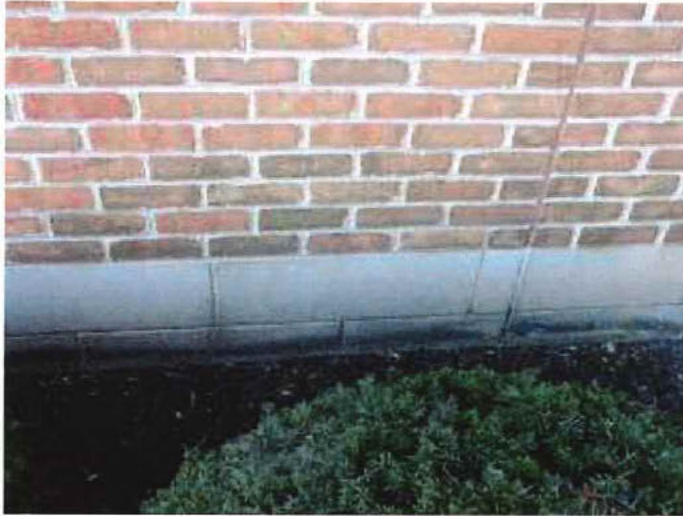
Description: The overall facility is equipped with concrete foundation walls on concrete spread footings, which displayed no locations of significant differential settlement, cracking, or leaking, and are in good condition. No significant issues related to foundation cracking or spalling were encountered. The District reports that there has been no past leaking. No grading or site drainage deficiencies were noted around the perimeter of the structure that are contributing or could contribute to foundation wall structural deterioration.

Foundation wall exposed

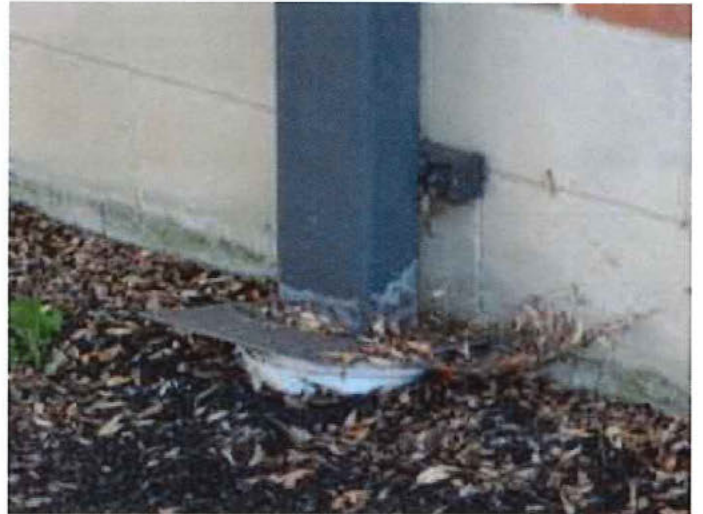
Foundation wall at downspout

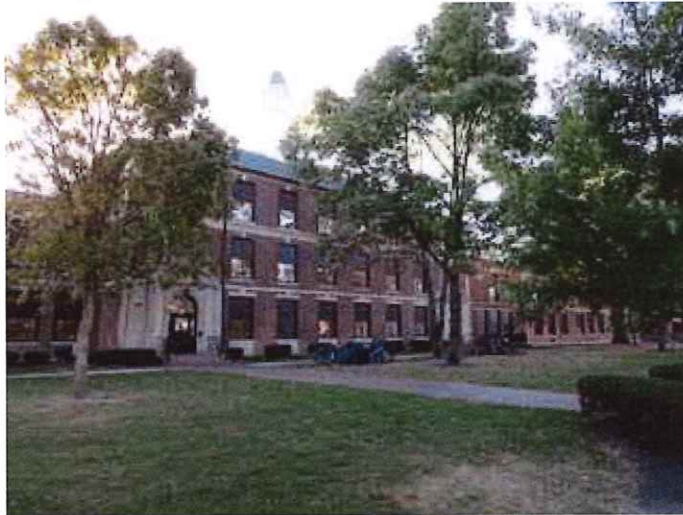
Brick building cleaned and sealed

Provide tuckpointing in all areas of mortar deterioration. Provide masonry cleaning and sealing. Provide weeps.

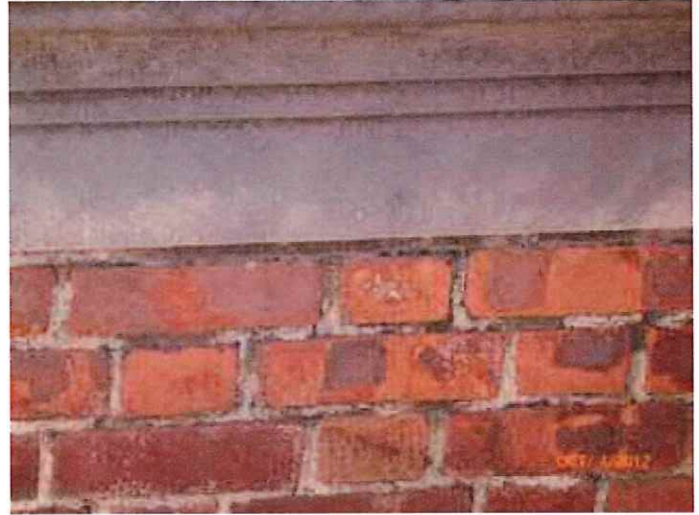
The 1927 facility has a brick veneer on load bearing masonry wall system, which displayed locations mortar of deterioration, and is in fair condition. Control joints are not provided at lintel locations, at doors and windows, building corners, and wall offsets though are not needed. The school does not contain expansion joints and none are needed, as there is no indication of exterior masonry cracking or separation. All of the 1927 brick work needs tuckpointing. The 1993 and 2001 additions have a brick veneer on load bearing masonry, which displayed no locations of deterioration, and is in good condition. The exterior masonry appears to have appropriately spaced and adequately caulked control joints in good condition. Control joints are provided in walls. The school does have sufficient expansion joints, and they are in good condition. Exterior walls in the 1927 facility are inadequately insulated. Brick veneer masonry walls are not cavity walls. Exterior walls in the 1993 and 2001 addition are adequately insulated. Brick veneer masonry walls are cavity walls. Weep holes and vents are not provided or required on the 1927 building. Weep holes are not provided in sufficient quantity at the base of masonry cavity walls in the 1993 and 2001 addition. The exterior masonry on the 1993 and 2001 have not yet been cleaned and sealed, showing no evidence of mortar deterioration. The 1927 building has not been cleaned and sealed in recent years, and shows evidence of mortar deterioration in the entire building, has no locations of efflorescence and mold. Architectural exterior accent materials consist of stone which is in good condition. Exterior building fenestration in the overall facility represents over 12.50% of the exterior surfaces. Interior Corridor and demising walls are concrete masonry units, glazed block metal stud framed partitions with gypsum board, project full height from floor to bottom of deck, and are in good condition. Interior masonry appears to have inadequately spaced control joints. Interior soffits are of metal stud with gypsum board type construction, and in good condition. The window sills are in good condition. The exterior lintels are steel, and are in good condition. Chimneys are in fair condition and need to be repointed. Canopies over entrances are framed with a flat roof and attached to the wall with metal bracket type construction, and are in fair condition. Exterior soffits are of metal stud and gypsum type construction, and in good condition. The school is not equipped with a loading dock.

Brick wall to be tuck pointed

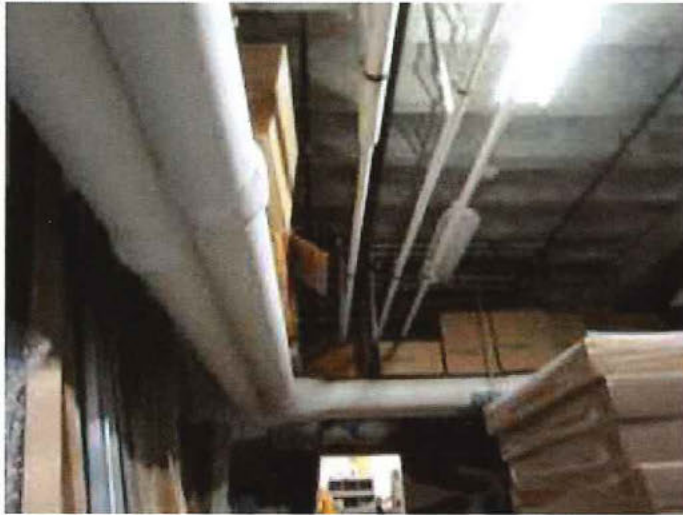
Precast concrete deck

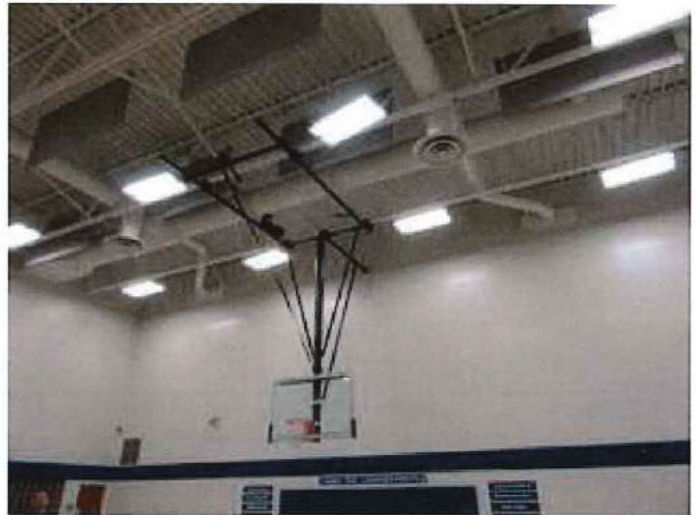
Exposed metal deck

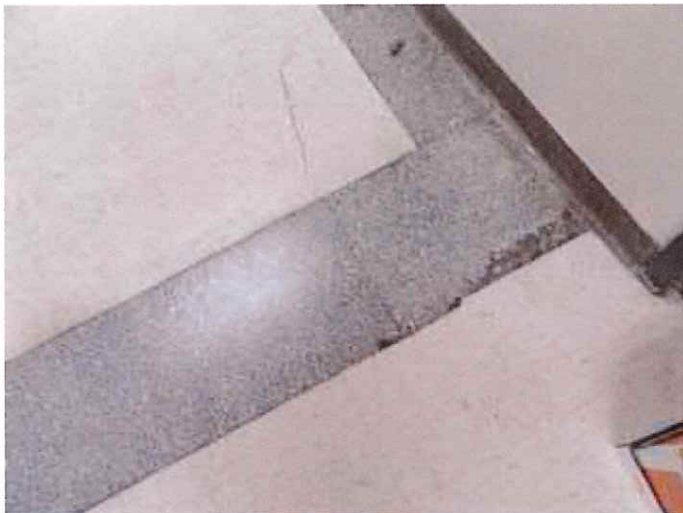
Terrazzo and VCT flooring

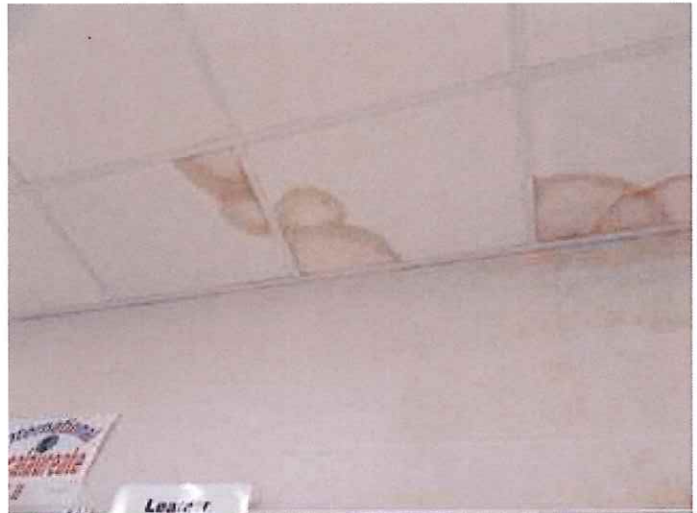
Damaged ceiling tile

Insulate exterior walls. Replace finishes less casework. Classrooms require ADA sink mounted drinking fountains. Replace base cabinet. Refer to Item O for ADA sinks and drinking fountains. Replace doors, frames and hardware. Refer to Item O Replace acoustical ceilings due to Item K lighting replacement.

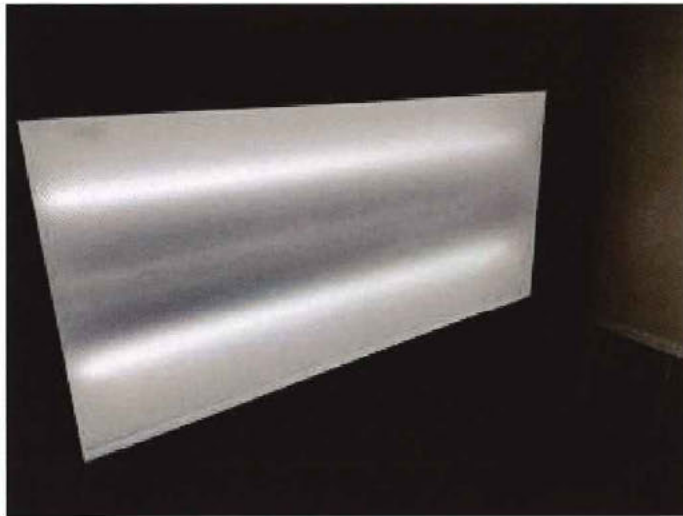
Classroom Light Fixture

Recommendations: Provide complete replacement of lighting system due to installation of systems outlined in Item U.

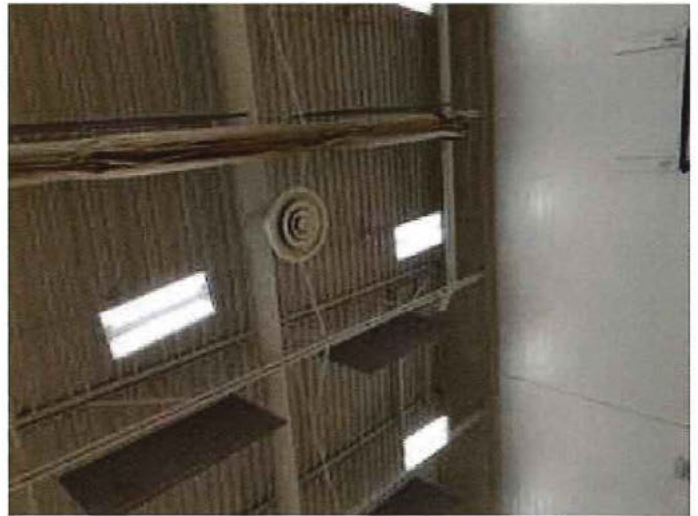
Gymnasium Lighting

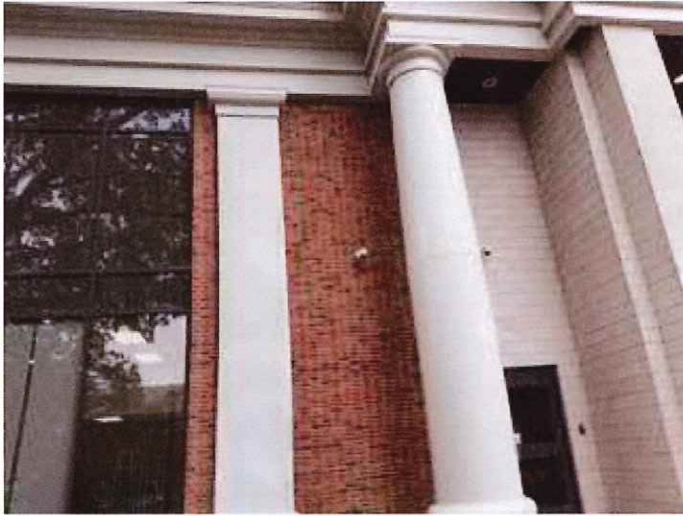
Exterior CCTV Cameras

Provide new security system to meet Ohio School Design Manual guidelines.

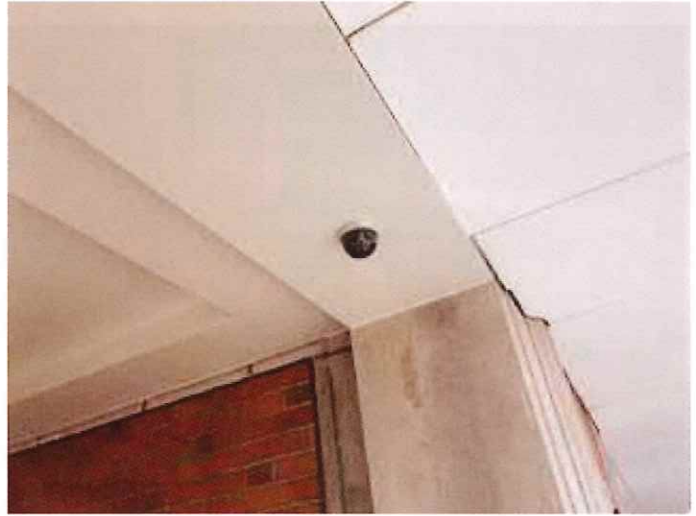
Interior CCTV Camera

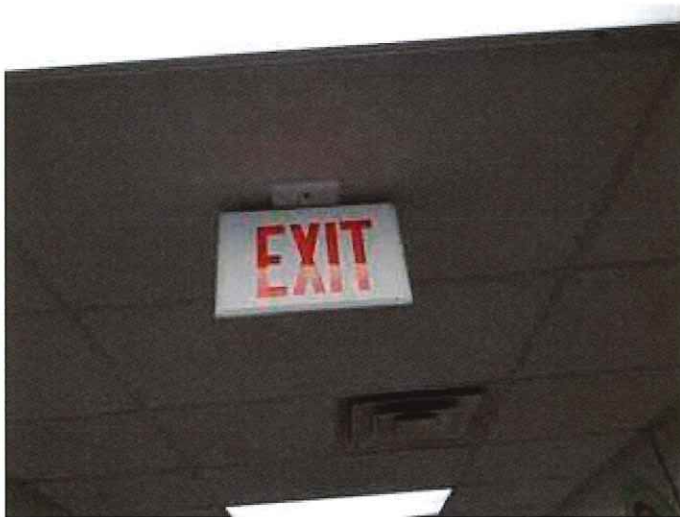
Noncompliant Exit Sign

Recommendations: Provide complete replacement of emergency / egress lighting system to meet Ohio School Design Manual and Ohio Building Code guidelines and to facilitate work in Item U.

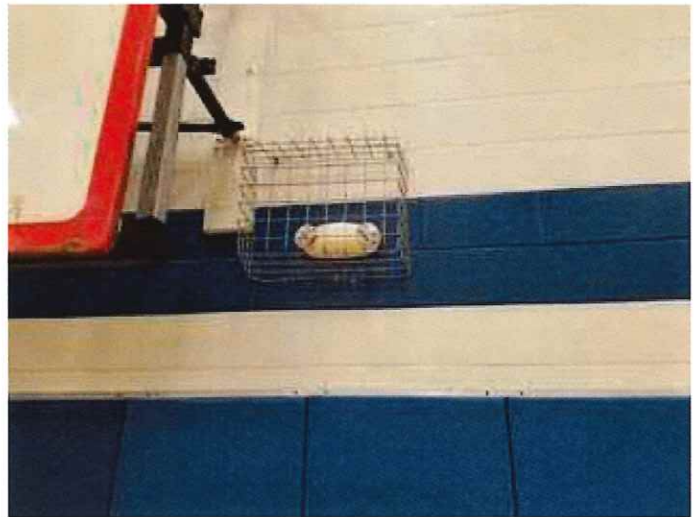
Typical Egress Light

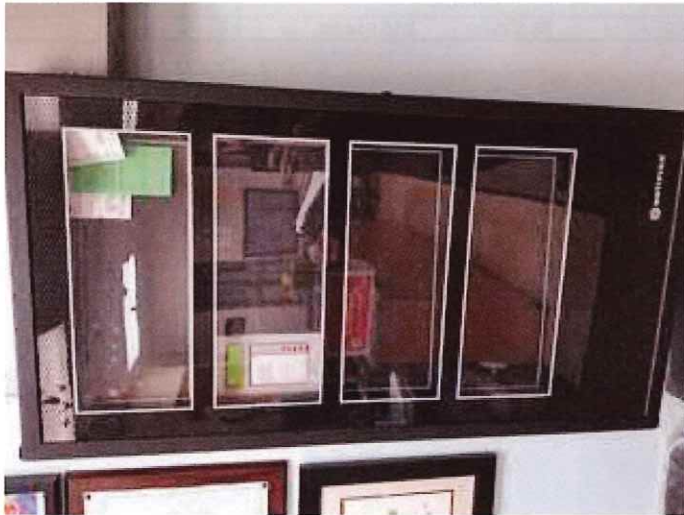
Fire Alarm Control Panel

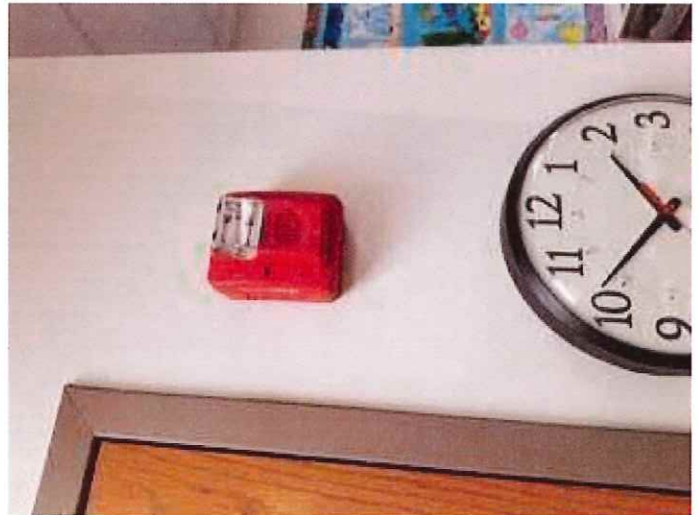
Typical Horn/Strobe

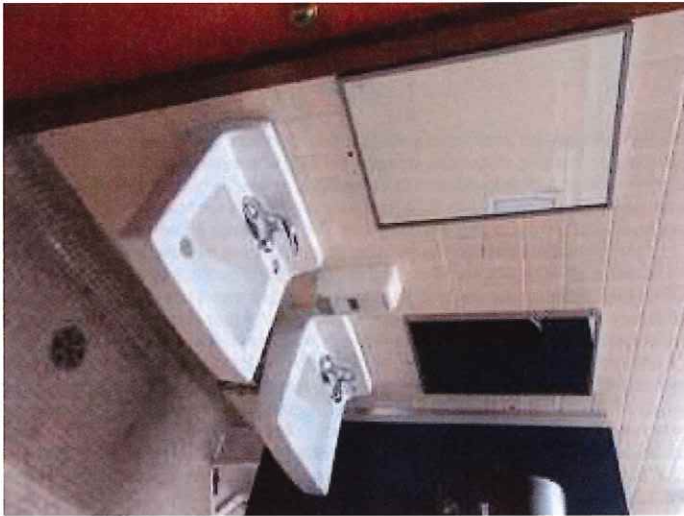
Non-compliant fixtures and mirrors

Other: Drinking Fountains	\$800.00	each			22 Required			\$17,600.00	Replace sinks and drinking fountains in classrooms. Does not include cabinets.
Other: Replace Handrails	\$100.00	ln.ft.			120 Required			\$12,000.00	Replacement handrails to match existing
Sum:			\$124,457.20	\$1,300.60	\$118,666.20	\$1,307.60	\$3,182.80

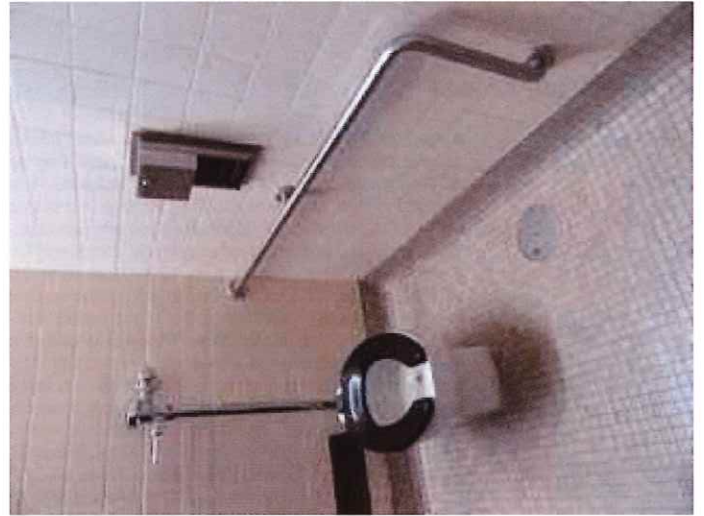
Non-compliant toilet accessories

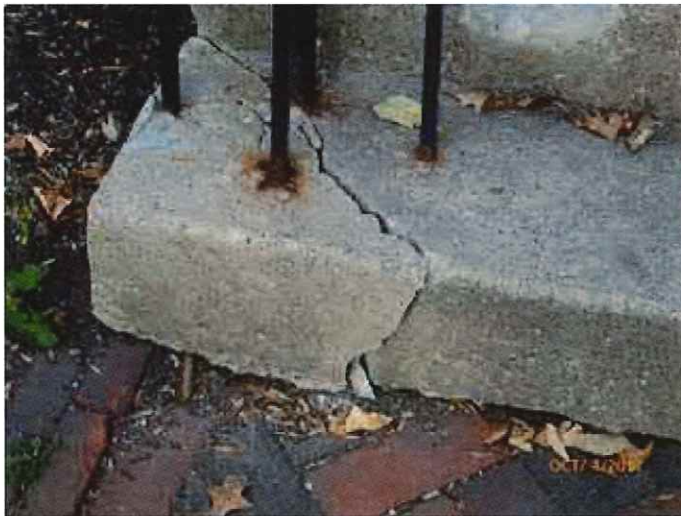
Broken concrete steps

Replace ADA handrails at the front entrance. Replace concrete steps and landing at the front entrance.

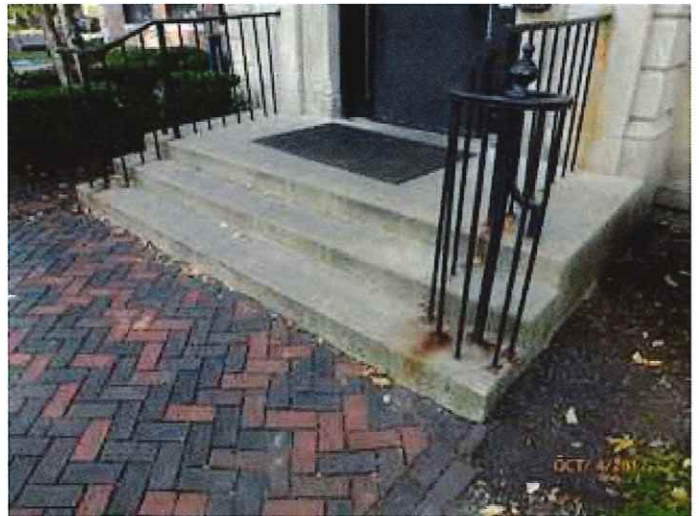
Handrails

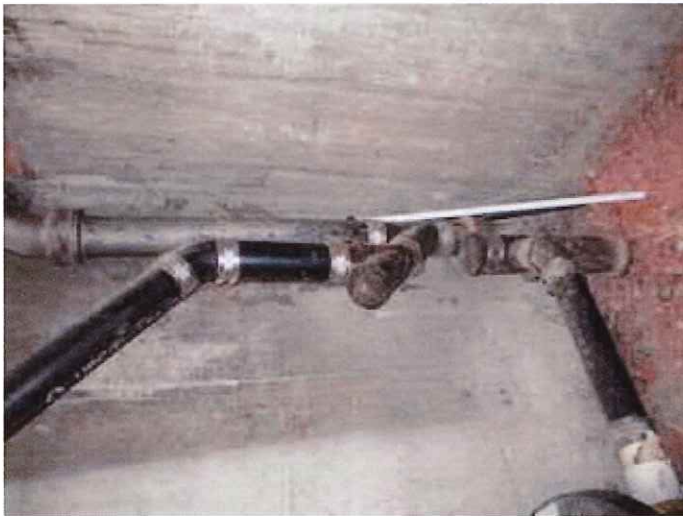
Exposed Waste

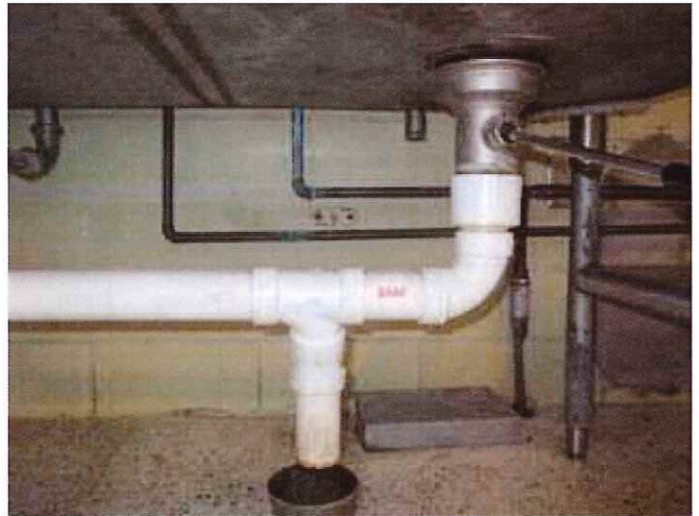
Kitchen Sink Waste

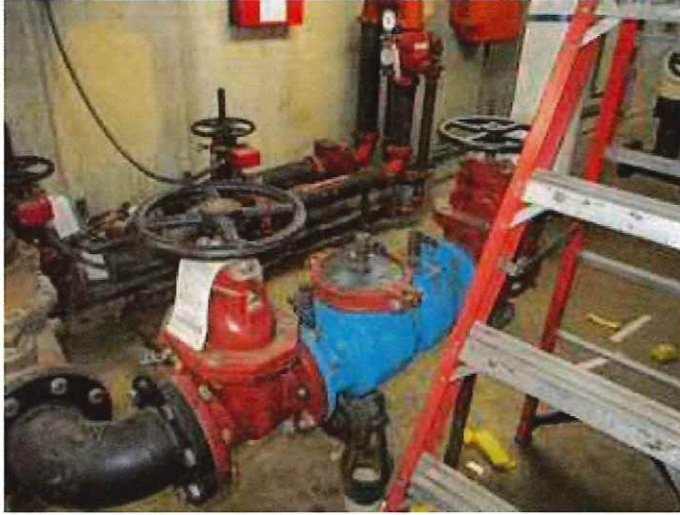
Backflow Preventer

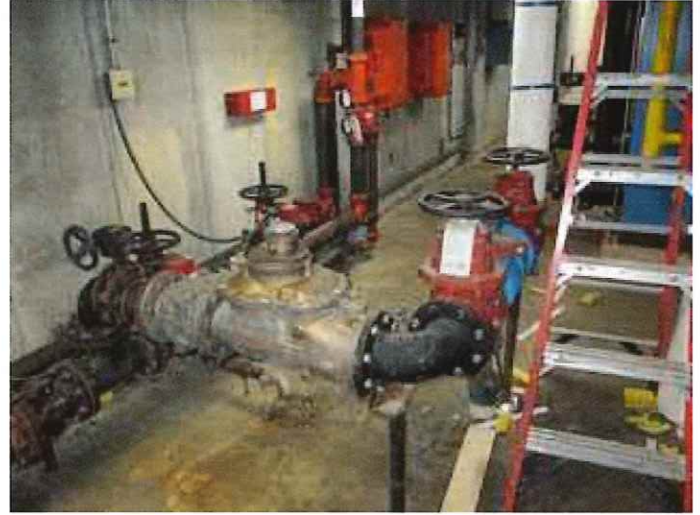
Water Meter

Recommendations: Provide a new city water supply line of adequate capacity to support the existing needs of the facility, as well as a future automated fire suppression system. Funding provided in Item U.

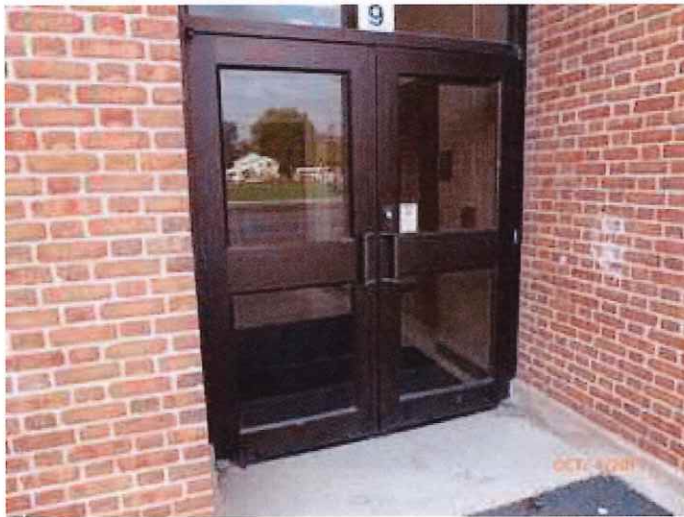
Single pane exterior doors

Recommendations: Replace all exterior and entrance doors to comply with Ohio Building Code, ADA, and Ohio School Design Manual guidelines.

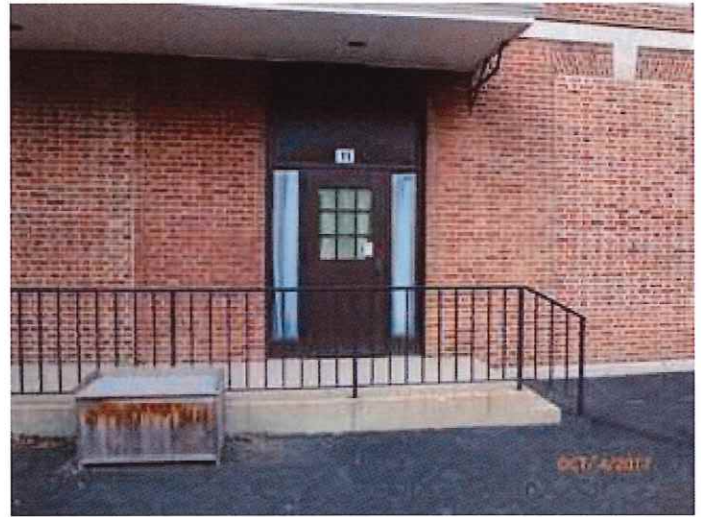
Exterior steel door and frame

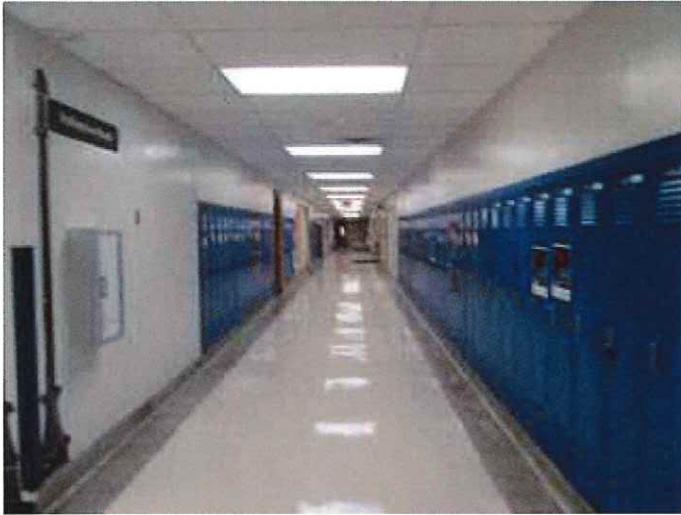
asbestos free flooring

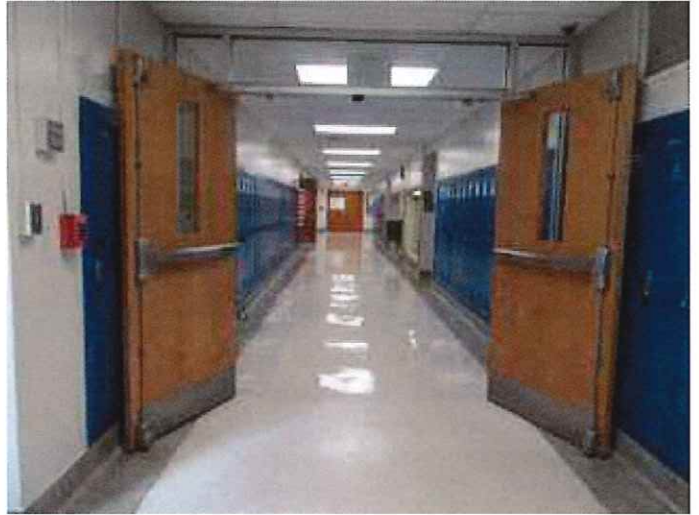
Asbestos free fire doors

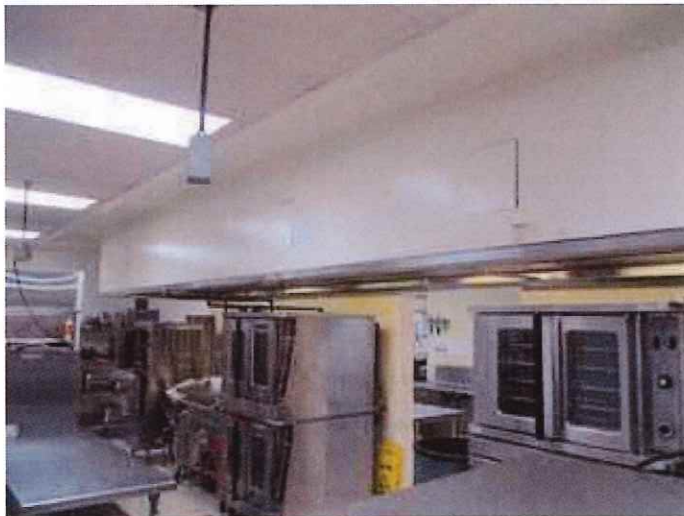
Kitchen Hood

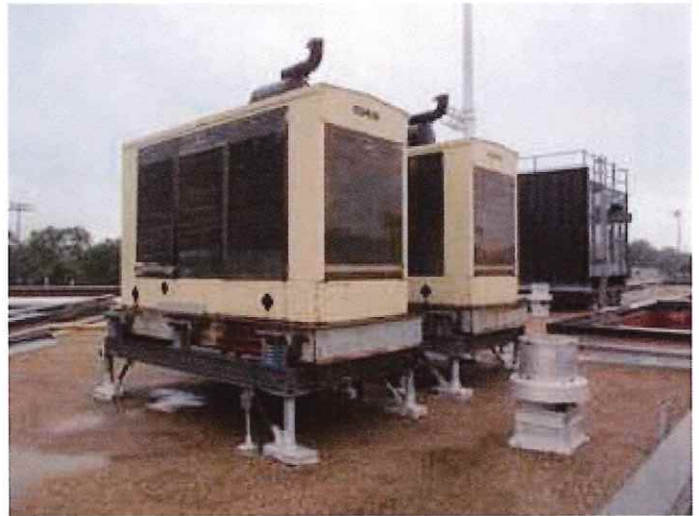
Generators

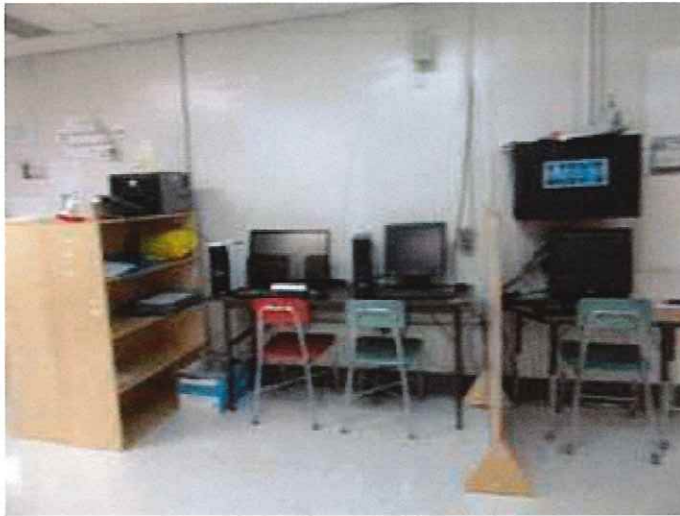
Mismatched loose furnishings

Recommendations: Provide for replacement of outdated or inadequate furnishings.

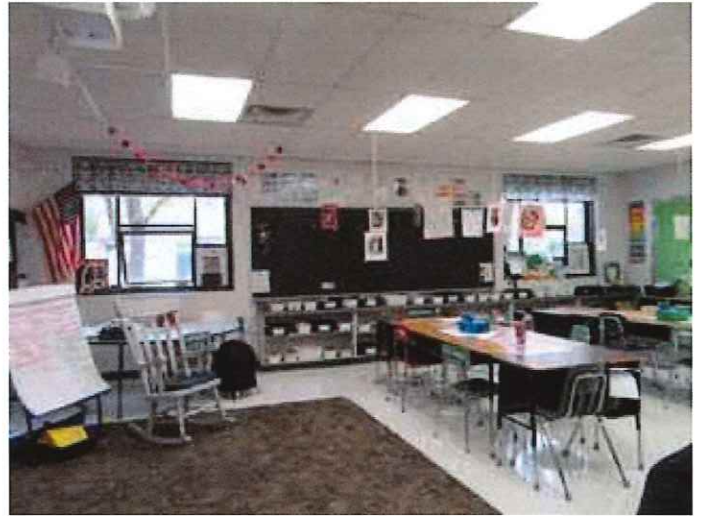
Mismatched loose furnishings

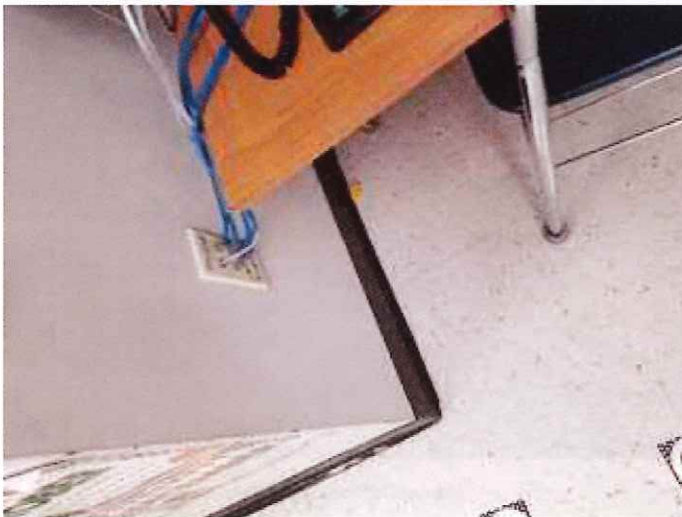
Typical Classroom Data Jacks

Recommendations: Provide complete replacement of technology systems to meet Ohio School Design Manual requirements, and to sustain the capacity to keep pace with technological development.

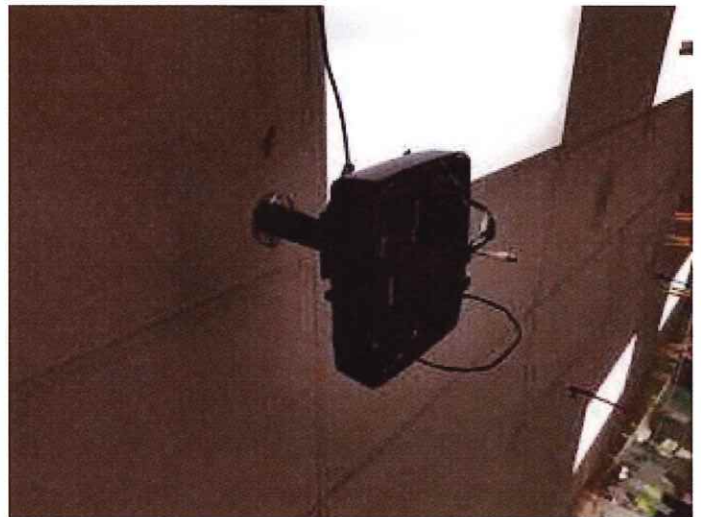
Classroom Smart Board Projector
