*Bexley City School District*

*Building Assessment Summary*

*Maryland Elementary School*

**Building Information - Bexley City (43620) - Maryland Avenue Elem**

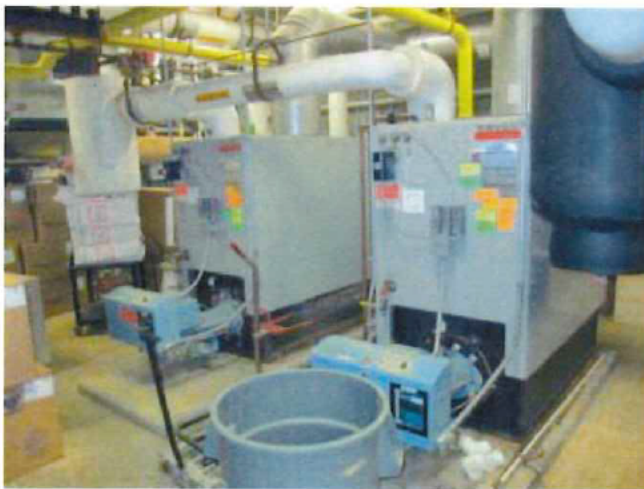
**Description:** The existing system for the overall facility is a gas fired heating hot water system, installed in 2002, and is in fair condition. The heating and chilled water system in the overall facility is a 4-pipe system, with a capacity for simultaneous heating and cooling operation, which is compliant with the OSDM requirements for basic system type. The 2 gas fired boilers, manufactured by Bryan, were installed in 2002 and are in poor condition. Heating water is distributed to terminal units consisting of cabinet heaters, unit heaters, air handlers, and VAV boxes. The terminal equipment was installed in 2002 and is in fair condition. The system does comply with the 15 CFM per person fresh air requirements of the Ohio Building Code mechanical code and Ohio School Design Manual. The DDC type system temperature controls are in good condition. The system does feature individual temperature controls in all spaces required by the OSDM. The overall system does not feature any central energy recovery systems. The facility is not equipped with louvered interior doors to facilitate Corridor utilization as return air plenums. The existing system is ducted, though lack of need for HVAC system replacement at this time negates any need to evaluate the potential integration of existing ductwork into a new system. The overall heating system is evaluated as being in safe but inefficient working order, and long-term life expectancy of the existing system is not anticipated. The structure is equipped with central air conditioning. The site does not contain underground fuel tanks.

**Rating:** 3 Needs Replacement

Gas Fired Boilers

**Recommendations:** Provide new boilers and pumps due to existing condition. Replace the existing air handlers and rooftop air handlers due to age and condition.

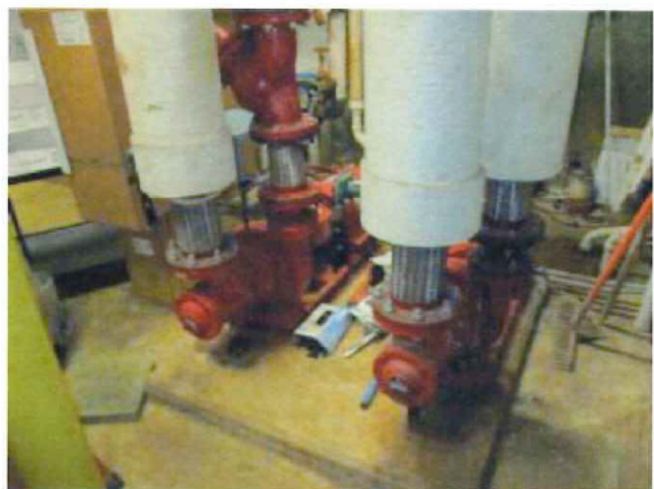
Heating Hot Water Pumps

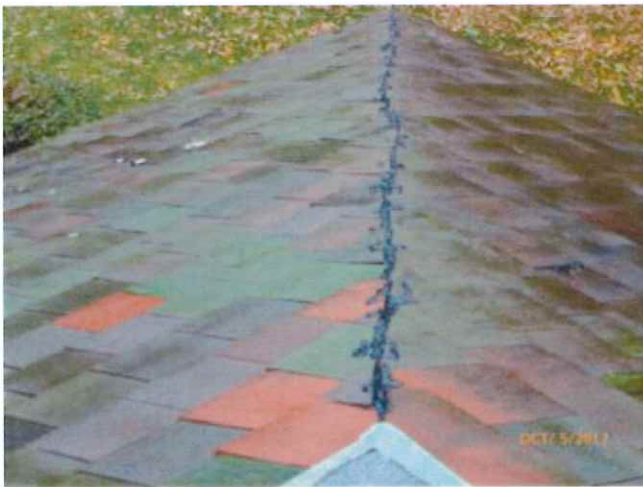
**Description:** The roof over the overall facility is a built-up asphalt system that was installed in over 20 years ago and has had additional layers installed at a later date, and is in fair condition. There are also areas of clay tile roofing in fair condition. There are no District reports of current leaking. Signs of past leaking were observed during the physical assessment. Access to the roof was gained by access ladder that is in good condition. Fall safety protection cages are not required, and have not provided. There were no observations of standing water on the roof. Metal and Clay tile cap flashings and are in good condition. Roof storm drainage is addressed through a system of gutters and downspouts, as well as roof drains, which are located, and in good condition. The roof is not equipped with overflow roof drains though they are needed on this building. No problems requiring attention were encountered with any roof penetrations There are not any covered walkways attached to this structure.

Missing tile ridge cap

**Recommendations:** Provide roof over the overall facility requires replacement to meet Ohio School Design Manual guidelines due to age of system and projected lifecycle. Provide flashing, coping and tile ridge cap on the overall facility require replacement due to condition. Provide downspouts were the existing downspouts have been damaged. Provide overflow drains.

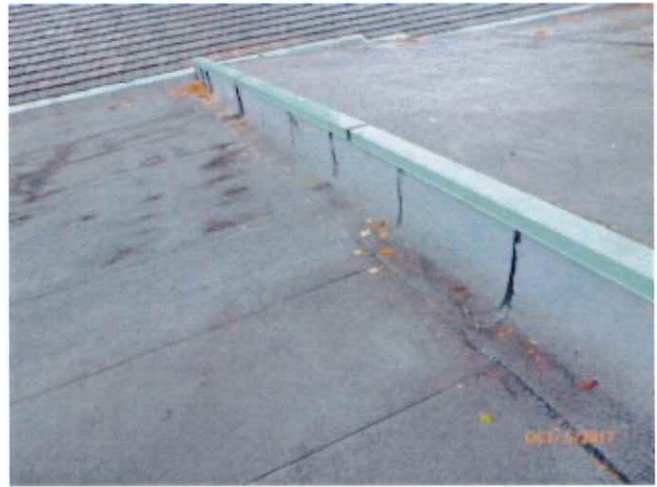
Metal cap flashing

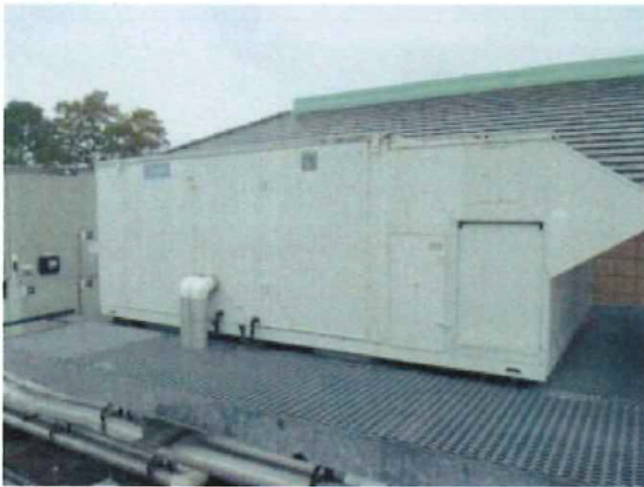
**Description:** The overall facility is equipped with an air-cooled chiller type central air conditioning system, which is in poor condition. The ventilation system in the overall facility consists of air handlers, installed in 2002 and in fair condition, providing fresh air to Classrooms, and air handlers, installed in 2002 and in fair condition, providing fresh air to other miscellaneous spaces such as Gymsnasiums, Student Dining, and Media Center. Relief air venting is provided by ceiling plenums. The ventilation system does meet the Ohio Building Code 15 CFM per occupant fresh air requirement. The overall system is compliant with Ohio Building Code and Ohio School Design Manual requirements. Dust collection systems are not required in this facility. The Art program is equipped with a kiln, and existing kiln ventilation is inadequate, and in poor condition. General building exhaust systems for Restrooms are adequately placed, and in fair condition.

Rooftop Unit

**Recommendations:** Replace the existing air handlers and rooftop air handlers due to age and condition. Cost included in Item A. Replace the existing air-cooled chiller due to age and condition. Since the chiller is a single unit that is located on the roof of the original building, all costs have been assigned to the original building. Replace the existing kiln exhaust system with new.

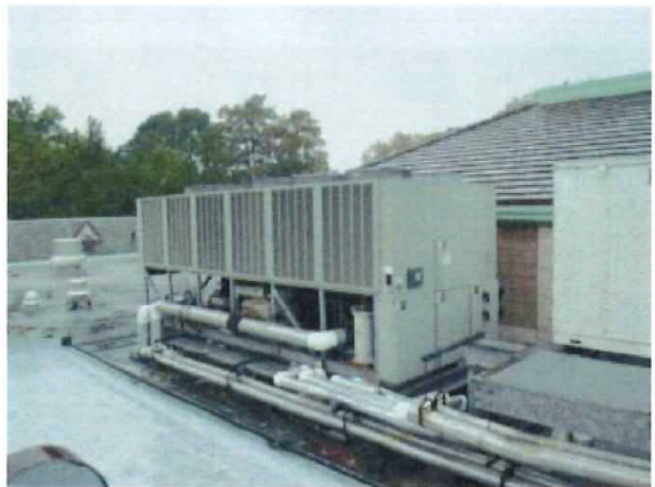
Air Cooled Chiller

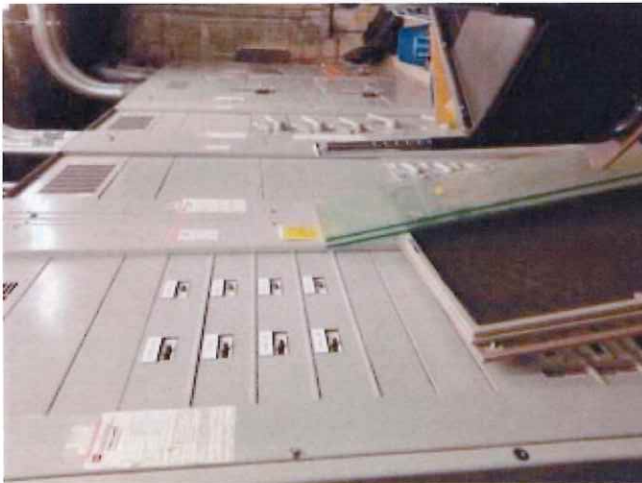
**Description:** The electrical system provided to the overall facility is a 2500A, 208/120V, 3PH, 4W system installed in 2002, and is in good condition. Power is provided to the school by a single utility owned, pad-mounted transformer in good condition. The panel system, installed in 2002, is in good condition, and can be expanded to add additional capacity. The Classrooms are equipped with adequate electrical outlets. The typical Classroom contains 5 general purpose outlets and 2 dedicated outlets for each Classroom computer. There are not any spaces that have no electrical outlets. The Corridors are equipped with adequate electrical outlets for servicing. Adequate GFI protected exterior outlets are provided around the perimeter of the building. The facility is not equipped with an emergency generator. Adequate lightning protection safeguards are not provided. Stage lighting power system including control panel, breakers, and dimmers is inadequately provided, in fair condition and does not meet OSDM requirements. The overall electrical system does not meet Ohio School Design Manual requirements in supporting the current needs of the school, and will be inadequate to meet the facility's future needs.

Main Distribution Switchgear

**Recommendations:** The entire electrical system requires replacement to meet Ohio School Design Manual guidelines for overall capacity and lack of OSDM-required features.

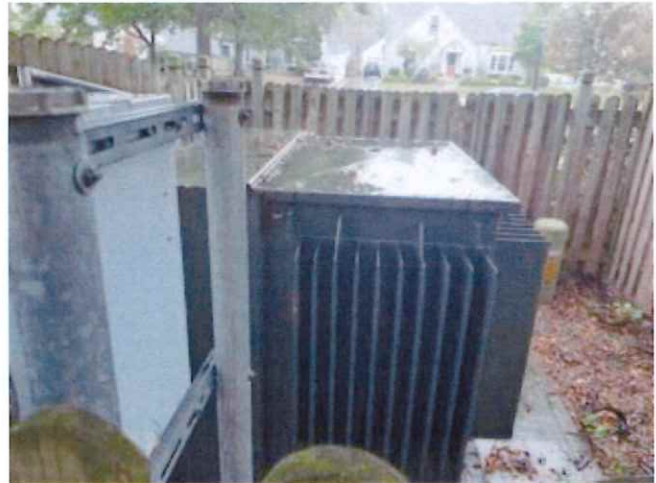
Utility Transformer

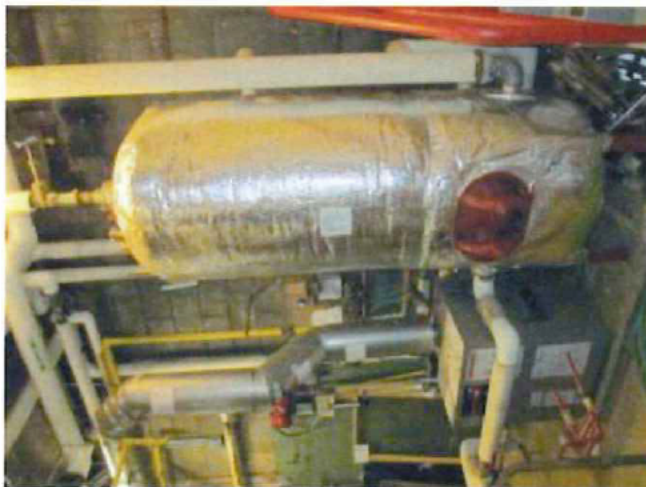
**Description:** The service entrance is equipped with a reduced pressure backflow preventer in fair condition. A water treatment system is not provided. The domestic water supply piping in the overall facility is copper and PVC, and is in fair condition. The waste piping in the overall facility is cast iron and PVC, and is in fair condition. The facility is equipped with 1 gas water heater in fair condition, with 1 separate 150-gallon storage tank in fair condition. The school contains 2 Large Group Restrooms for boys, 2 Large Group Restrooms for girls, 8 Restrooms associated with specialty Classrooms, and 2 Restrooms for staff. Boys' Large Group Restrooms contain 0 ADA and 12 non-ADA floor mounted flush valve toilets, 0 ADA and 8 non-ADA floor mounted flush urinals, as well as 0 ADA and 12 non-ADA wall mounted lavatories. Girls' Large Group Restrooms contain 1 ADA and 17 non-ADA floor mounted flush valve toilets, as well as 0 ADA and 13 non-ADA wall mounted lavatories. Staff Restrooms contain 0 ADA and 1 wall mounted urinals, as well as 0 ADA and 4 non-ADA wall mounted lavatories. Condition of fixtures is good. The facility is equipped with 0 ADA and 0 non-ADA drinking fountains, as well as 1 ADA and 7 non-ADA electric water coolers, in fair condition. The 19 Elementary Classrooms are equipped with 0 ADA and 19 non-ADA sink mounted type drinking fountains, in good condition. Special Education Classroom is equipped with the required Restroom facilities, and fixtures are in good condition. Kitchen is not equipped with the required Restroom. Health Clinic is equipped with the required Restroom, and fixtures are in good condition. Kindergarten Classrooms are equipped with Restroom facilities, and fixtures are in good condition. Kitchen fixtures consist of 1 single-compartment sink, 1 triple-compartment sink, 2 hand sinks, and a dishwasher, which are in fair condition. The Kitchen is not equipped with a satisfactory grease interceptor. The Kitchen is provided the required 140-degree hot water supply via an Insta Hot water heater, which is in good condition. The school does not meet the OBC requirements for fixtures. Relative to LEED requirements, the school is not equipped with low flow type fixtures. Per OBC and GSDM requirements this facility should be equipped with 40 toilets, 8 urinals, 33 lavatories, 19 Classroom sink mounted drinking fountains, and 14 electric water coolers. Observations revealed that the school is currently equipped with 30 toilets, 8 urinals, 25 lavatories, 19 Classroom sink mounted drinking fountains, and 8 electric water coolers. ADA requirements are not met for fixtures and drinking fountains (see Item O). Custodial Closets are not properly located and are not adequately provided with required service sinks or floor drain sinks. Adequate exterior wall hydrants are not provided.

Gas Fired Water Heater

**Recommendations:** Provide 4 exterior wall hydrants. Provide a grease interceptor for the kitchen. See Item O for all fixtures ADA requirements

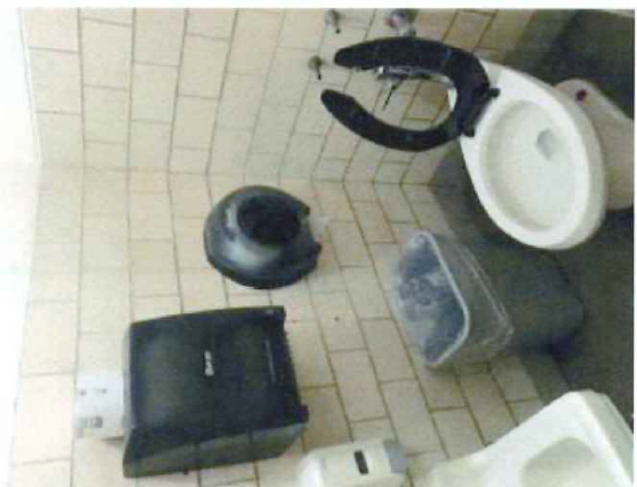
Non-compliant fixtures

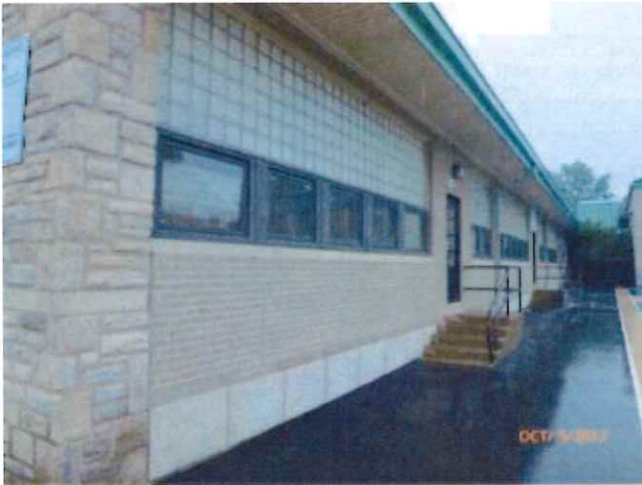
The overall facility is equipped with wood frame double glazed insulated glazing type window system, with an unknown installation date, and is in poor condition. The window system features operable windows throughout the building and operable windows are not equipped with opening limiters and the insect screens are in fair condition. Window system seals are in poor condition, with frequent air and water infiltration being experienced. Window system hardware is in poor condition. The window system features integral blinds, which are in fair condition. There are glass block windows in the original building, in fair condition. The exterior doors in the facility are equipped with thermally broken aluminum frame sidelights and transoms with double glazed insulated, in good condition. Exterior door vision panels are double glazed insulated glazing. The building does not contain skylights. The building does contain 8 clerestories, and clerestory windows are in fair condition. Interior glass is not OBC-compliant, it is wire glass. Window security grilles are not provided for ground floor windows. There is not Greenhouse associated with this facility.

Glass block windows

Due to age and condition, provide a new insulated window system with integral blinds, with work recommended within 0 -2 years. Replace glass block with window. Replace interior wire glass.

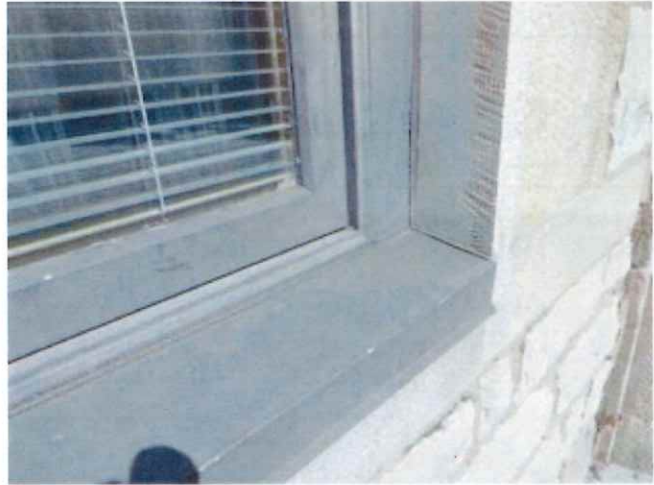
Window frame and glazing

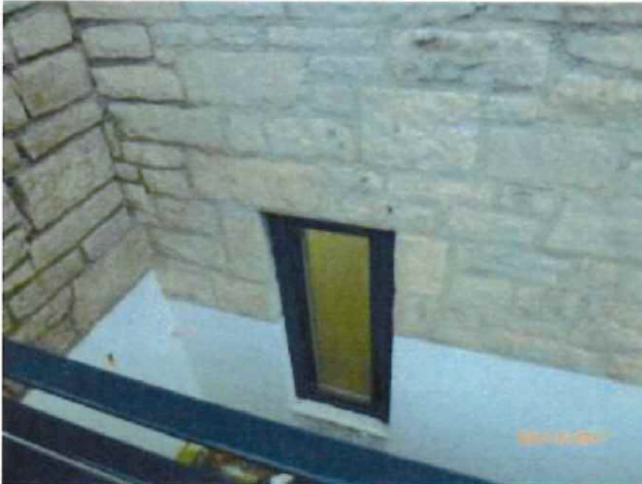
**Description:** The overall facility is equipped with concrete foundation walls on concrete footings, which displayed no locations of significant differential settlement, cracking, or leaking, and are in good condition. No significant issues related to foundation cracking or spalling were encountered. No grading or site drainage deficiencies were noted around the perimeter of the structure that are contributing or could contribute to foundation or wall structural deterioration.

Foundation wall exposed

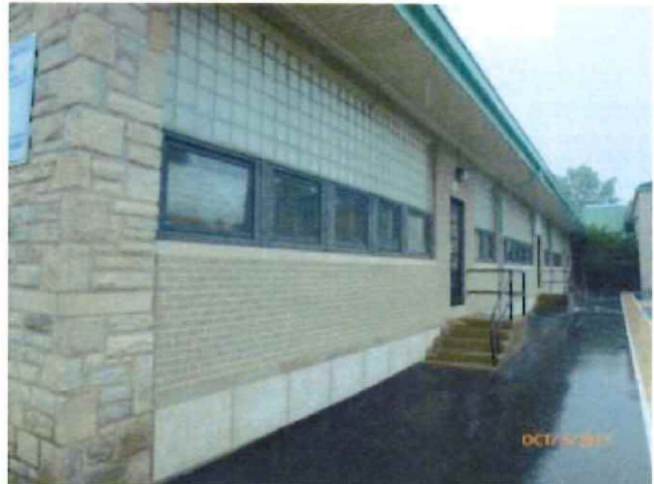
foundation wall exposed

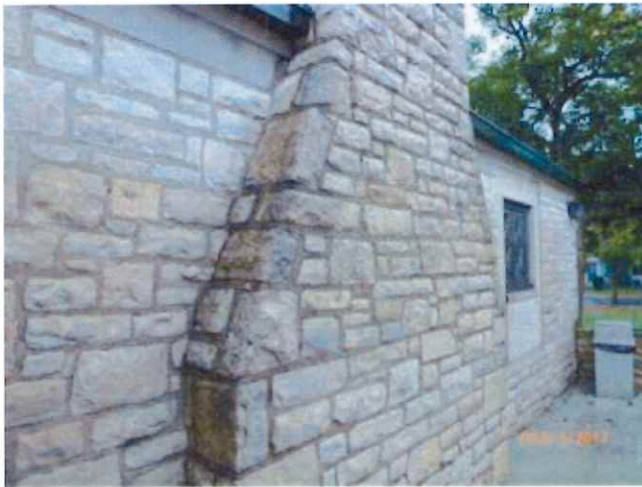
The 1952 facility has a stone and brick veneer on load bearing masonry wall system, which displayed minimal locations of deterioration, and is in good condition. Overall the exterior masonry appears to have appropriately spaced and caulked control joints in good condition. Two control joints should be cut in on the south side wall. The school does not contain expansion joints, and none are needed, as there is no indication of exterior masonry cracking or separation beyond the two locations of minor cracking. The precast panels on the roof level have cracks that need to be repaired and control joints should be added. The 2001 Addition has a split-face block on a load bearing masonry wall system, which displayed no locations of deterioration, and is in good condition. The exterior masonry appears to have appropriately spaced and adequately caulked control joints in good condition. Control joints are provided at building corners, and wall offsets and are in good. The school does have sufficient expansion joints, the existing ones are in good condition. Exterior walls in the 1952 facility are inadequately insulated. Brick veneer masonry walls are not cavity walls. Weep holes and vents are not provided or required. The exterior masonry has not yet needed to be cleaned and sealed, showing mortar deterioration at the 1st floor fireplace chimney. Exterior building fenestration in the overall facility exceeds 12.50% of the exterior surfaces. Installation of new HVAC systems will result in removal of any existing unit ventilators, necessitating the exterior masonry infill of associated exterior wall voids. Interior Corridor and demising walls are concrete masonry units and glazed block, project full height from floor to bottom of deck, and are in good condition. Interior masonry appears to have adequately spaced and caulked control joints in good condition. Interior soffits are of metal studs and gypsum board type construction, and in good condition. The window sills are solid surface laboratory countertop material, and are in good condition. The exterior lintels are steel, and are in good condition. The chimney for the heating system is in good condition. The fireplace chimney requires tuckpointing. Canopies over entrances are metal stud and gypsum type construction, and are in good condition. Exterior soffits are of metal panel type construction, and in good condition. The school is not equipped with a loading dock.

Fireplace to be tuckpointed

Provide tuckpointing at the 1952 fireplace. Provide masonry cleaning and sealing as required through the overall facility. Sawcut and caulk new appropriately spaced control joints in existing masonry 1952 facility. Repair cracks in precast panels. Exterior wall insulation deficiencies are addressed in Item J.

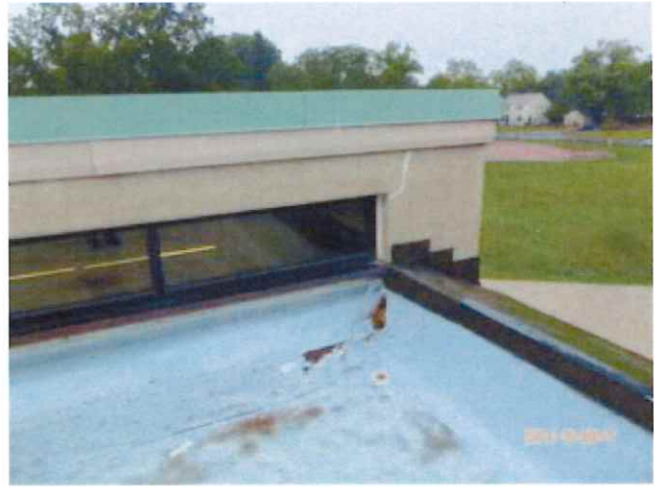
Precast panel with cracks

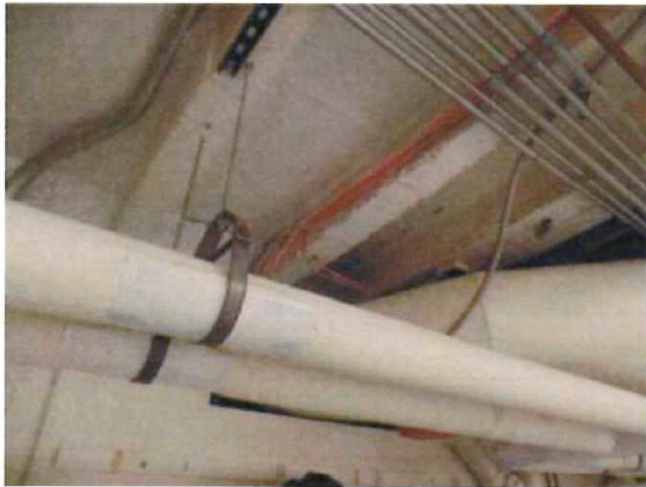
**Description:** The floor construction of the base floor of the overall facility is concrete slab on grade type construction, and is in good condition. There is crawl space located under east and west wings below classrooms. The floor construction of the intermediate floor is cast-in-place concrete type construction, and is in good condition. Ceiling to structural deck spaces are sufficient to accommodate HVAC, electrical, and plumbing scopes of work in required renovations. The roof construction of the overall facility is metal deck of bar joists or steel truss type construction, and is in good condition.

Cast concrete deck

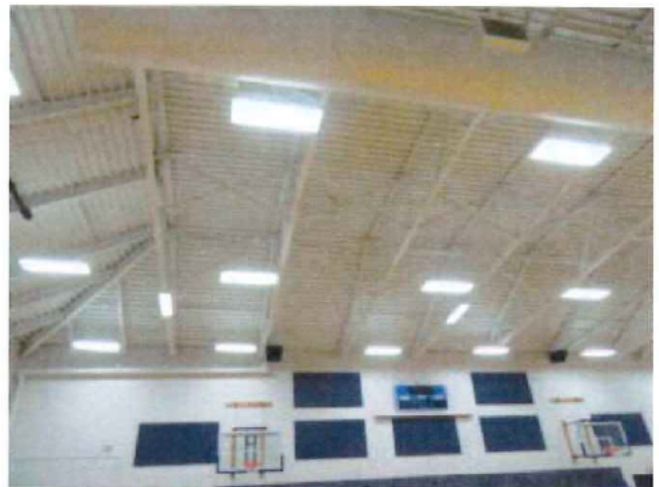
Exposed metal deck

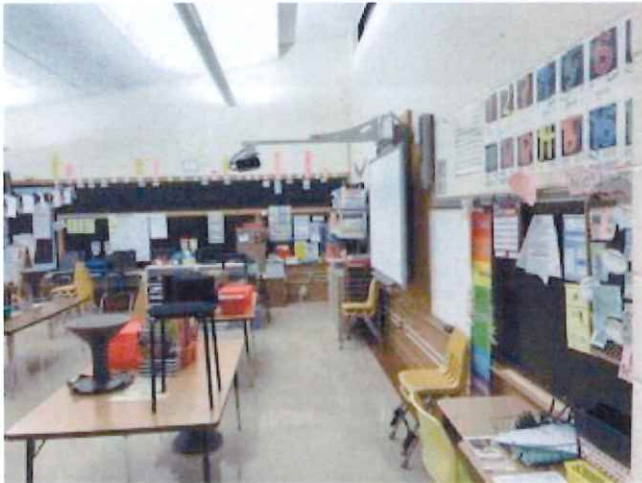
The overall facility features conventionally partitioned Classrooms with VCT, wood, carpet and ceramic tile type flooring, acoustic ceiling tile type ceilings, as well as painted, and glazed block type wall finishes, and they are in fair condition. The overall facility has Corridors with VCT type flooring, acoustical ceiling tile type ceilings, as well as painted and glazed block type wall finishes, and they are in fair condition. The overall facility has Restrooms with ceramic tile and VCT type flooring, acoustical ceiling tile type ceilings, as well as ceramic tile, glazed block and painted type wall finishes, and they are in fair condition. Toilet partitions are metal, and are in poor condition. Classroom casework in the overall facility is wood type construction with plastic laminate tops, is adequately provided, and in poor condition. The typical Classroom contains 20 lineal feet of casework, and Classroom casework provided ranges from 14 to 24 feet. Classrooms are provided adequate chalkboards, markerboards and tackboards which are in fair condition. The Classroom storage cubbies, located in the Classrooms are adequately provided, and in poor condition. The Art program is equipped with a kiln in fair condition, and existing kiln ventilation is inadequate. The facility is equipped with wood non-louvered interior doors that are flush mounted not recessed with proper ADA hardware and in good condition. The Gymnasium space has wood type flooring, open type ceilings, as well as painted type wall finishes, and they are in good condition. Wood Gymnasium flooring has been well maintained, will accommodate multiple future sandings and refinishings, and is rated at a median stage of its product lifecycle. There is no visible tartan flooring. Gymnasium telescoping stands are plastic type construction in good condition. Gymnasium basketball backboards are electrically operated type, and are in good condition. The Media Center, located in the 1952 facility, has carpet type flooring, acoustical ceiling tile type ceilings, as well as painted type wall finishes, and they are in fair condition. Student Dining, located in the 1952 facility, has VCT type flooring, acoustical ceiling tile type ceilings, as well as glazed block and painted type wall finishes, and they are in fair condition. OSDM-required fixed equipment for Stage is adequately provided, and in good condition. Existing Gymnasium, Student Dining, Media Center and Music spaces are not provided with appropriate sound attenuation acoustical surface treatments.

Joists enclosed by acoustical ceiling

Provide complete replacement of finishes and casework due to condition and installation of systems outlined in Items: K, U and W. Provide additional exterior wall insulation.

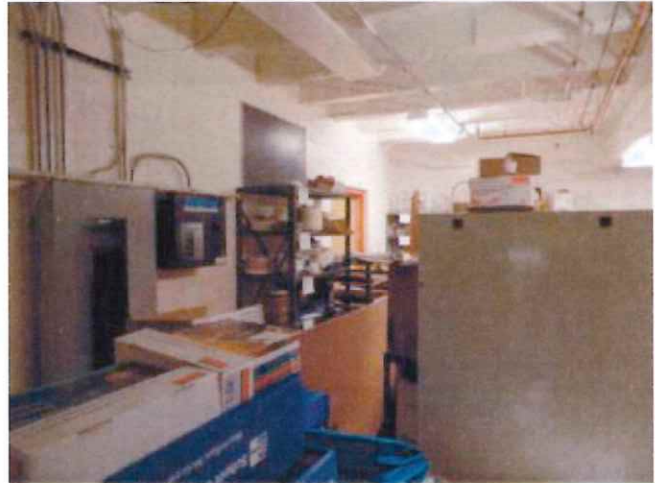
Cast in place concrete floor deck

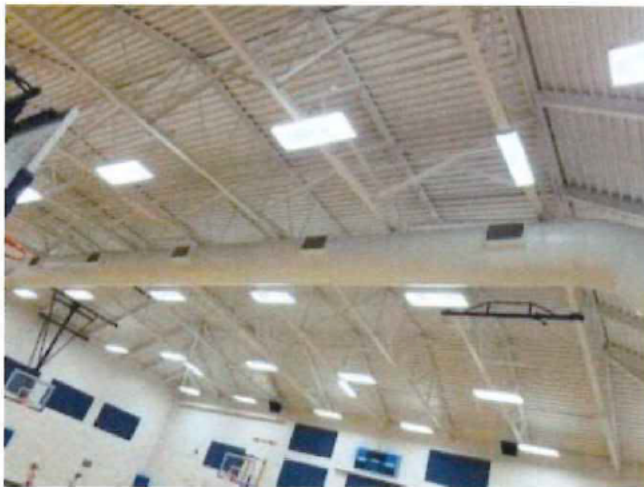
**Description:** The typical Classrooms in the overall facility are equipped with T-8 lay-in fluorescent fixtures with dual level switching. Classroom fixtures are in good condition, providing an average illumination of 64 FC, thus complying with the 50 FC recommended by the OSDM. The typical Corridors in the overall facility are equipped with T-8 lay-in 2x4 fluorescent fixtures with single level switching. Corridor fixtures are in good condition, providing an average illumination of 20 FC, thus complying with the 20 FC recommended by the OSDM. The Gymnasium spaces are equipped with T-8 suspended 2x4 fluorescent fixture type lighting, in good condition, providing an average illumination of 30 FC, which is less than the 50 ES / MS FC recommended by the OSDM. The Media Center is equipped with T-8 lay-in fluorescent fixture type lighting in good condition, providing an average illumination of 69 FC, thus complying with the 50 FC recommended by the OSDM. The Student Dining spaces are equipped with 2x4 lay-in T-8 fluorescent fixture type lighting with multi level switching. Student Dining fixtures are in good condition, providing an average illumination of 75 FC, thus complying with the 50 FC recommended by the OSDM. The Kitchen spaces are equipped with T-8 lay-in fluorescent fixture type lighting with single level switching. Kitchen fixtures are in good condition, providing an average illumination of 65 FC, which is less than the 75-80 FC recommended by the OSDM. The Service Areas in the overall facility are equipped with lay-in 2x4 T-8 fluorescent fixture type lighting in fair condition. The typical Administrative spaces in the overall facility are equipped with lay-in 2x4 T-8 fluorescent fixture type lighting in good condition, providing adequate illumination based on OSDM requirements. The overall lighting systems of the facility are not fully compliant with Ohio School Design Manual requirements due to inadequate lighting levels.

Gymnasium Lighting

**Recommendations:** Provide complete replacement of lighting system due to installation of automatic fire suppression system outlined in Item U.

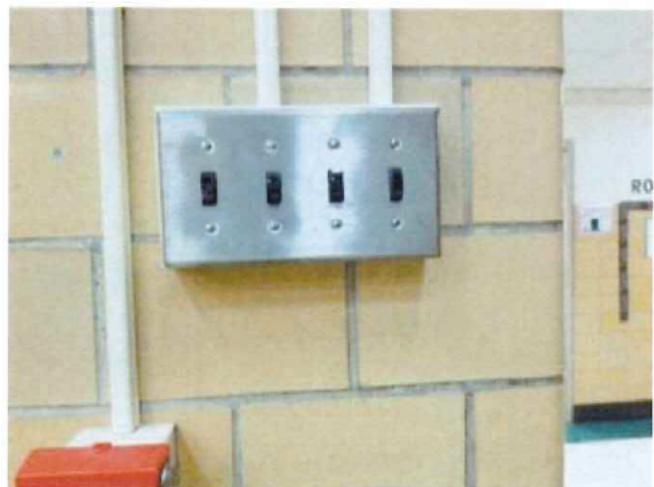
Student Dining Multilevel Switching

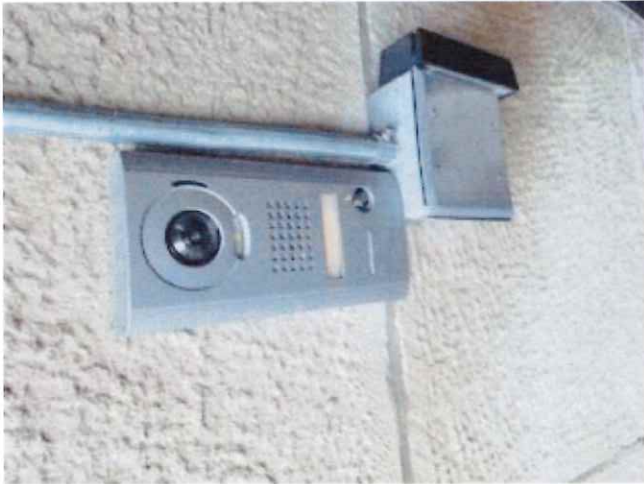
**Description:** The overall facility contains a CCTV type security system in good condition. Motion detectors are not provided in main entries, central gathering areas, offices, main Corridors, and spaces where 6 or more computers are located. Exterior doors are not equipped with door contacts. An automatic visitor control system is provided. Compliant color CCTV cameras are inadequately provided at main entry areas, parking lots, central gathering areas, and main Corridors. CCTV is monitored in Administrative Area with the use of an LCD monitor and computer based hard disk recording device. A compliant computer controlled access control system integrating alarms and video signals, with appropriate UPS backup, is not provided. The system is not equipped with card / biometric readers. The security system is not adequately provided throughout, and the system is not compliant with Ohio School Design Manual guidelines. The exterior site lighting system is equipped with surface mounted HID entry lights in fair condition. Parking and bus pick-up / drop off areas are not illuminated. The exterior site lighting system provides adequate inadequate illumination due to insufficient fixture capacity and sparse placement of fixtures.

Visitor Control System

**Recommendations:** Provide complete replacement of security system to meet Ohio School Design Manual guidelines. Provide new exterior site lighting system to meet Ohio School Design Manual guidelines.

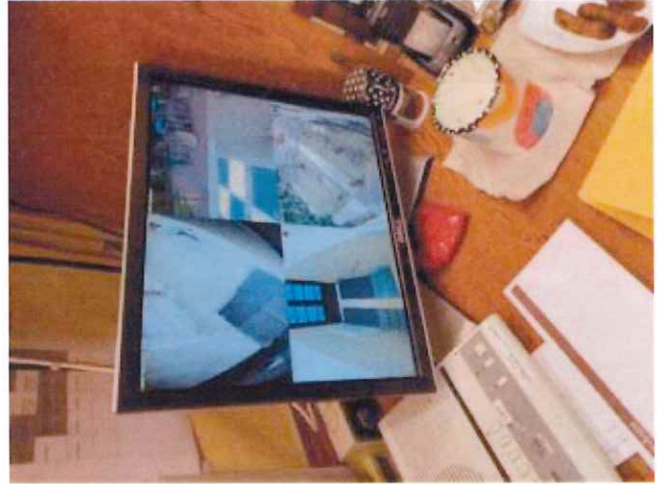
CCTV Monitor with All Zones Shown

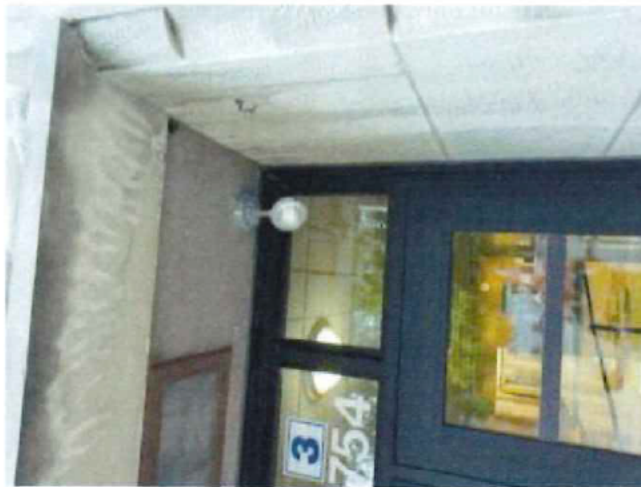
**Description:** The overall facility is equipped with an emergency egress lighting system consisting of non compliant plastic construction and the system is in good condition. The facility is equipped with emergency egress floodlighting and the system is in good condition. The system is provided with appropriate battery backup. The system is adequately provided throughout, and meets Ohio School Design Manual and Ohio Building Code requirements.

Egress Light Remote Head

**Recommendations:** Provide complete replacement of emergency / egress lighting system to facilitate work in Items A, K, and U.

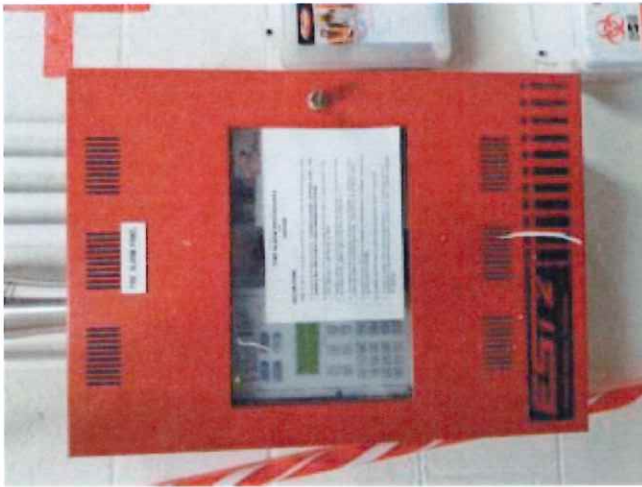
**Description:** The overall facility is equipped with an Edwards System Technology EST2 type fire alarm system, installed in 2002, and in good condition, consisting of manual pull stations and horn and strobe indicating devices. The system is automatic and is monitored by a third party. The system is equipped with sufficient audible horns / strobe indicating devices / smoke detectors / heat sensors. The system is not equipped with any flow switches / tamper switches. The system thus will support future fire suppression systems. The system is adequately provided throughout, and does have additional zone capabilities. The system is compliant with Ohio Building Code, NFPA, and Ohio School Design Manual requirements.

Fire Alarm Control Panel

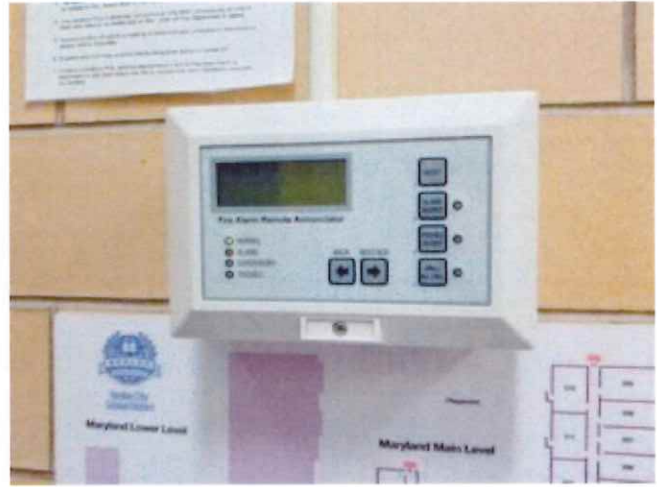
Remote Annunciator

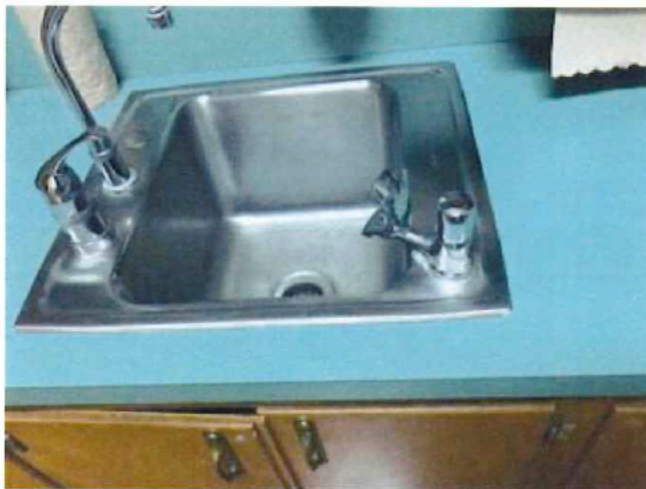
Non-compliant sink mounted drinking fountain

**Recommendations:** Provide ADA-compliant plumbing fixtures and electric water coolers. Provide ADA-compliant sink mounted drinking fountains in the classrooms. Provide power assist door operators. Provide handrails to stage. Provide toilet accessories. Remount mirrors to ADA height.

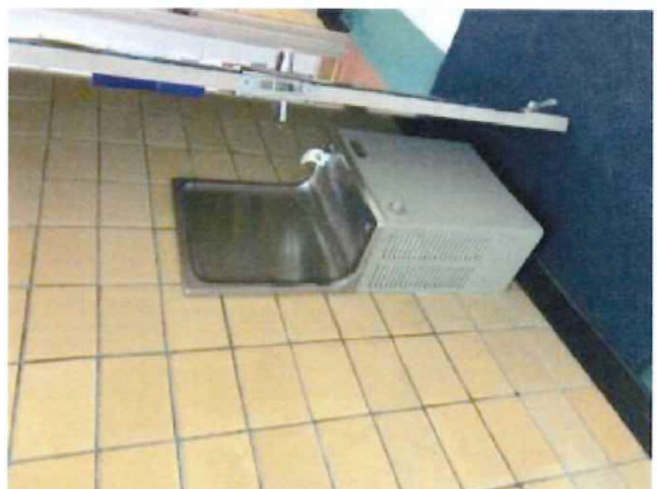
Non-compliant electric water cooler

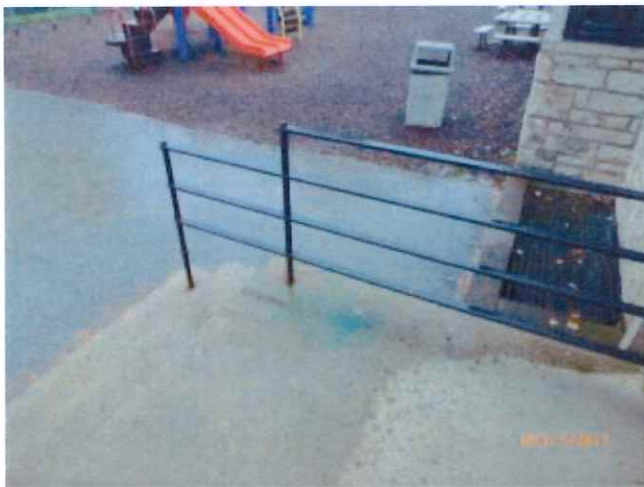
The 4.10 acre relatively flat site is located in a suburban residential setting with moderate tree and lawn type landscaping. There are no outbuildings. There are no apparent problems with erosion or ponding. The site is bordered by lightly traveled city streets. A single entrance is provided onto the site. Staff and visitor parking is facilitated by an asphalt parking lot in good condition, containing 18 parking places, which does not provide adequate parking for staff members, visitors, and the disabled. The site and parking lot drainage design, consisting of catch basins and storm sewers, provides adequate evacuation of storm water, and no problems with parking lot ponding were observed. Concrete curbs in good condition are appropriately placed. Concrete sidewalks are properly sloped, are located to provide a logical flow of pedestrian traffic, and are in good condition. Trash pick-up and service drive pavement is heavy duty and is in good condition, and is not equipped with a concrete pad area for dumpsters. There are three sets of steps that need the handrails replaced with ADA-compliant handrails. The perimeter of the site is partially fenced in. The playgrounds are separated from parking area by fences. There is an ungated single lane entrance to the hard playground from the street. The playground equipment is primarily constructed of coated steel and high-density plastic, and is in good condition. Playground equipment is placed to provide compliant fall zones, and on ADA-compliant rubber tile surface. Three basketball hoops are provided on an asphalt surface in good condition. The playground area is equipped with sufficient benches in good condition. The athletic facilities are comprised of a baseball field that is in good condition. Site features are suitable for outdoor instruction. The site is too small to add a building addition or parking.

Non-compliant handrails

Provide ADA-compliant handrails at 3 sets of steps. Provide concrete dumpster pad. Provide chain link fence and gate to close in the east side of the site and playground.

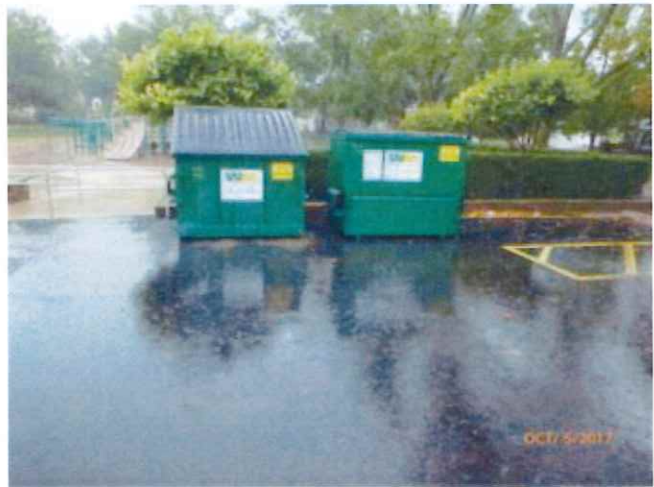
Dumpsters on asphalt

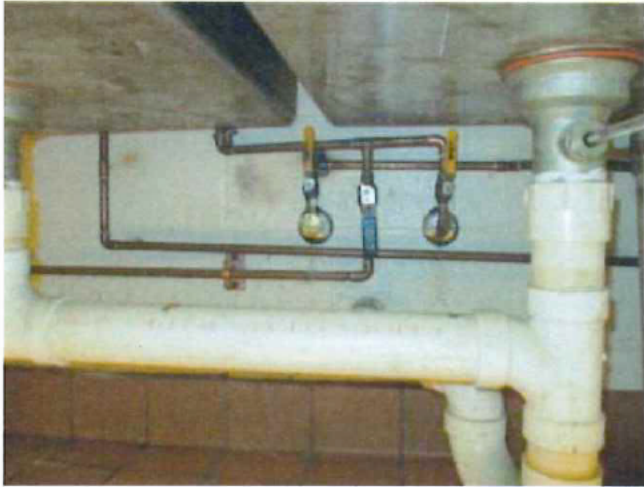
**Description:** The sanitary sewer system is tied in to the city system, and is in good condition. No significant system deficiencies were reported by the school district or noted during the physical assessment.

Kitchen Sink Waste

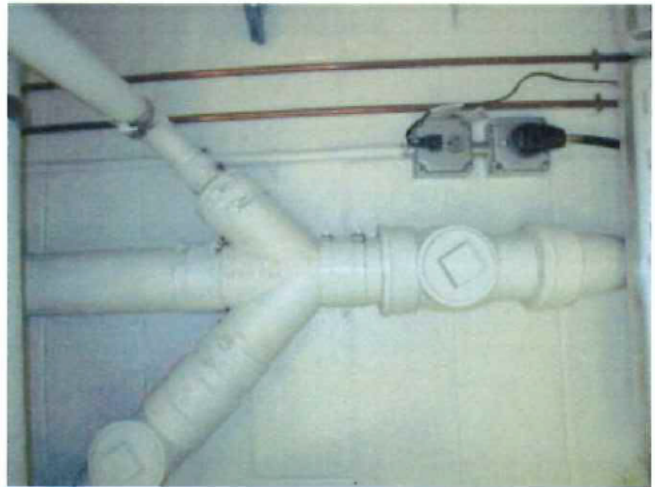
Exposed Sanitary Stack

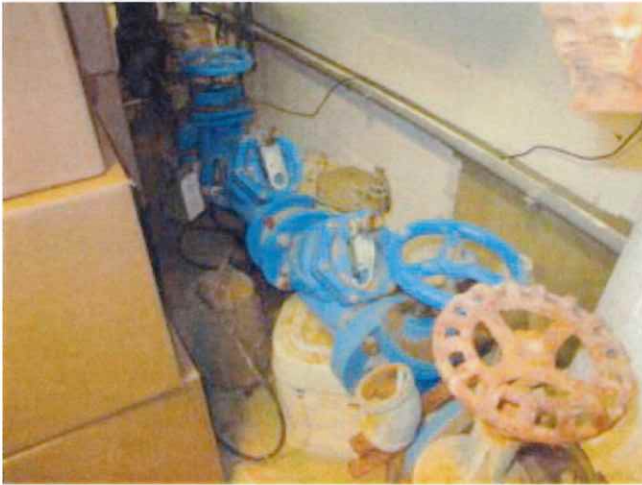
Backflow Preventer

**Recommendations:** Provide a new city water supply line of adequate capacity to support the existing needs of the facility, as well as a future automated fire suppression system. Funding provided in Item U.

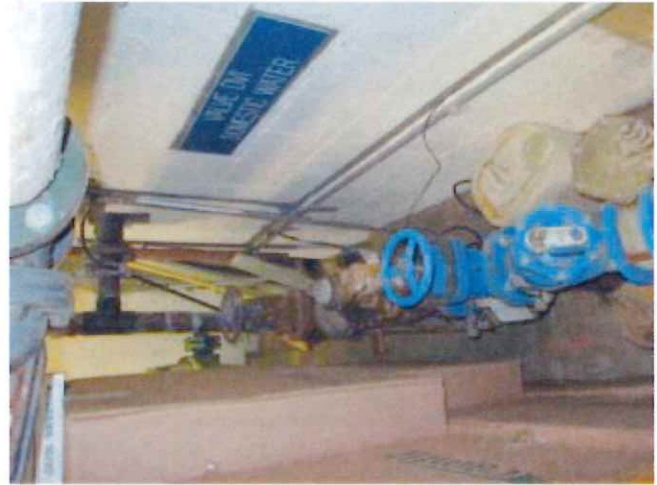
Incoming Water

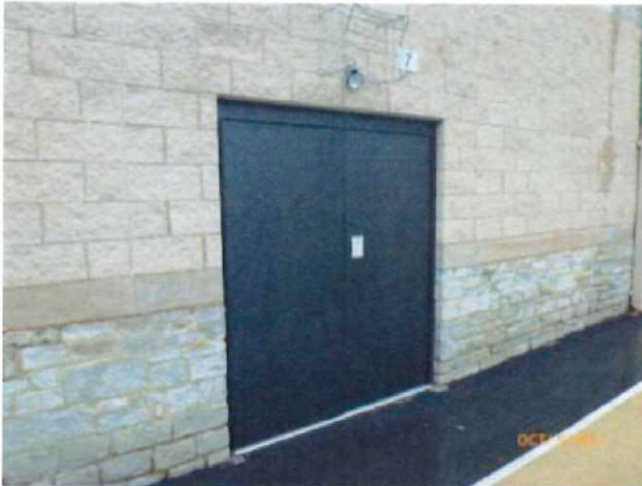
Aluminum doors with FRP panels

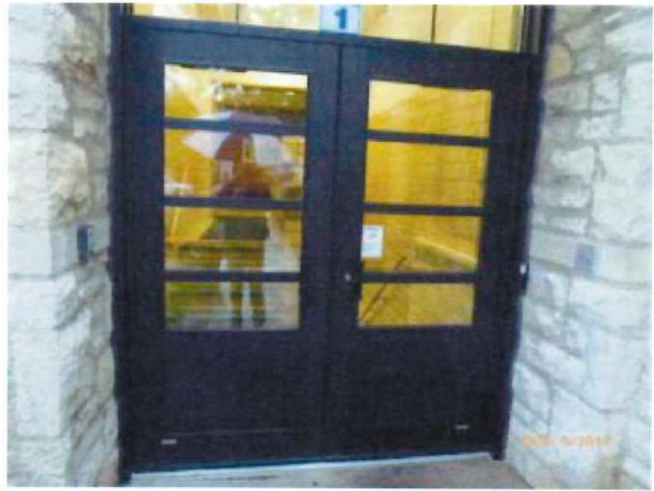
Aluminum entrance doors

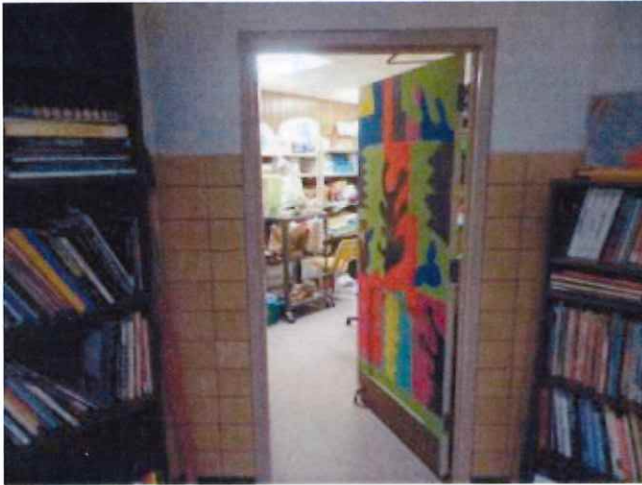
Asbestos containing floor tile

**Recommendations:** Remove asbestos containing resilient flooring. Abate all fluorescent fixtures due to complete lighting replacement. See Item K, Due to the construction date, there is a potential for lead based paint.

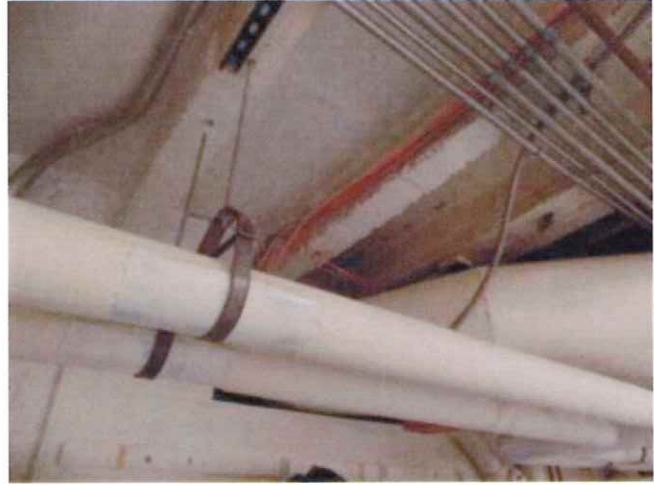
Asbestos free pipe insulation

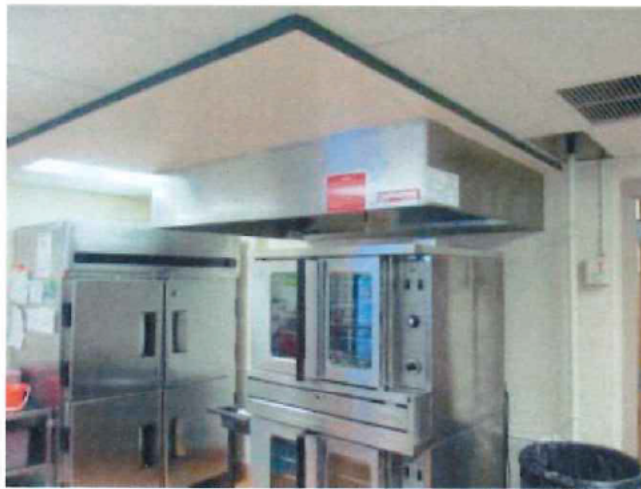
Kitchen Hood

**Recommendations:** Provide new automated fire suppression system to meet Ohio School Design Manual guidelines. Provide increased water service of a capacity sufficient to support the fire suppression system, funding included in fire suppression funding. Provide new emergency generator, with funding provided via complete replacement of electrical system in Item D.

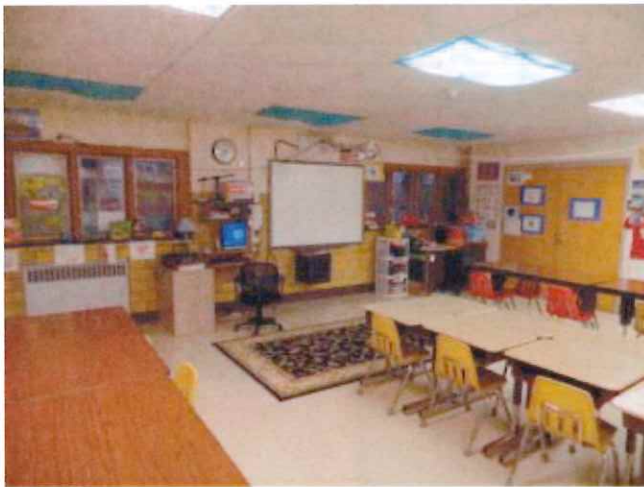
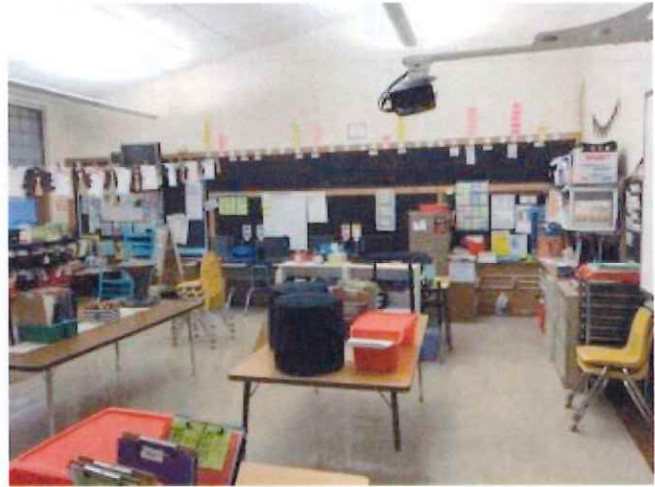
Loose furnishings

**Recommendations:** Provide for replacement of outdated or inadequate furnishings.

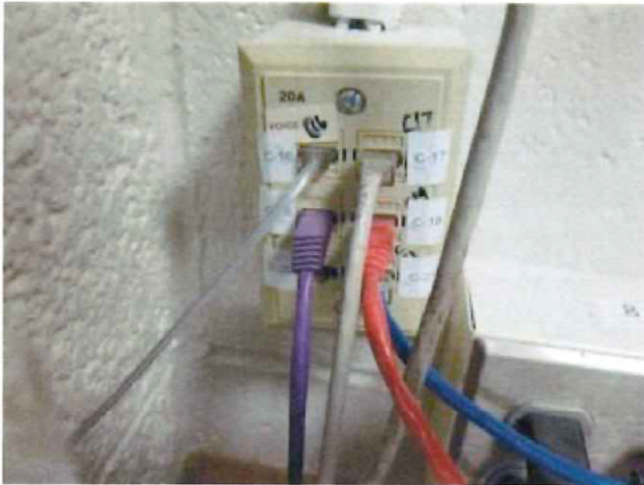
Typical Classroom Data Jacks

**Recommendations:** Provide complete replacement of technology systems to meet Ohio School Design Manual requirements, and to sustain the capacity to keep pace with technological development.

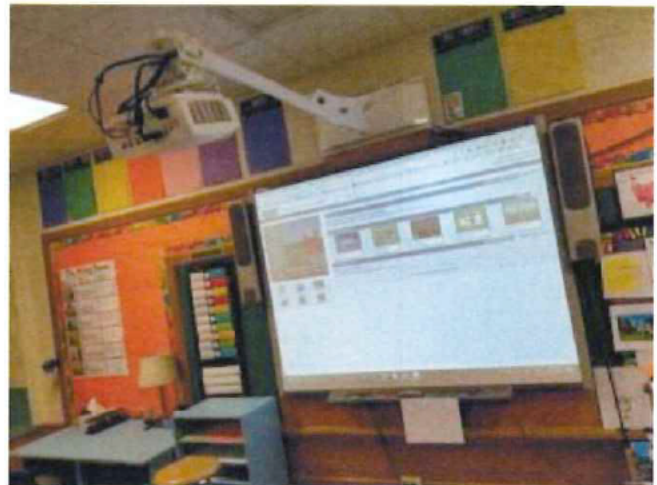
Classroom Smart Board
