Facilities Master Plan

Physical Assessment

DECEMBER 8, 2015

MOODY NOLAN | KORDA | EMH&T | TURNER

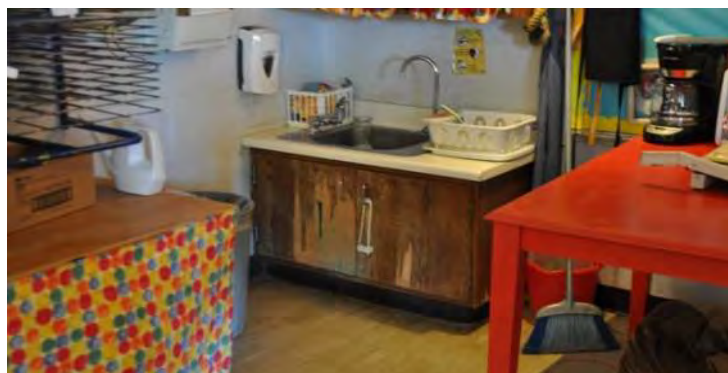
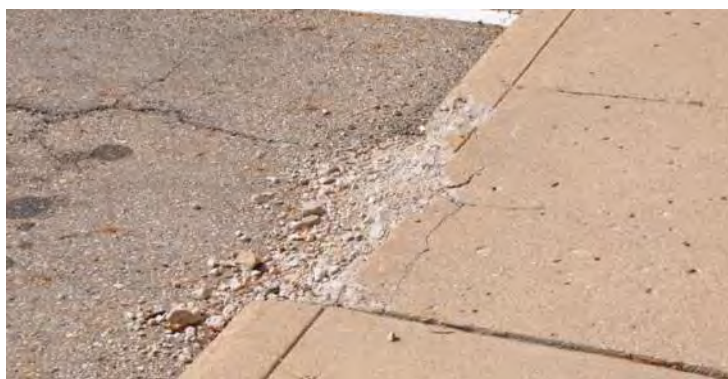
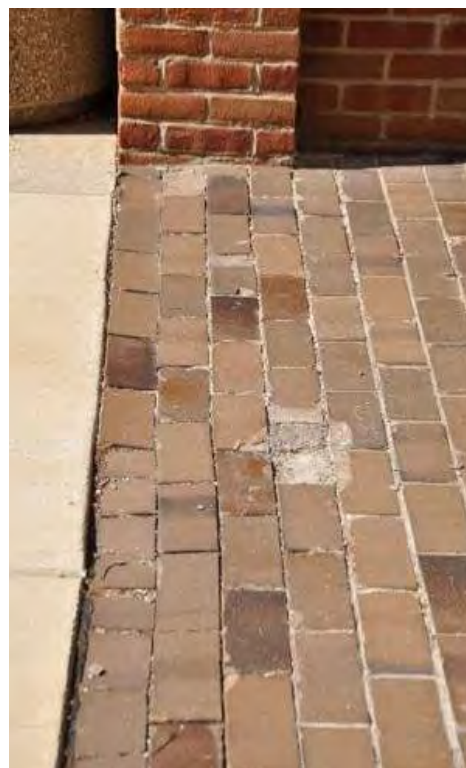
Top: Damaged interior finishes Bottom & Right: Cracked/timeworn exterior elements

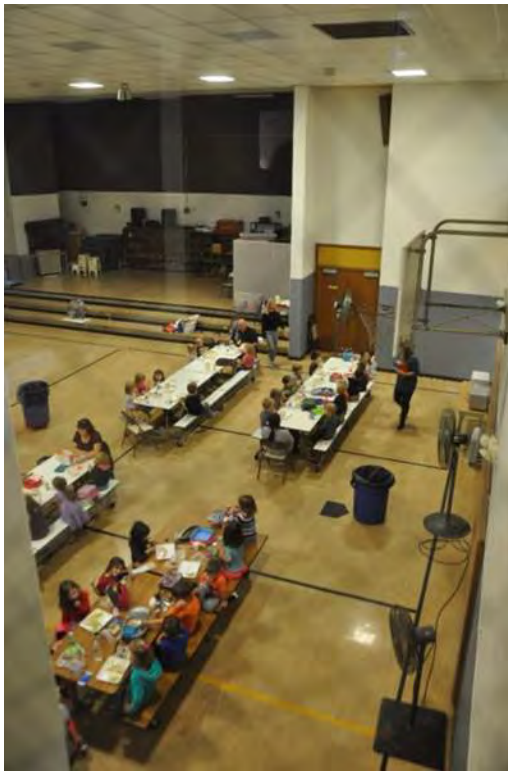
Gymnasium without air conditioning

- c. The gymnasium air handler is existing, and it should be replaced and equipped with a cooling coil and modified return duct path to improve ventilation and heating effectiveness. This will provide cooling as well as heating for this space.

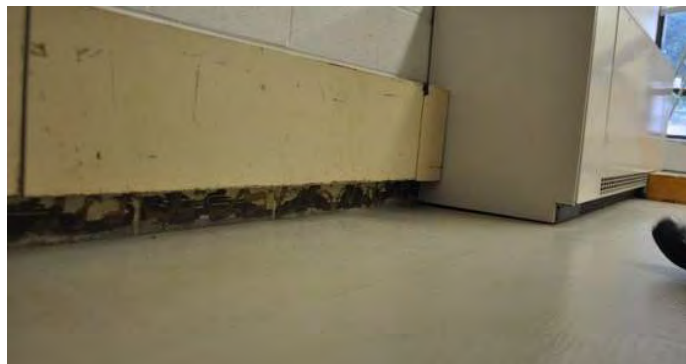
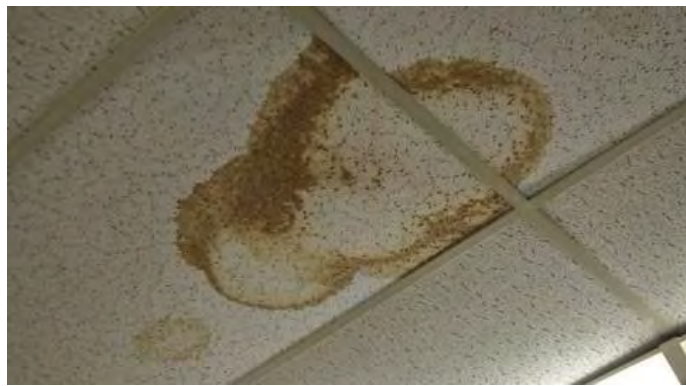
Water infiltration at floor and roof

- a. The roof is in fair condition. There is a large area above the main stair that is having major issues with roof leaks. This area seems soft and there was evidence of ponding due to water not traveling properly to the drains. A partial replacement to deck in this area will be needed immediately.

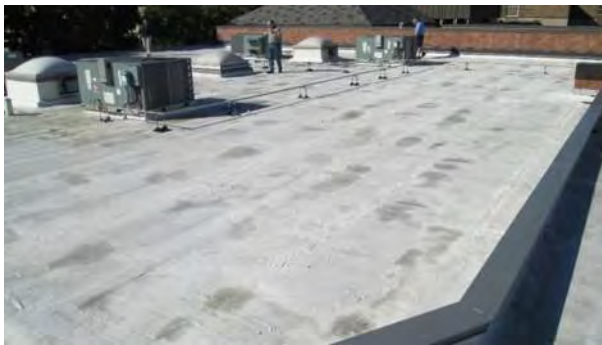
Roof sections in need of repair/replacement

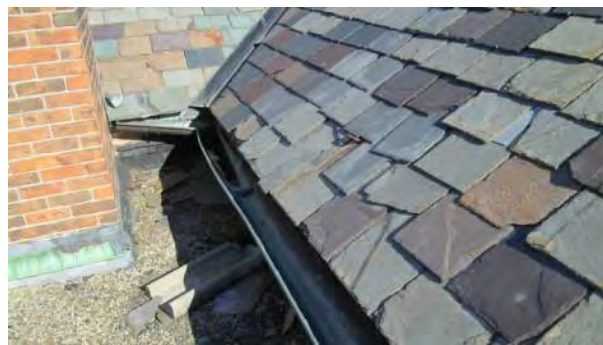
Damaged slate tile roof and drainage

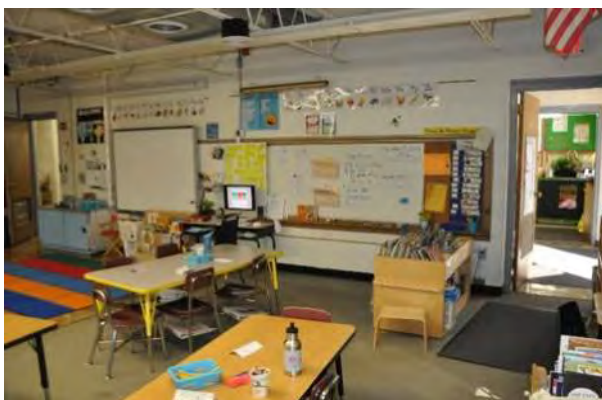
Classroom general finish upgrades needed

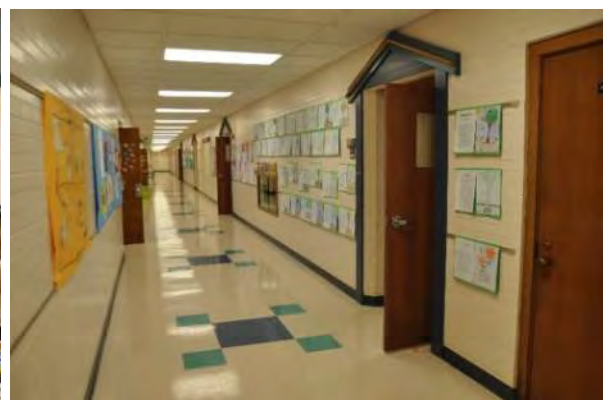
Classroom entry reconfigurations

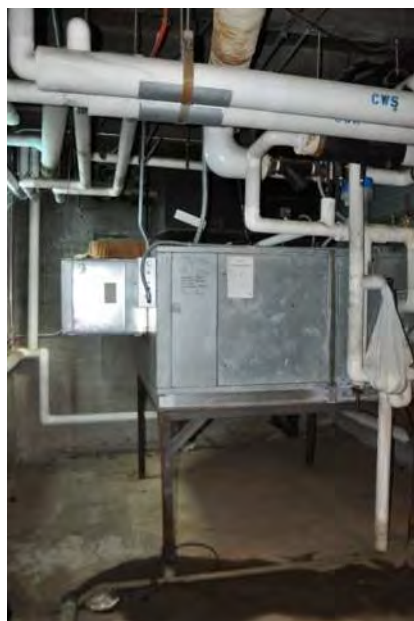
Timeworn HVAC system

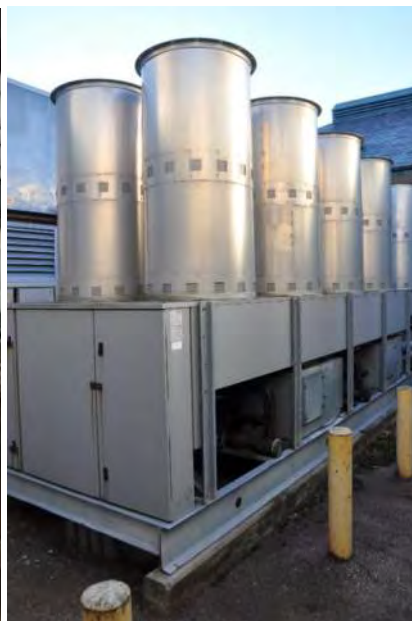
Building chiller near end of life

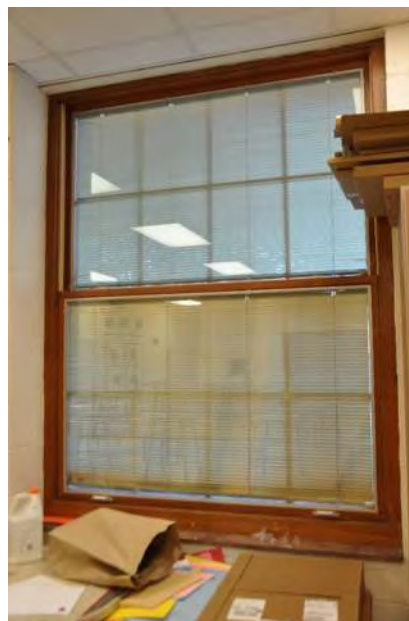
Window replacement

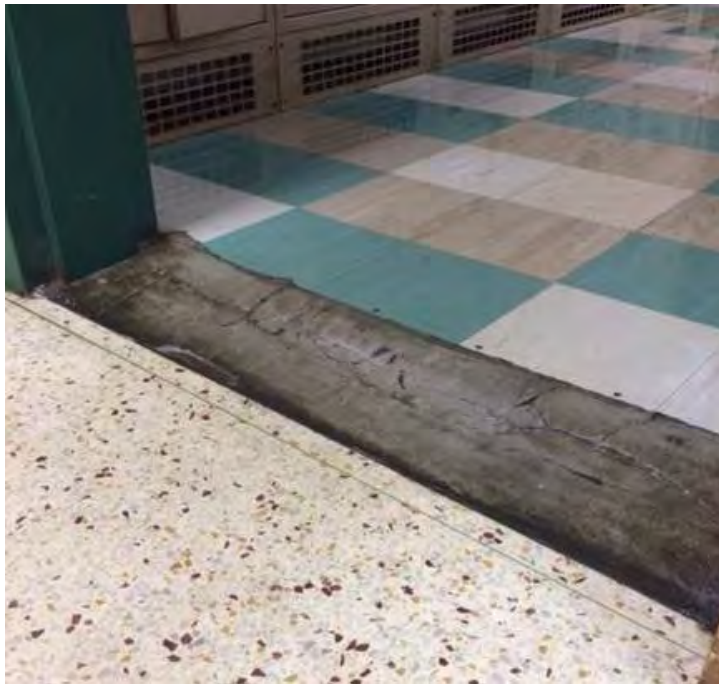
Differential floor elevation due to structural settlement

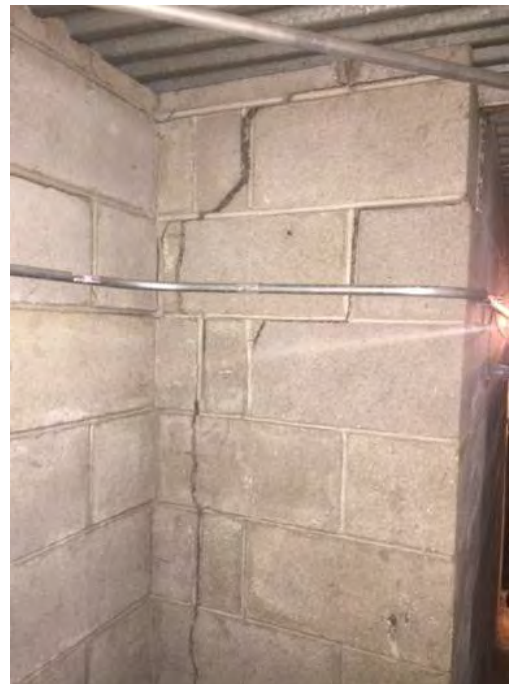
Cracking due to hydrostatic pressure

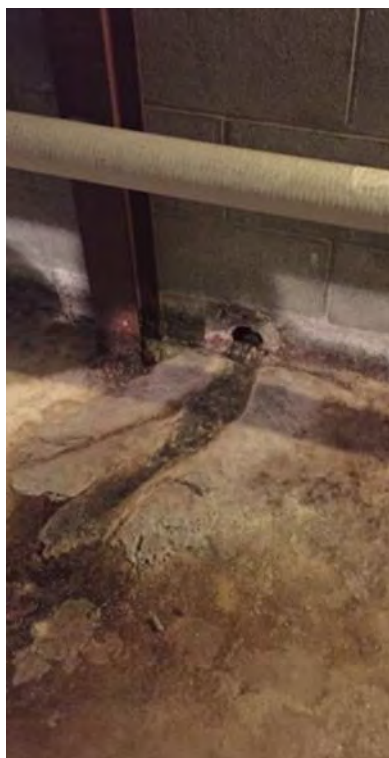
Water infiltration

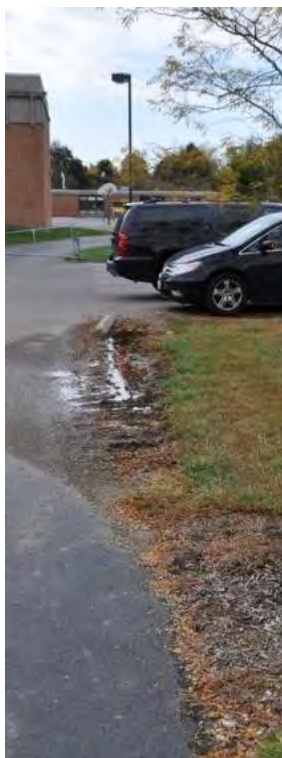
Site drainage issues

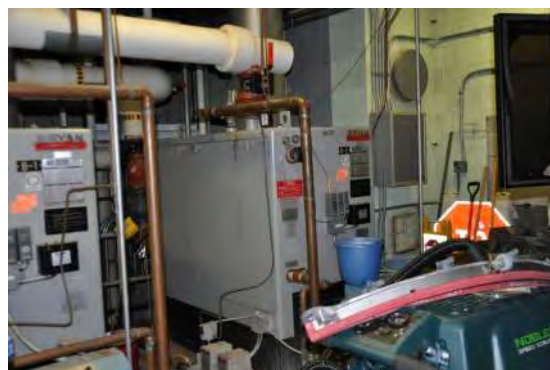
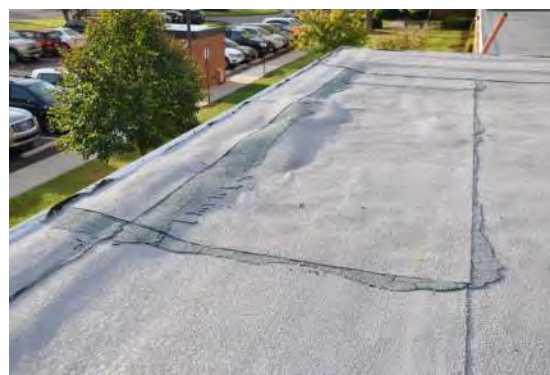
Top: Outdated HVAC Bottom: Timeworn Roof

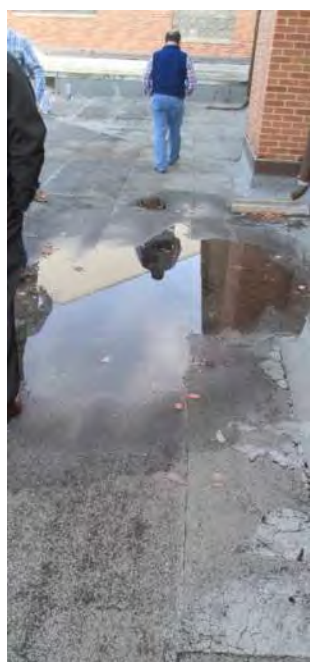
Roof needing repair

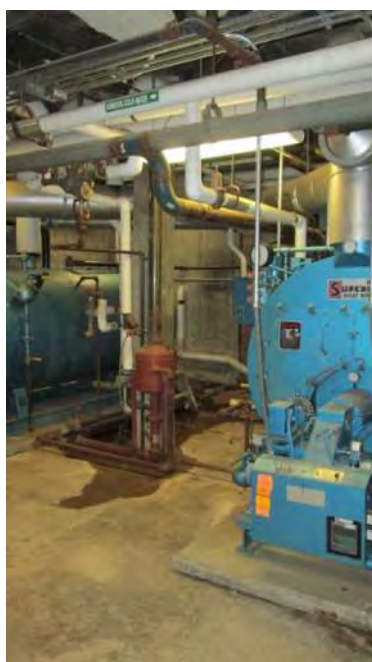
Outdated HVAC equipment

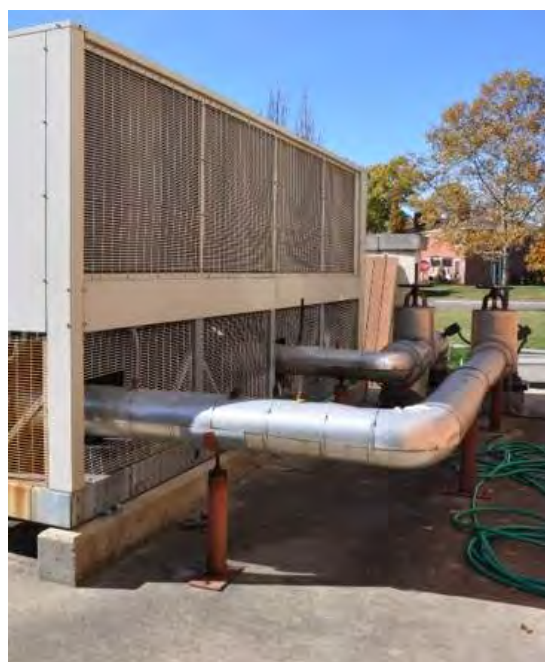
Air Cooled Chiller replacement

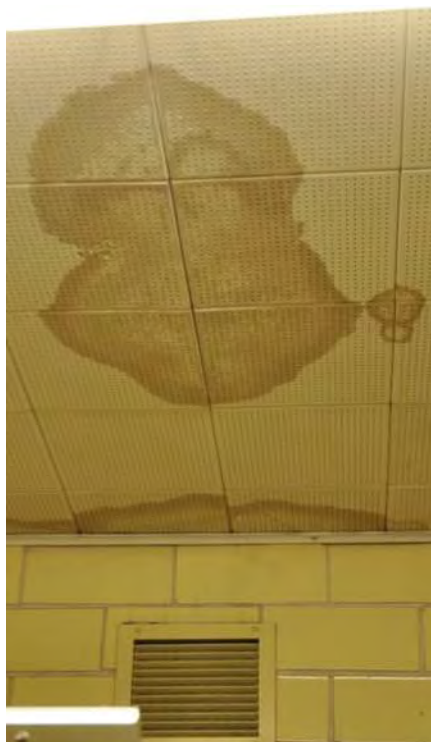
Leaking roof

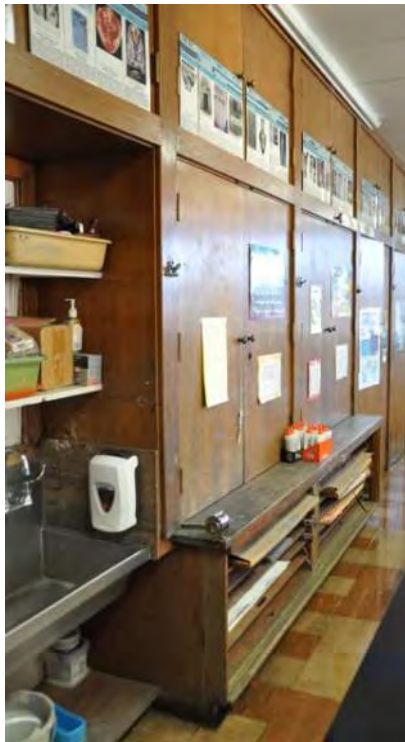
Outdated casework

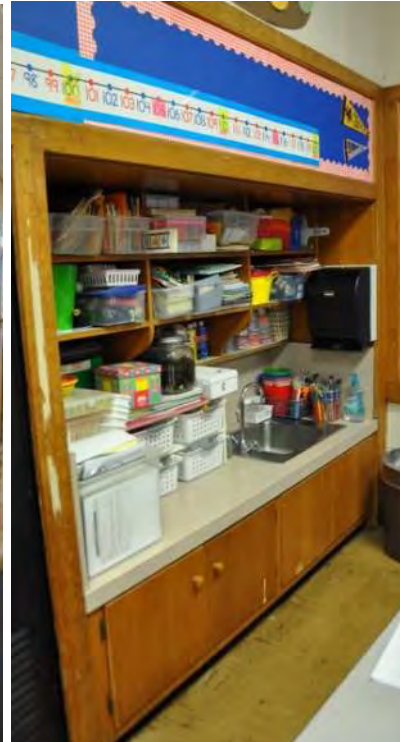
Timeworn finishes

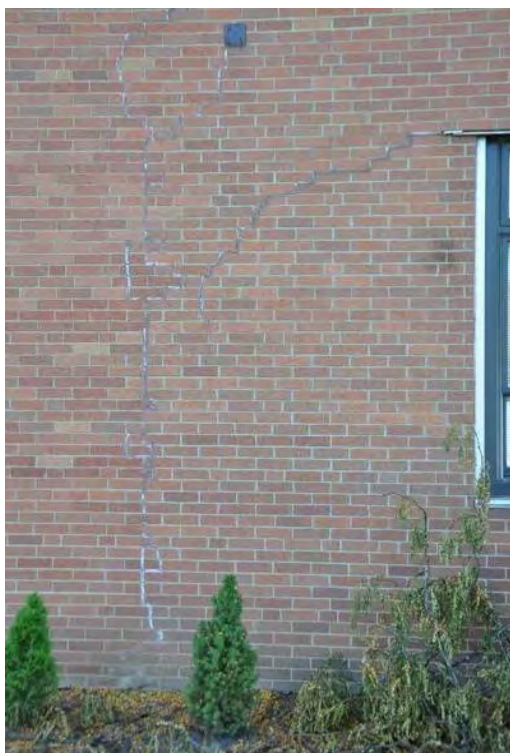
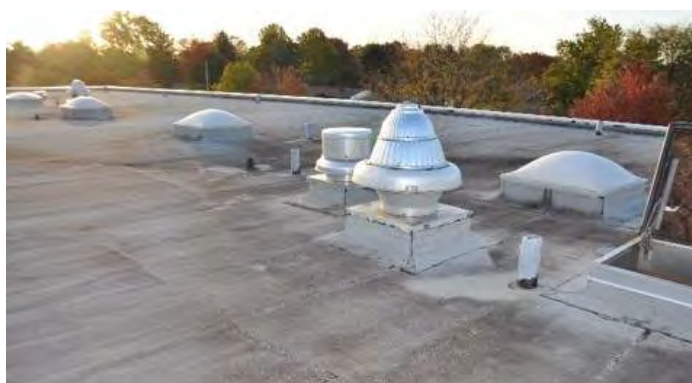
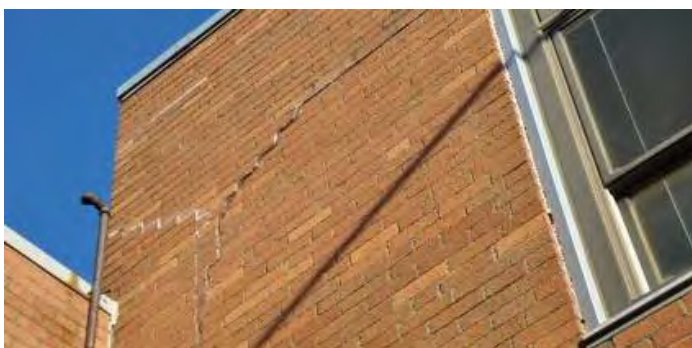
Left & Bottom: Masonry settlement at original building Top: Roof repair needed at library/media center

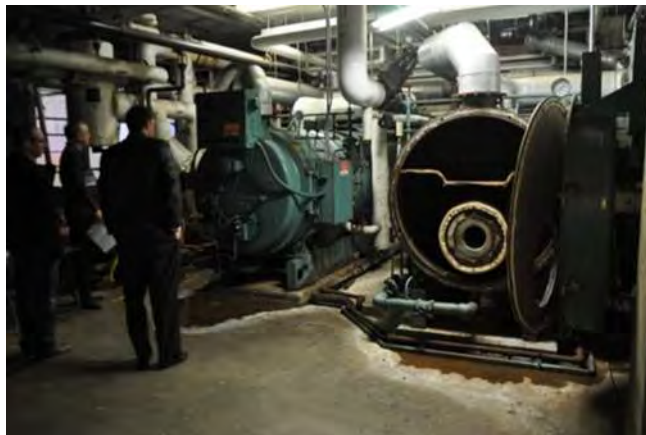
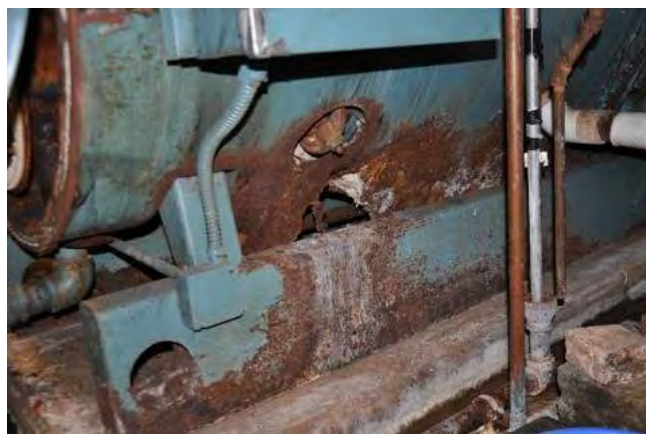
Failing HVAC specifically the existing boilers

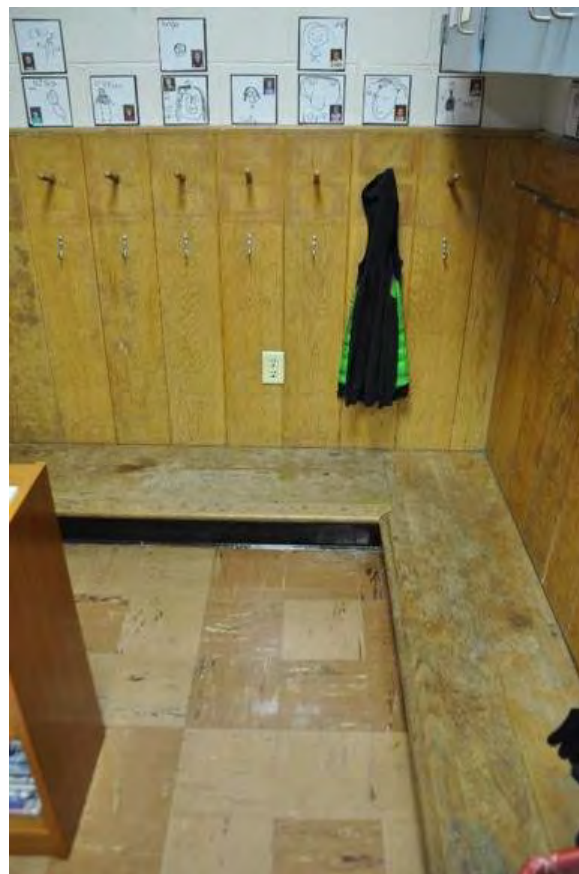
Timeworn finishes

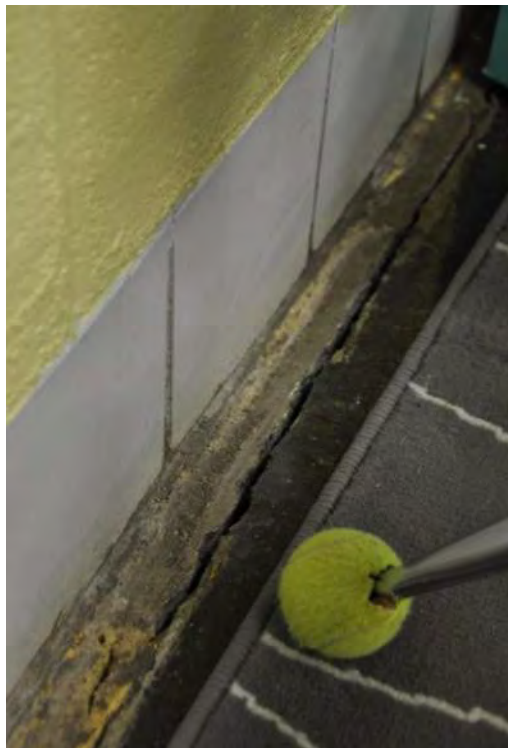
Wall and floor separation due to structural deficiencies

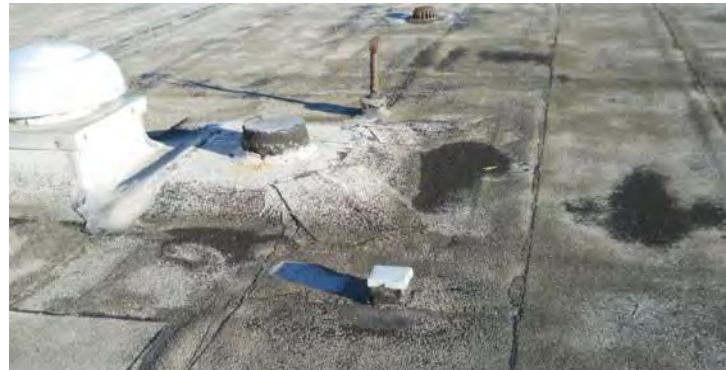
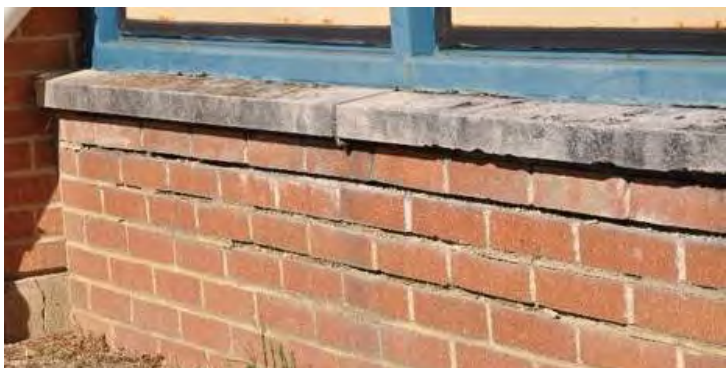
Top: Roof in need of repair Bottom: Failing exterior brick

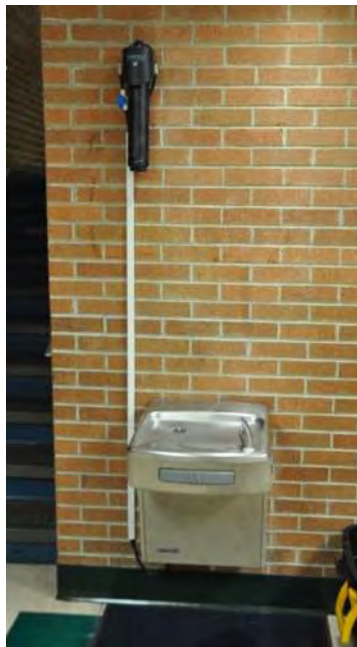
Drinking water quality

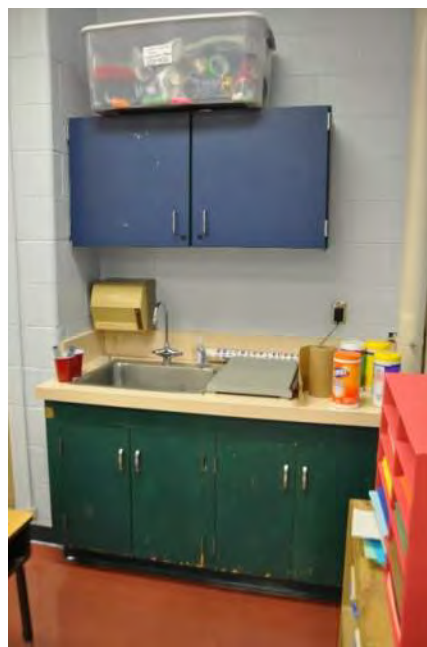
Casework in need of repair

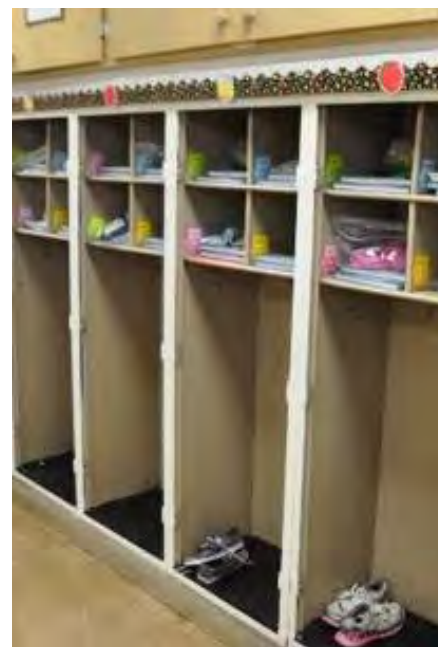
Updates to general finishes

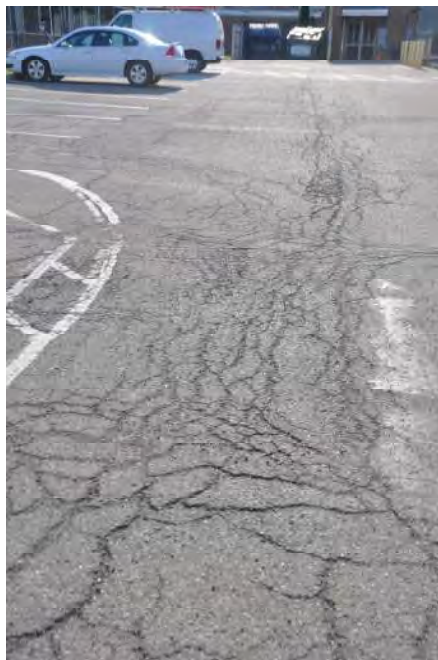
Cracked/timeworn asphalt

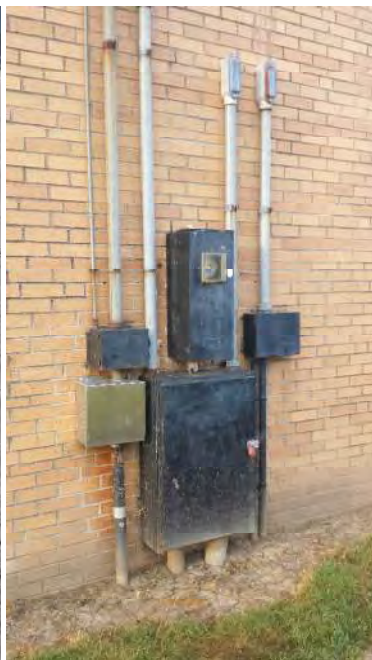
Outdated main electrical panel

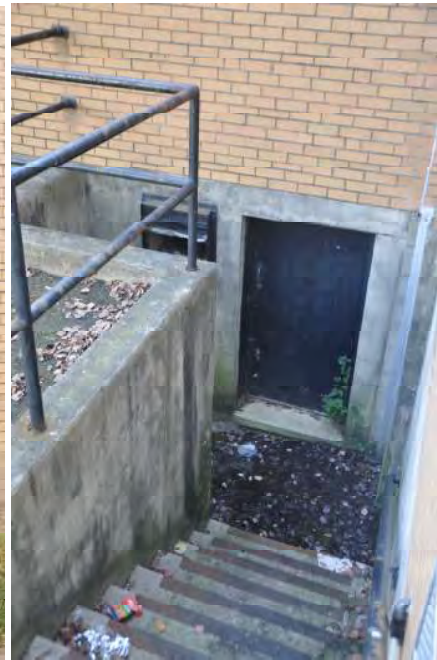
Inadequate drainage at stair well

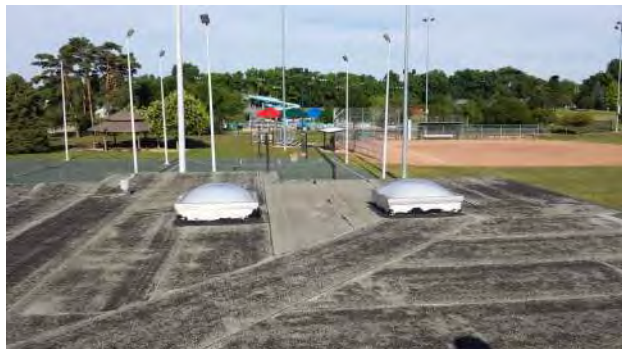
Roof sections in need of repair/replacement

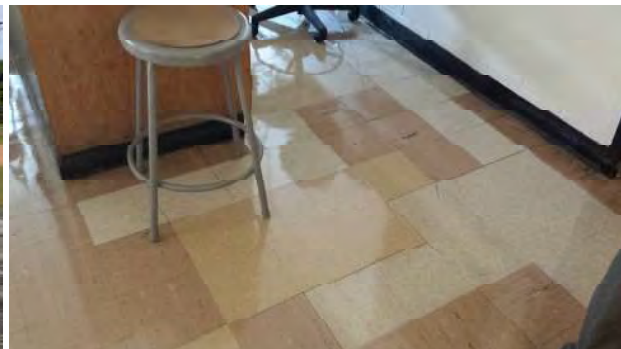
Damaged flooring

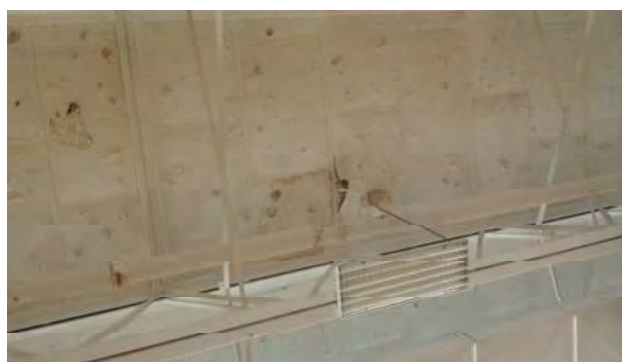
Gymnasium roof structure with water staining

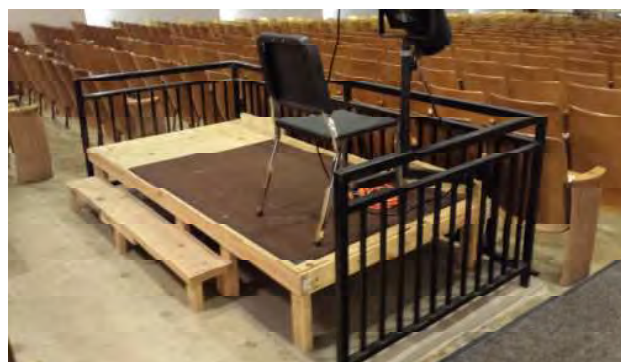
Auditorium finishes in need of repair/upgrade

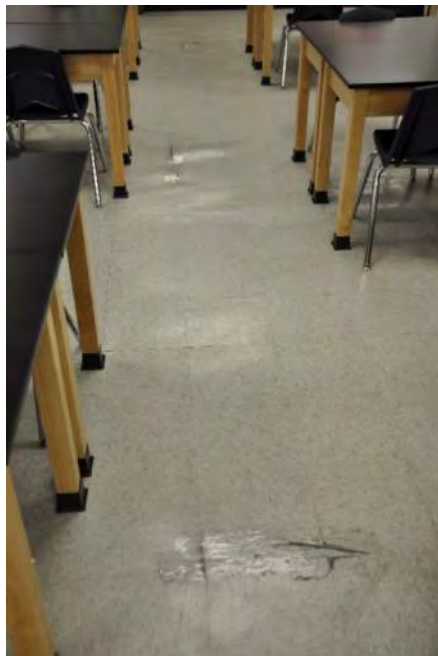
Damaged floor tiles

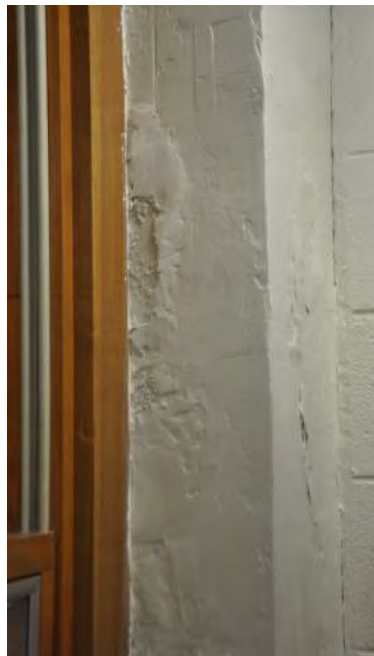
Plaster damage

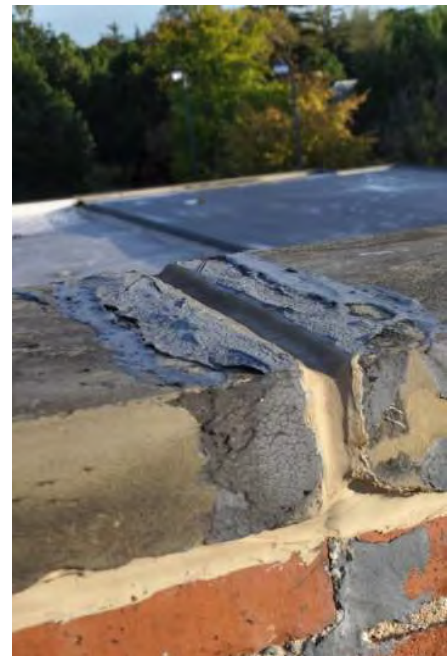
Damaged coping

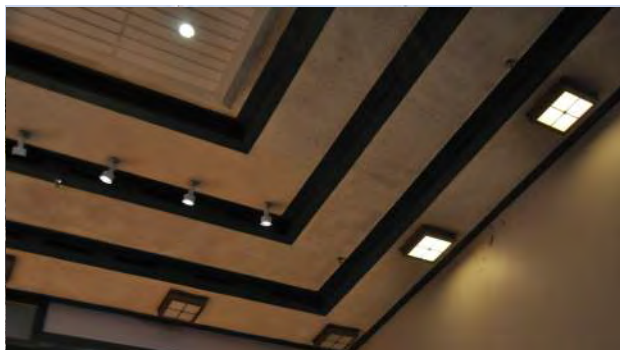
Auditorium ceiling and lighting damage

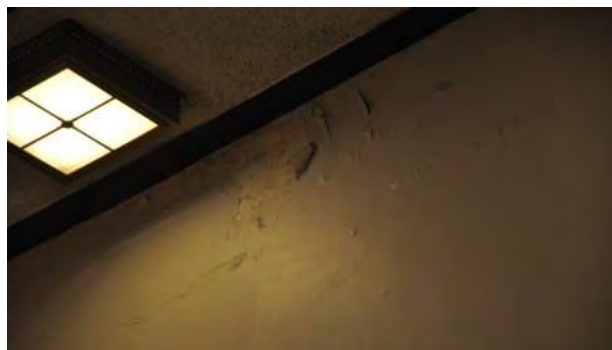
Wall damage

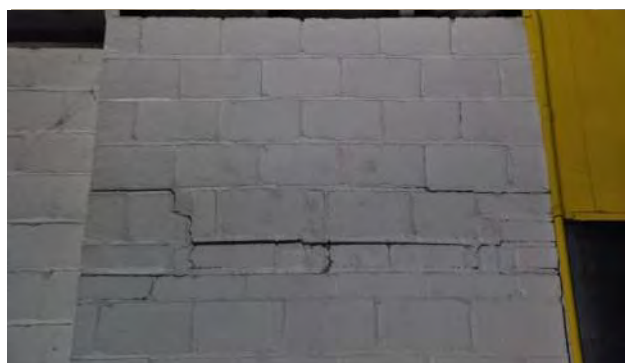
Masonry and structural settlement at Block House

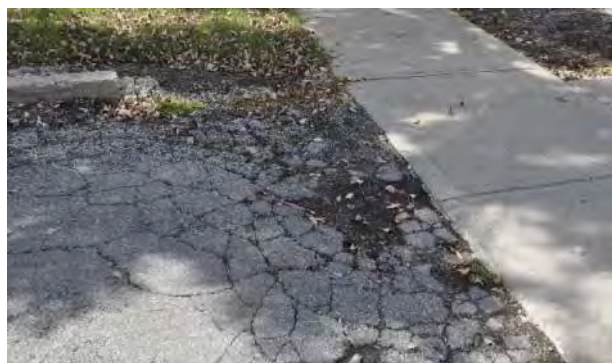
Asphalt damage at parking

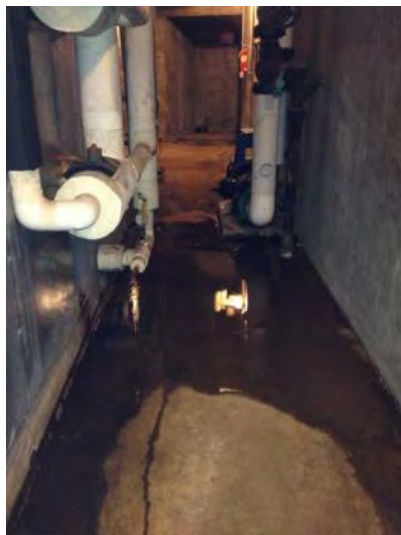
Basement Water Infiltration

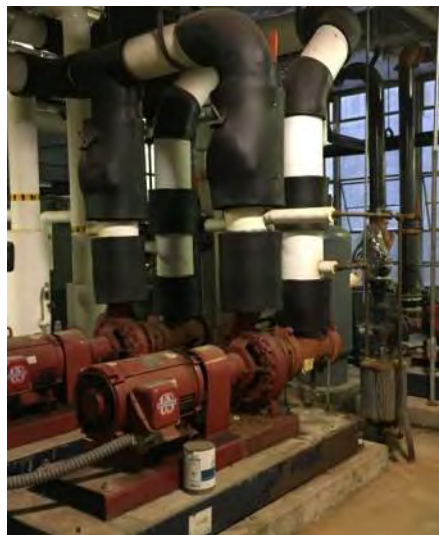
Dated HVAC systems

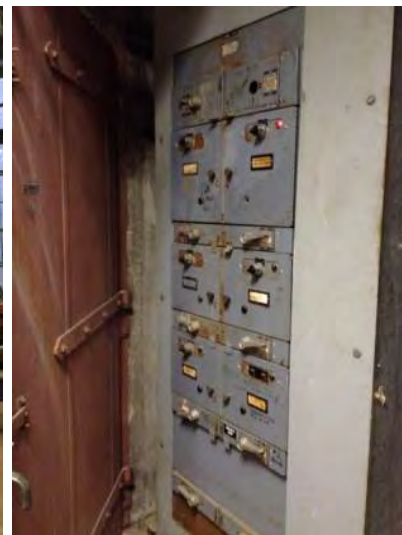
Timeworn Electrical Panel

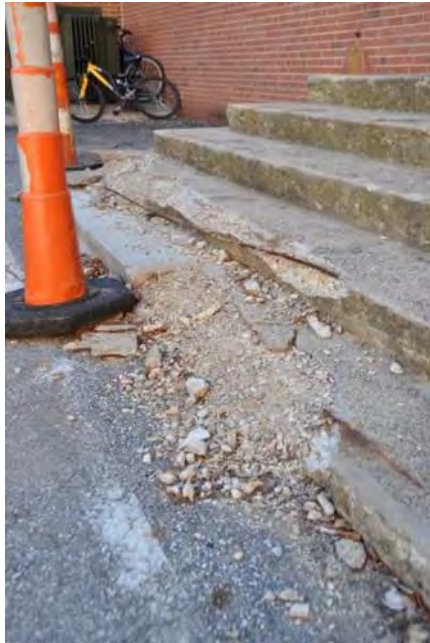
Failing concrete steps

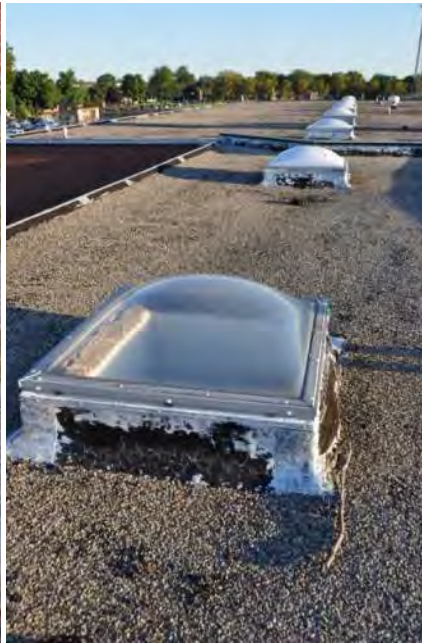
Roofing in need of repair

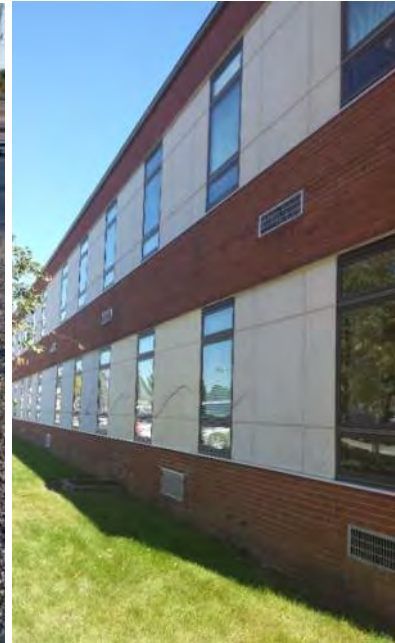
Window replacement locations
