Facility Study for the Brentwood Borough School District

HHSDR ARCHITECTS / ENGINEERS

TAB 1 - Introduction, Methodology and Data

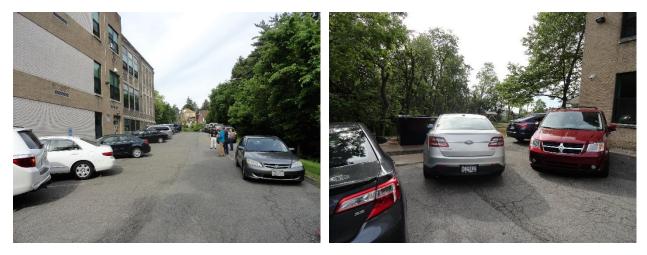
The paving is in poor condition and parking is inadequate.

Parking is inadequate.

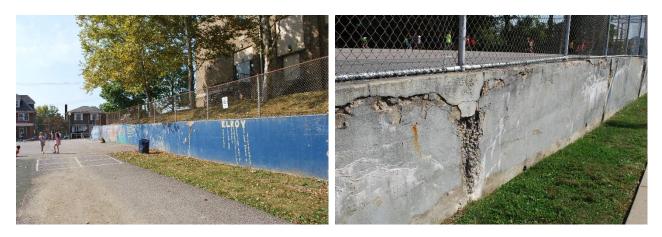
Retaining wall located between building and playground.

Another view of severely eroded playground retaining wall, located between playground and street.

- Replace retaining wall between street and playground
- Repair retaining wall between building and playground
- New paving
- New roof
- New windows
- Masonry restoration
- Office and Nurse area reconfiguration
- Kitchen and Cafeteria improvements
- Painting
- Replace exterior doors
- Replace interior doors and hardware
- · X-ray test the heating and domestic water piping
- Add air-conditioning
- Upgrade storm sewer system
- Replace air handling units
- Replace unit ventilators
- Upgrade temperature control system to DDC
- Replace domestic water system
- Replace plumbing fixtures with low flow type
- New electrical service if air-conditioning is added
- Replace switchboard
- Replace exterior lighting with LED
- Replace interior lighting with LED
- · Provide audio visual notification devices for the fire alarm system
- Update Public Address, clocks and phone system

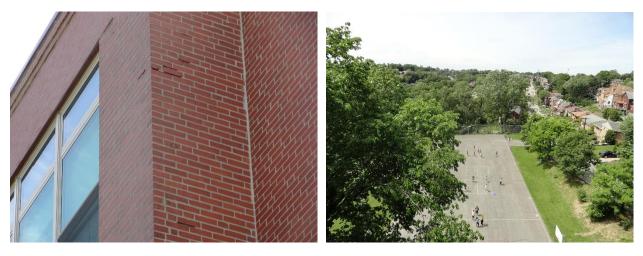
Typical exterior brick with some areas that need repairs.

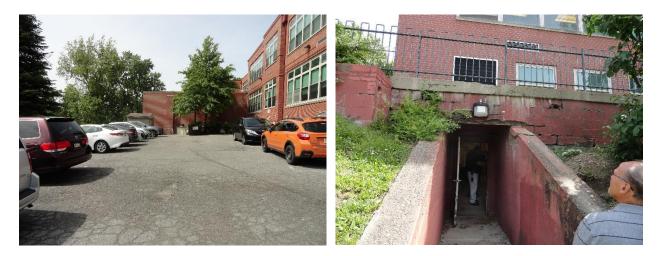
Exterior paving is in poor condition.

Exit from the boiler room has masonry/concrete deterioration.

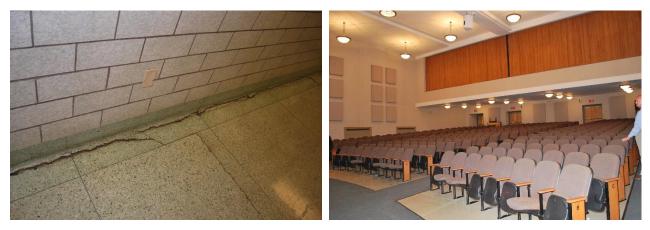
Terrazzo flooring is cracked at some locations.
