# Facility Study of the former Saint Sylvester School Brentwood, Pennsylvania

Performed for the  
Brentwood Borough School District

January 21, 2020  
Commission #4372

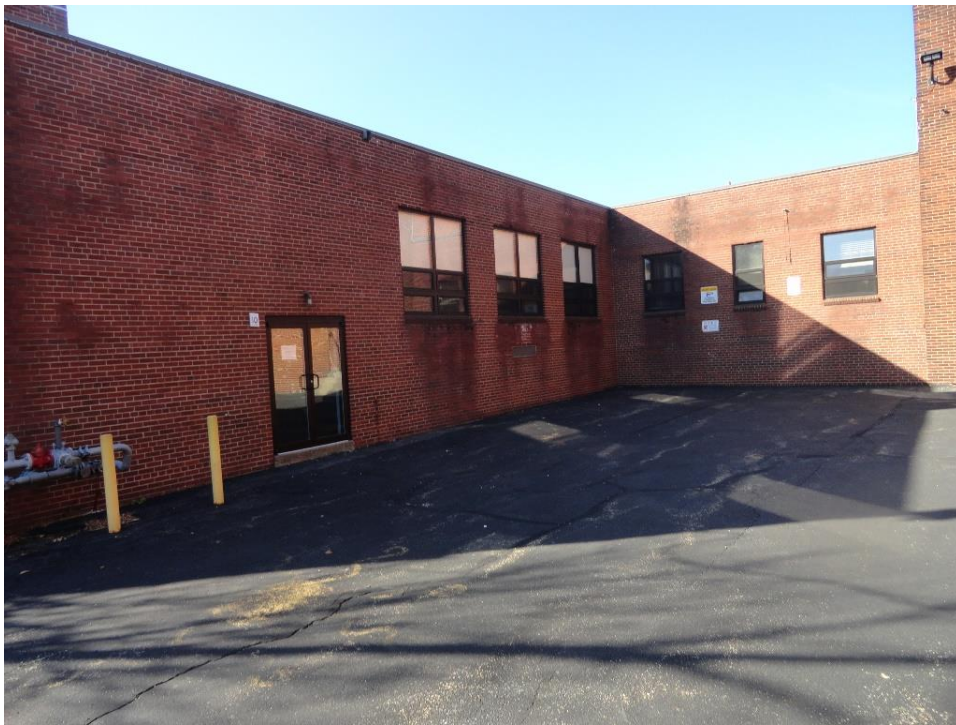
1. Exterior access to the building is from the church parking lot and West Willock Road for the gymnasium. The paving around at the building is in poor condition

Asphalt is in poor condition.

1. Repave the parking lot, rebuild the retaining walls, add a playground area.
2. Replace the roof system, exterior doors and repair the exterior brick where needed.
3. Construct an exterior accessible ramp at main entrance.

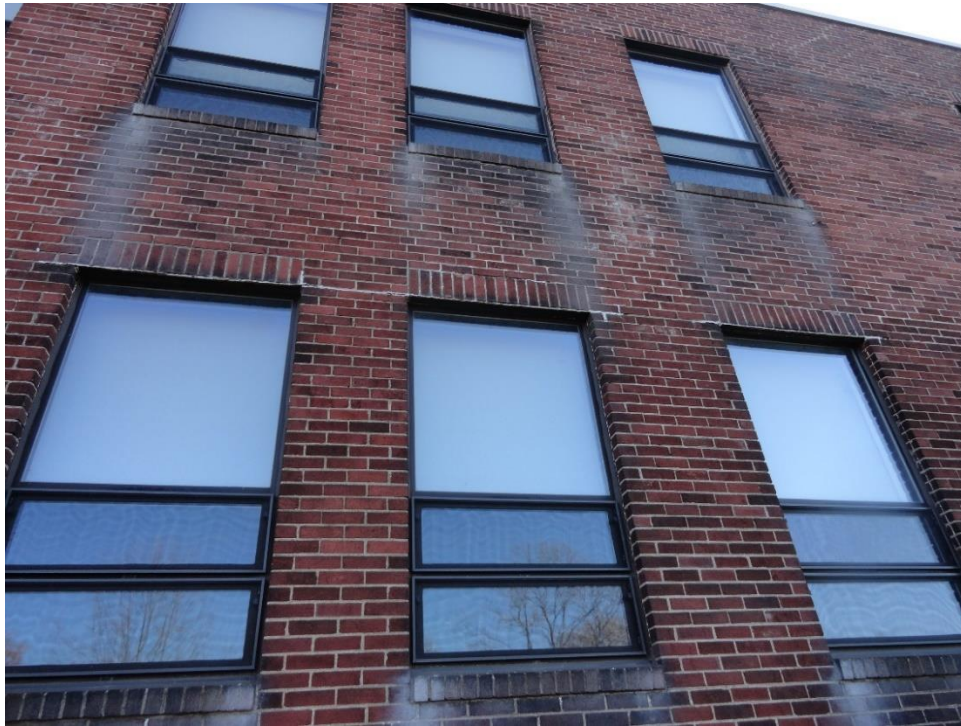
4. The exterior masonry is in fair condition. Some repairs were made, however several cracks on the brick, and rusted lintels still exist. The brick needs to be cleaned.

Exterior Brick and Lintels are in poor condition.

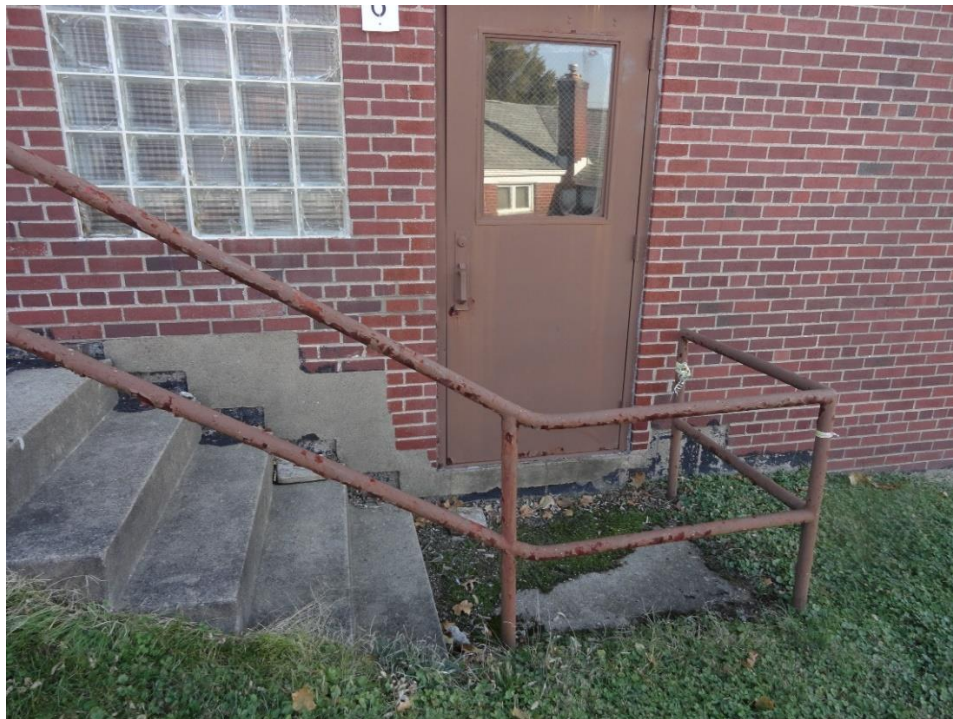
Exterior Concrete Steps and Landings are in poor condition.

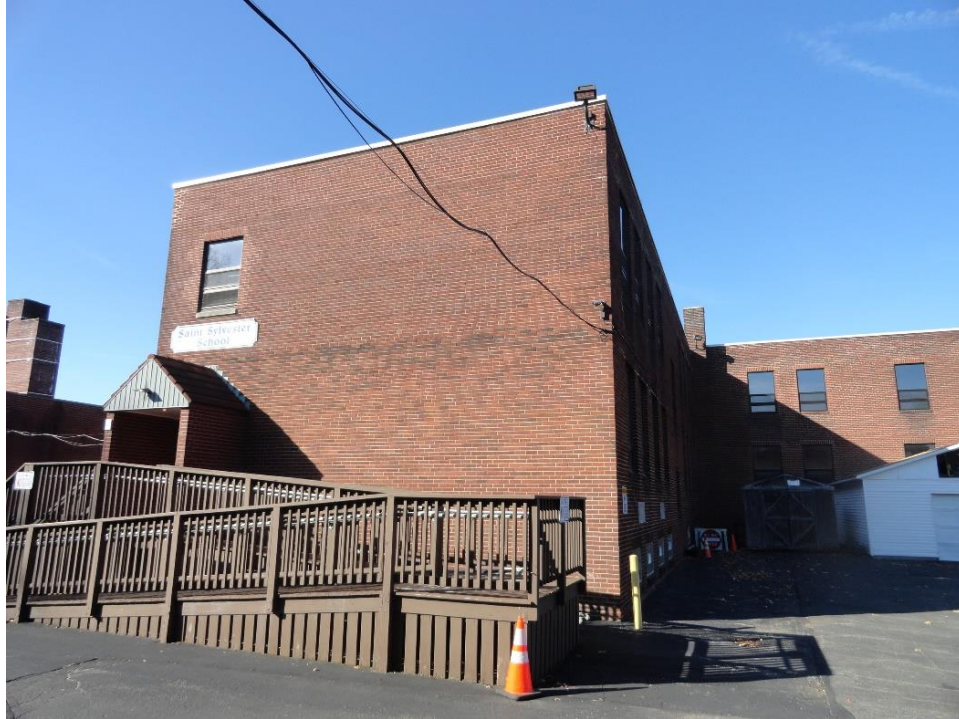
2. There is one ramp for handicapped access to part of the building, however it does not comply to current codes and regulations.
3. There are several exterior retaining walls that are in poor condition and need repairs or rebuild.

Handicap access ramp is in poor condition.

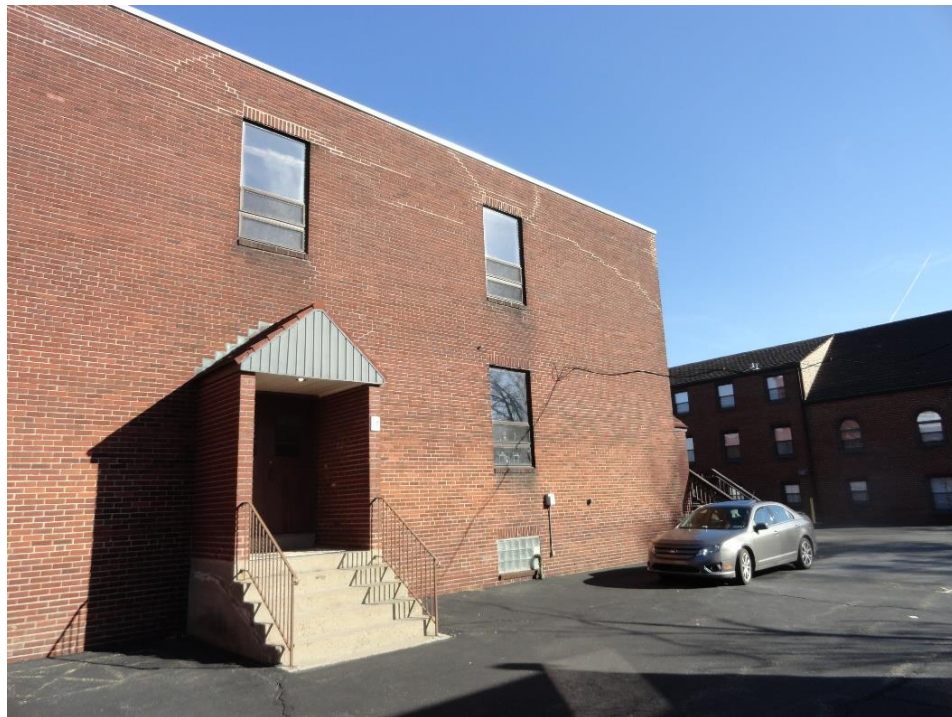
8. Accessibility is a major issue in the building as there are several levels with no elevator, lifts or ramps. The building also does not have a secure entrance.

Building ADA access concerns.

1. Completely renovate the spaces to current codes and Department of Education Standards and Regulations.
2. Add elevators, ramps and chair lift for handicapped accessibility in all areas.
3. Construct new secure vestibule for visitor entrance to the building.

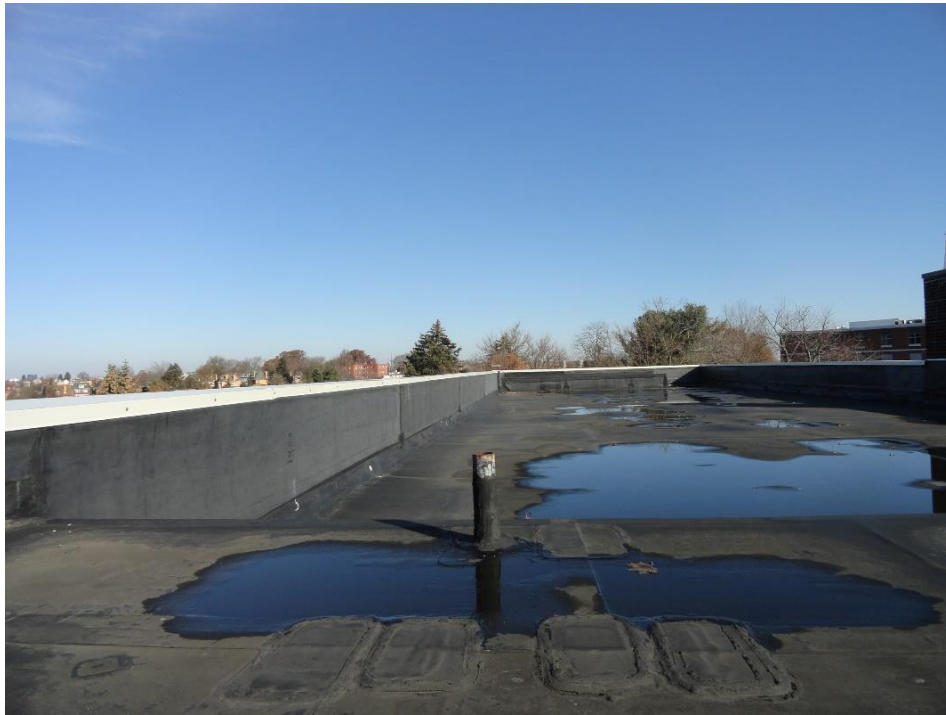
5. The windows are aluminum and in fair to good condition.
6. The exterior doors are in poor condition.
7. The roof is EPDM membrane and appears to be in fair condition. Some possible leaks have been observed inside the building with stained ceilings. Several areas of ponding have also been observed on the roof.

Aged EPDM rubber membrane and standing water.

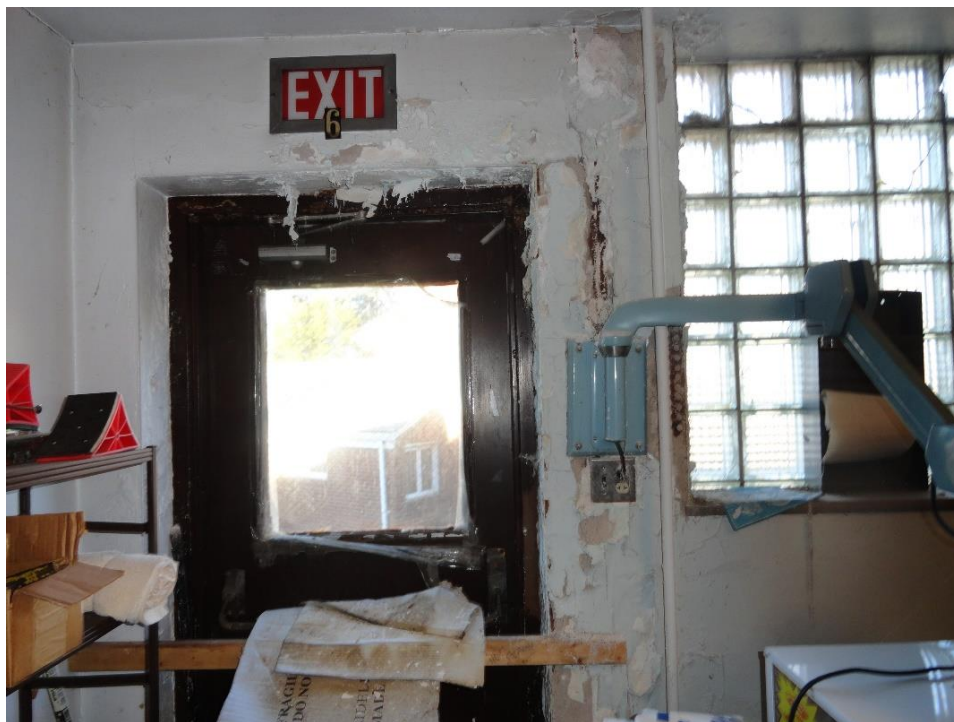
2. Several areas in the lower level have moisture intrusion damage and delaminated plaster throughout.
3. The building does not have a functioning kitchen. The cafeteria and kitchen were converted to a library in previous years when the building was used as a school.

Lower level moisture intrusion damage.

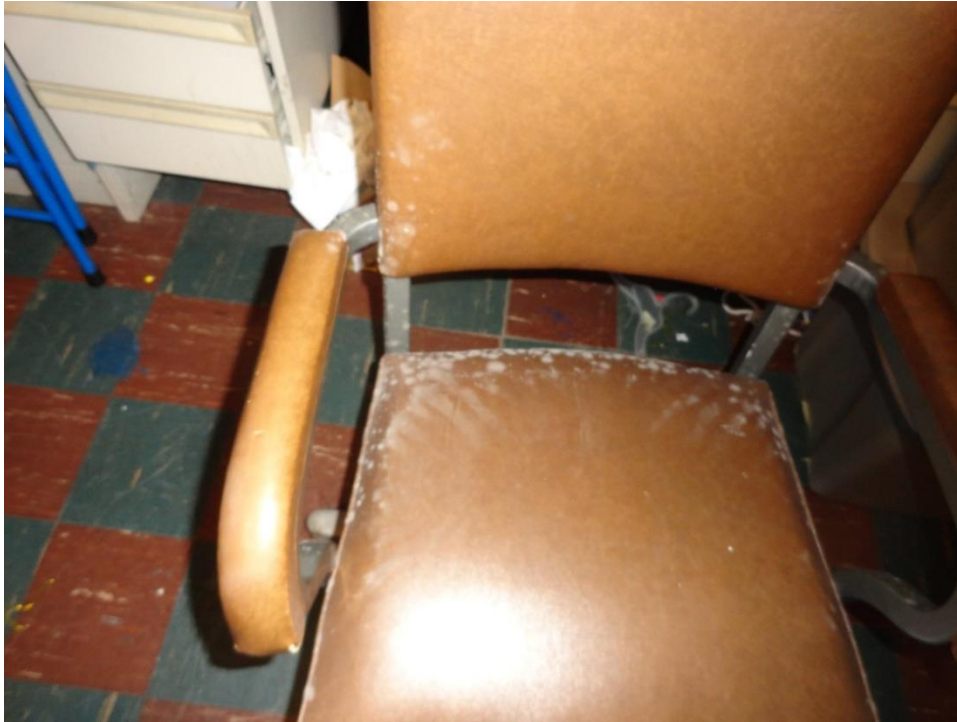
Lower Level mold-like substance on surfaces.

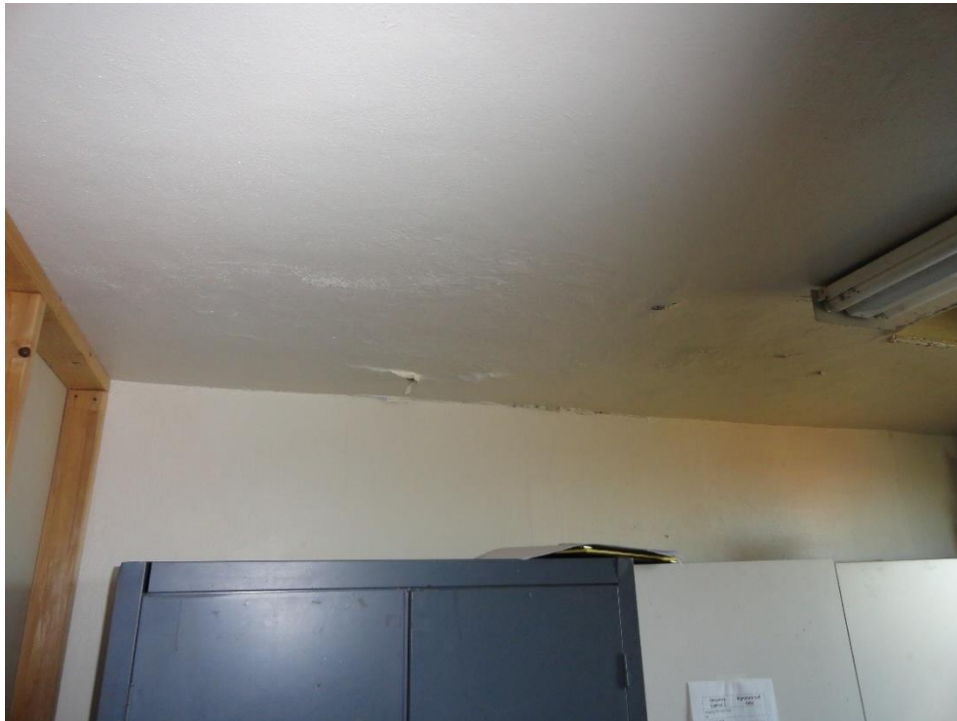
Upper level moisture intrusion damage.

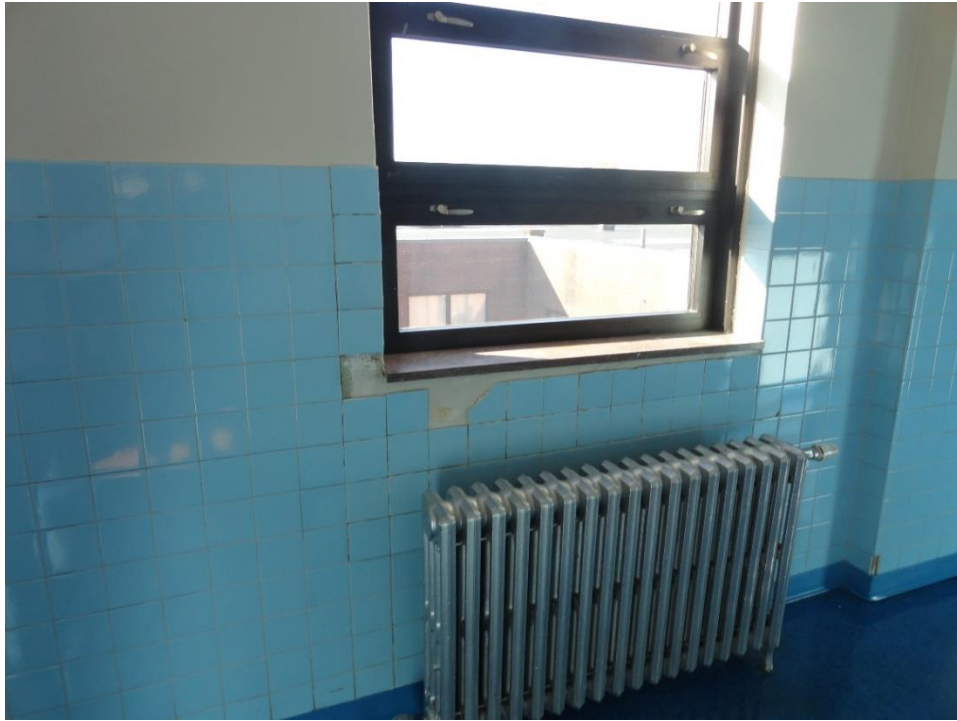
Hallway wall tiles are loose and missing.

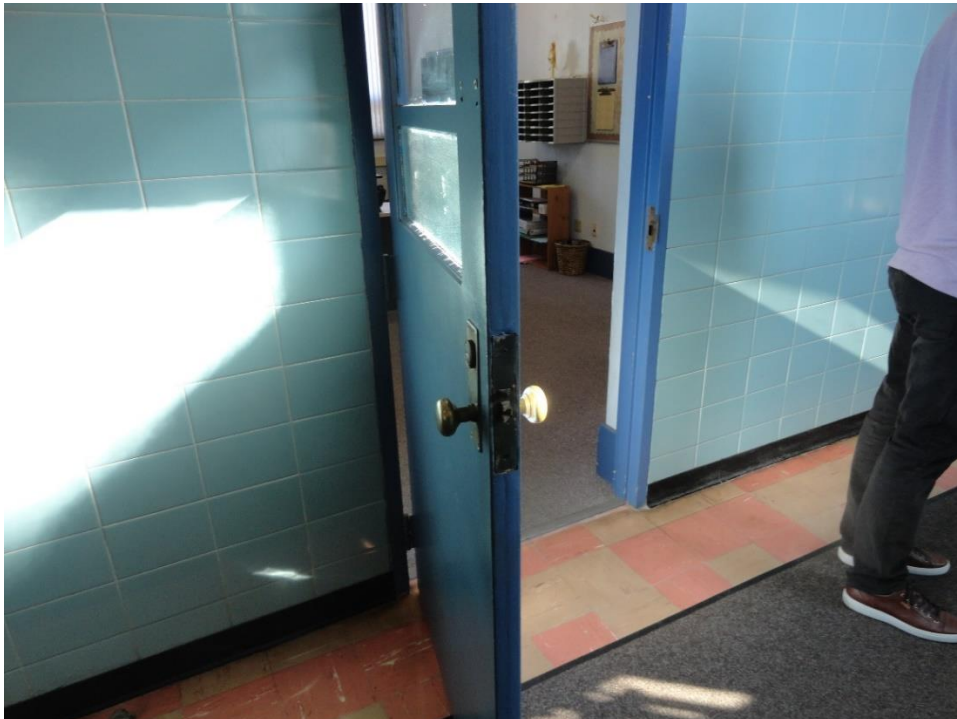
Interior doors are not ADA-compliant in many locations.

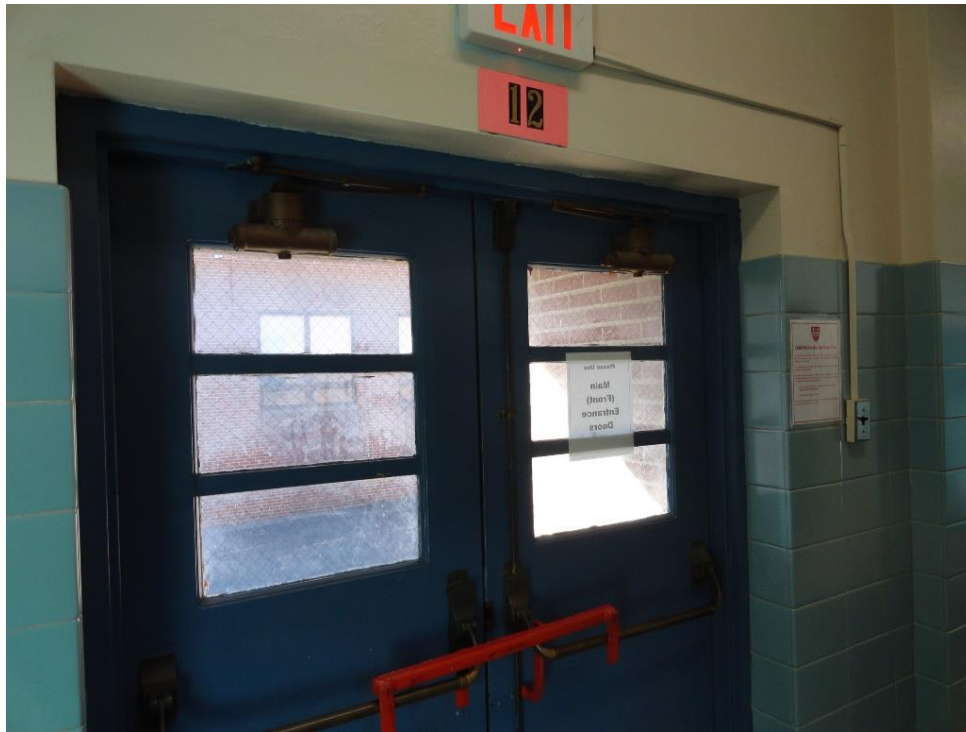
Exterior doors are not ADA-compliant in many locations.

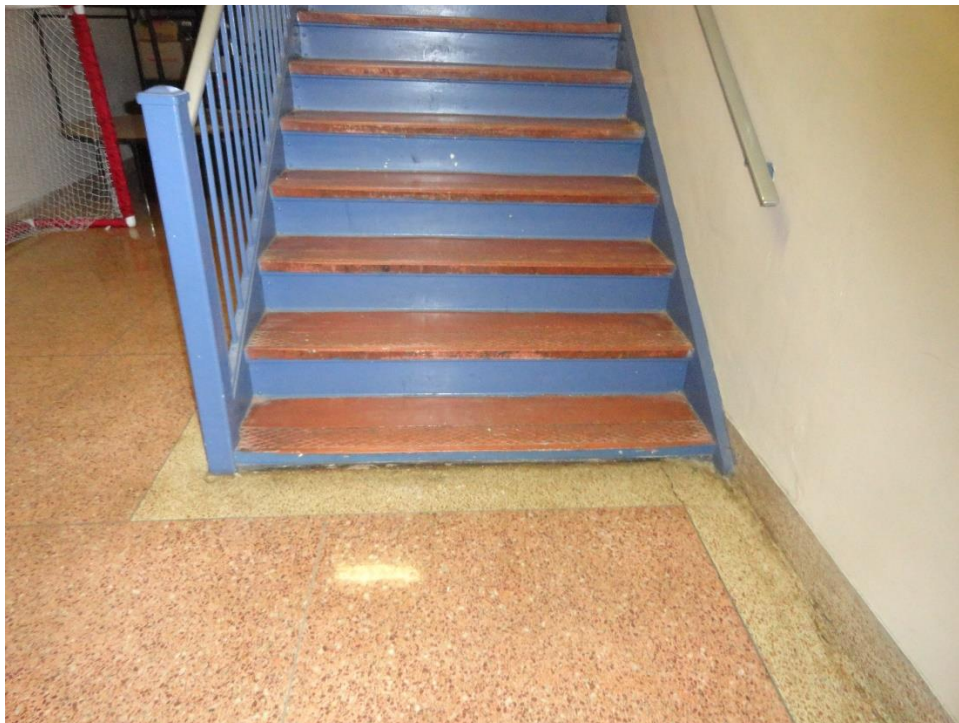
Inadequate stair riser (trip hazard).

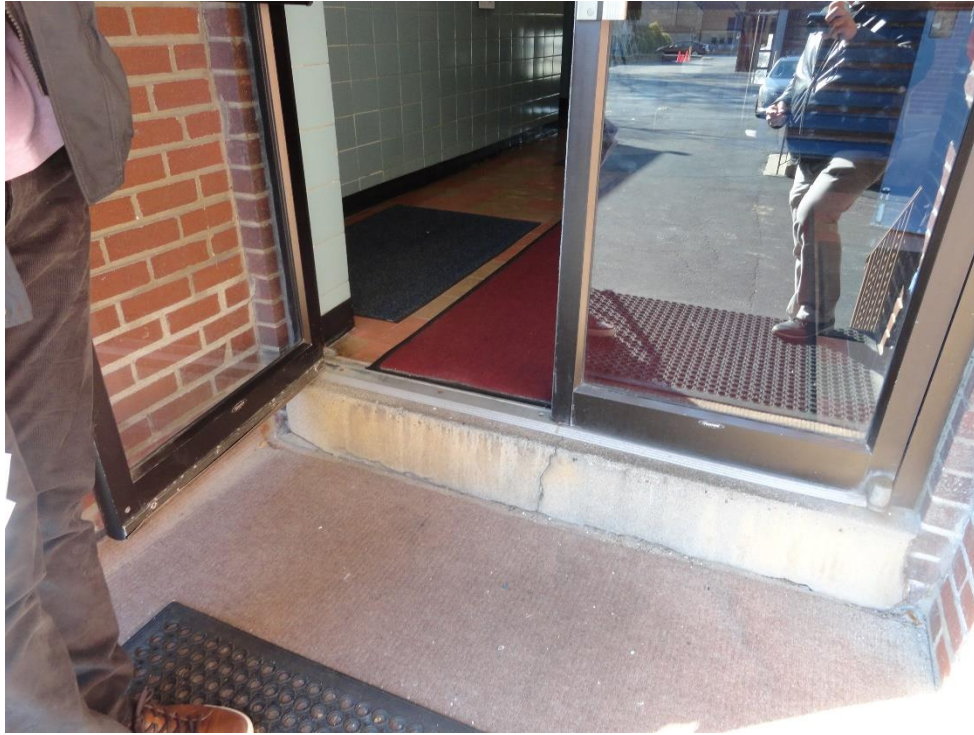
Non-code compliant riser at entry.

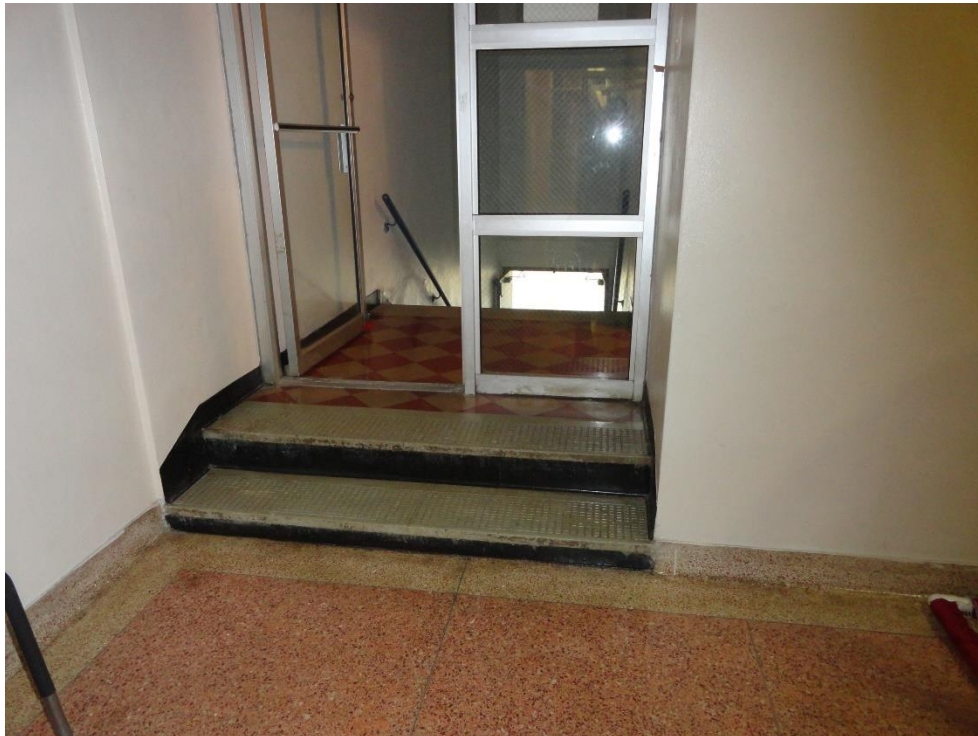
Non-standard, non-code compliant stair configurations.

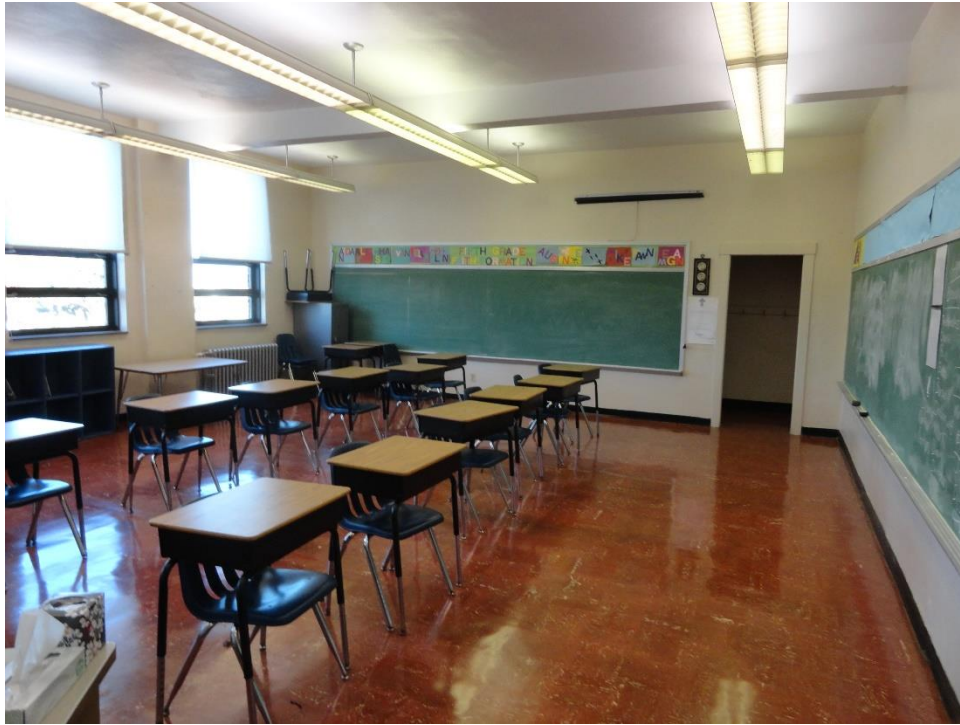
4. Several classrooms were modestly upgraded with new doors, carpet and visual display boards. Vinyl asbestos floor tiles appears to be in every room, in some instances under the carpet. The ceilings are plaster with exposed piping.

Likely Asbestos-containing floor tile throughout.

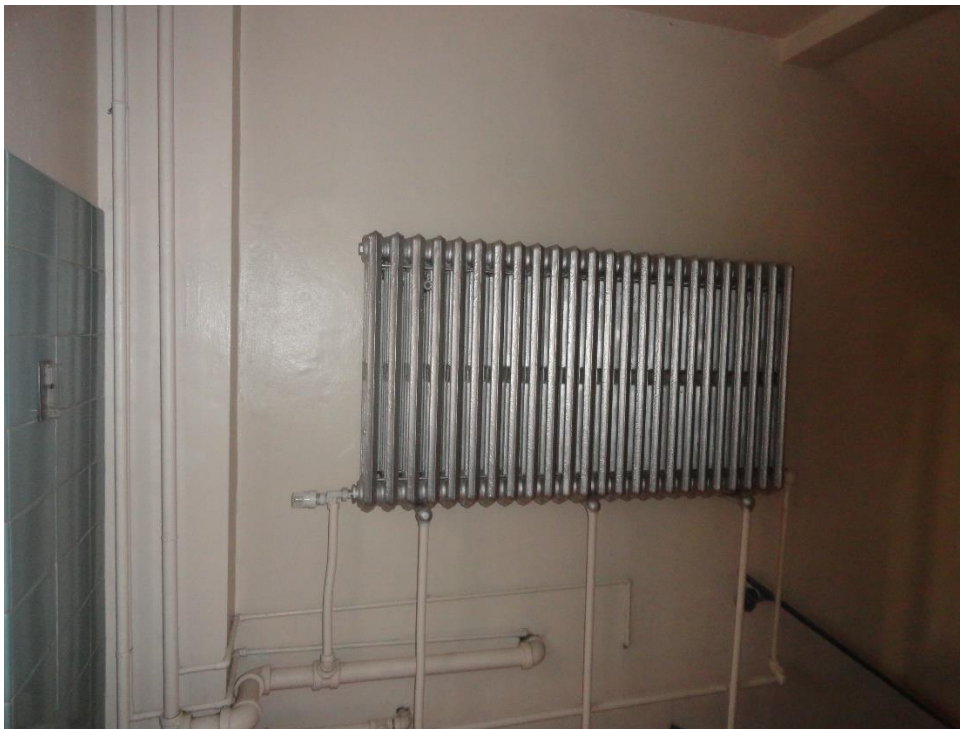
1. Most classrooms are served by floor cast iron steam radiators and are not ventilated. This is a code violation.
2. A couple rooms are equipped with unit ventilators which in 1958, did provide ventilation. These most assuredly do not function in this manner at present. Units are in poor condition and must be replaced.

Exposed cast-iron steam radiators are original to the building.

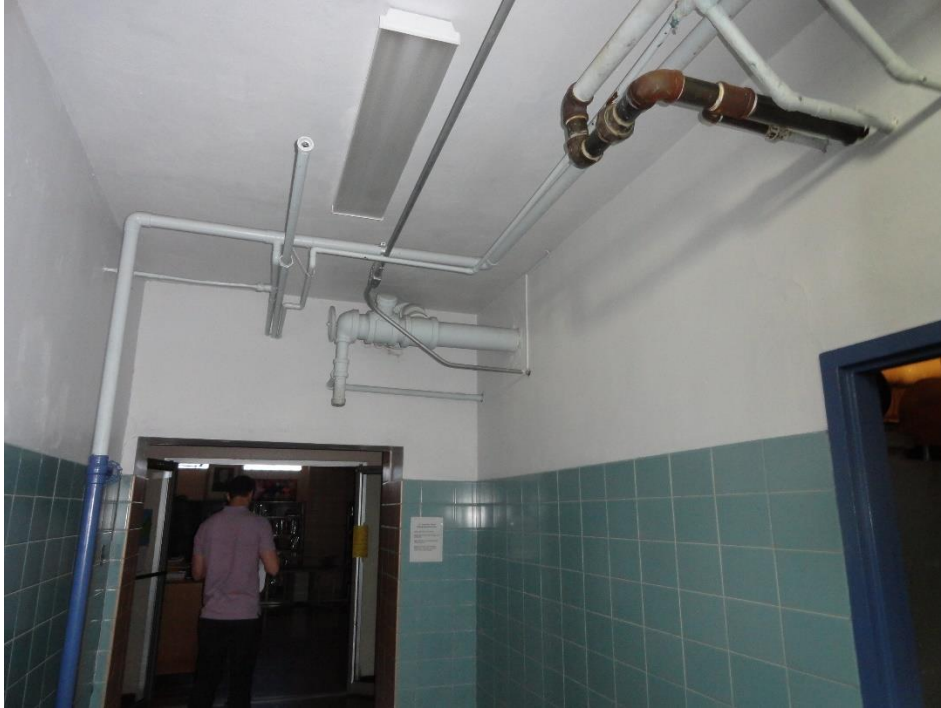
1. The original portion of the school is served by a 2-pipe (steam and condensate return) system. The piping is original and dates to the 1930's.
2. The 1958 addition is hot water. This piping is also original
3. Both systems are antiquated and must be replaced.

Antiquated Steam Heat Pipe System.

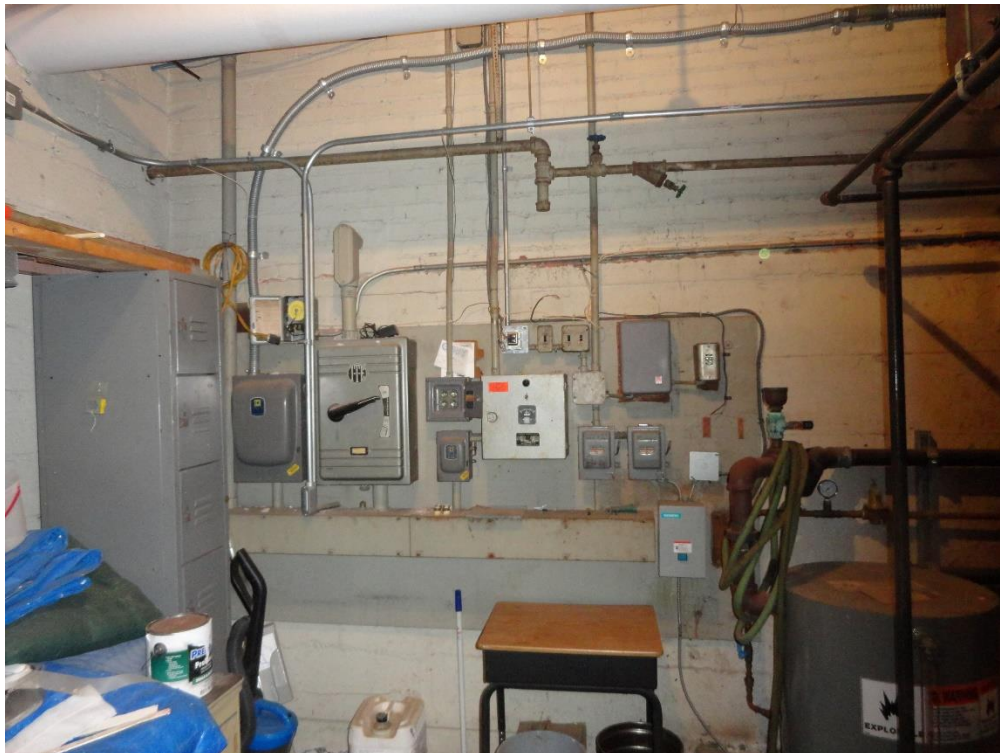
Inadequate & outdated Electrical System.

1. Replace the aged equipment and the upgrade the electrical service to a 600 Amp, 480/277V, 3 phase service to better serve the building now and in the future.

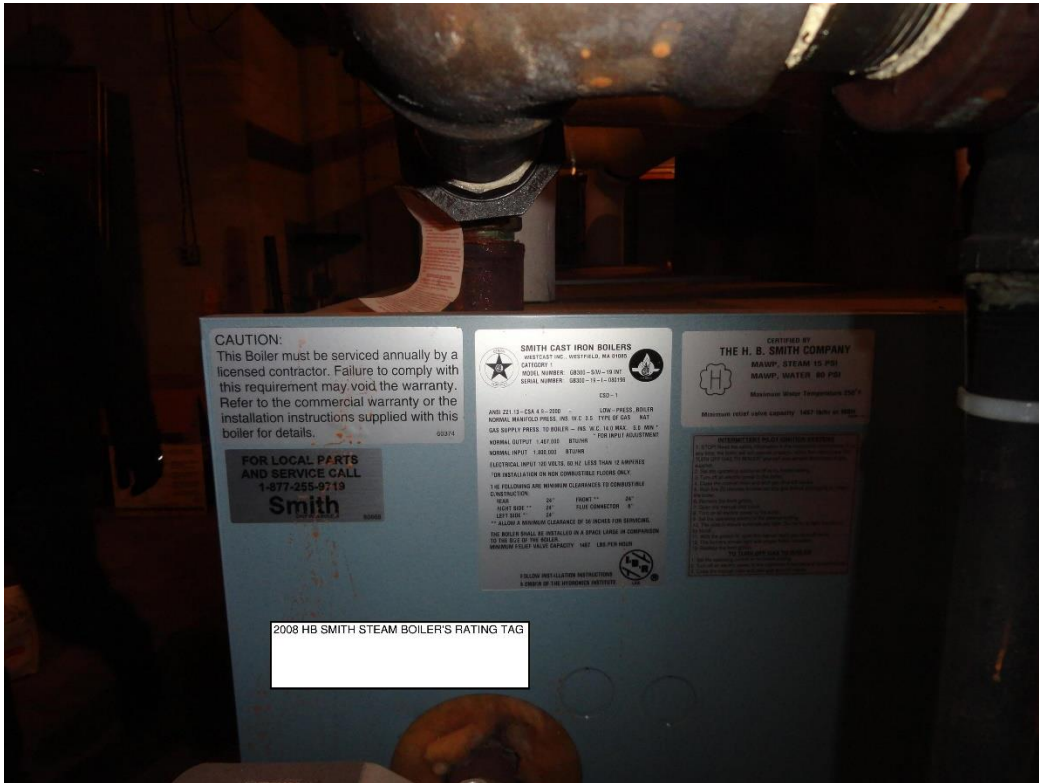
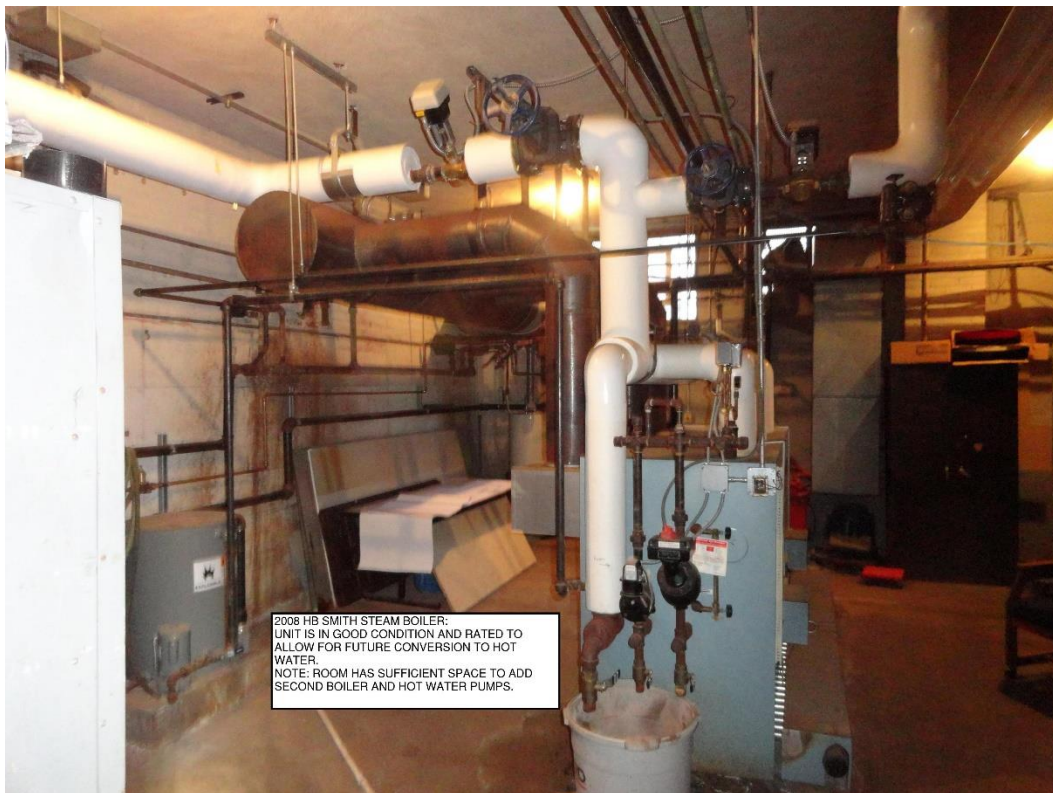
1. The building was originally constructed in the mid-1930's. That portion of the building's heating system is steam and is served by a recent (2008) HB Smith, gas-fired steam boiler. The boiler is in good condition and based on the tag data, could be reused if the building was upgraded and converted to hot water.
2. The addition dates to the 1950's. That portion of the building's heating system is hot water and is served by the original, 61-year-old boiler. This equipment is in poor condition.
3. The original building boiler stack looks to be in fair condition.
4. The addition boiler stack is in very poor condition and has 3 stainless steel bands around to prevent brick from failing.
5. The original boiler room is sufficiently sized to add a second boiler and could then be set up as the new consolidated hot water plant.

2008 HB Smith Steam Boiler.

2008 HB SMITH STEAM BOILER:  
UNIT IS IN GOOD CONDITION AND RATED TO  
ALLOW FOR FUTURE CONVERSION TO HOT  
WATER.  
NOTE: ROOM HAS SUFFICIENT SPACE TO ADD  
SECOND BOILER AND HOT WATER PUMPS.

2008 HB Smith Steam Boiler is in good condition, rated to allow future conversion to hot water.

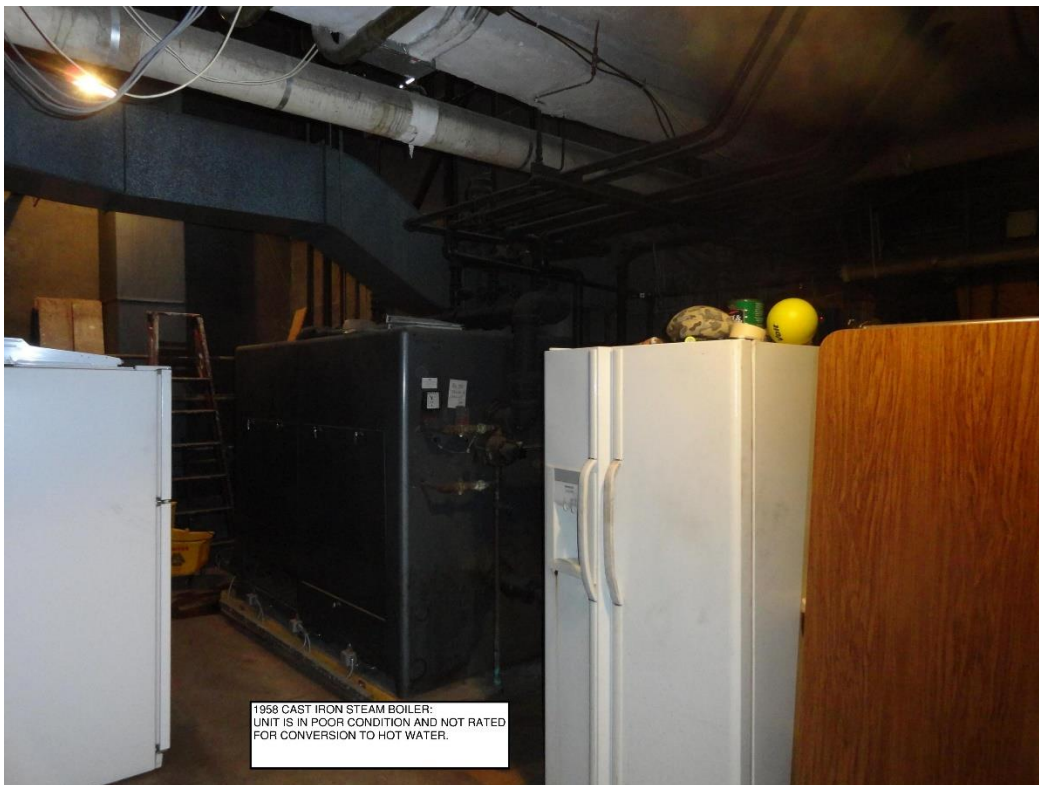
1958 cast-iron steam boiler is in poor condition and not rated for conversion to hot water.

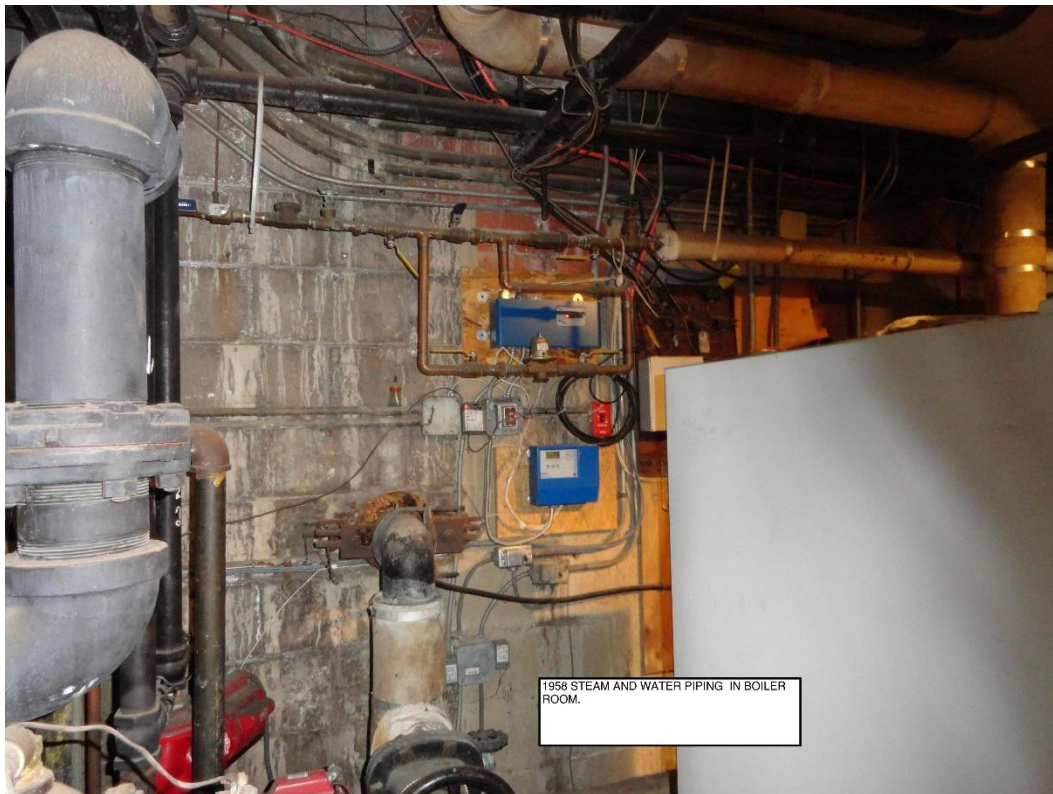
1958 STEAM AND WATER PIPING IN BOILER ROOM.

1958 steam and water piping in Boiler Room.

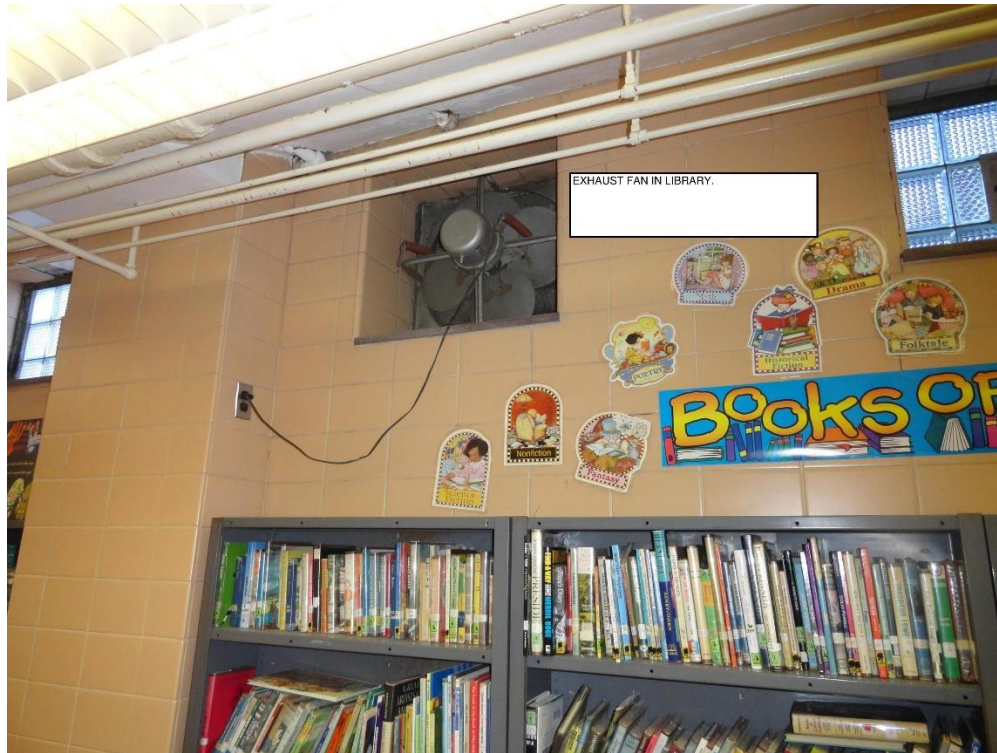
1. Roof exhaust fans are estimated to be in poor/inoperable condition.

Exhaust fan in Library.

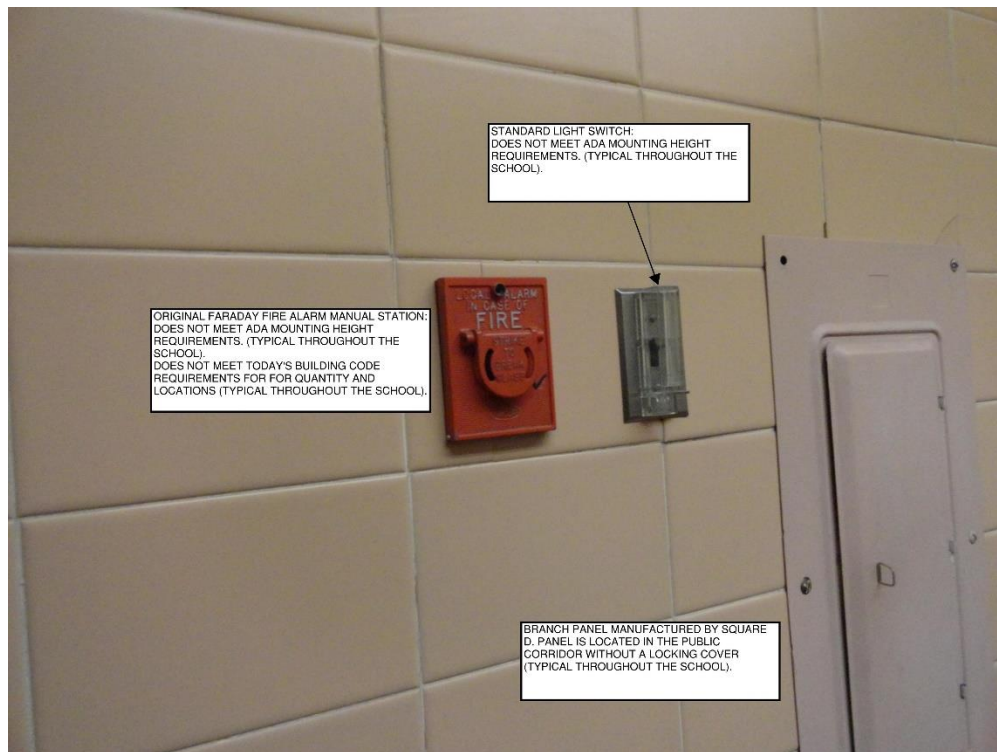
1. The fire alarm system is manufactured by Faraday. The system appears to be original to the building.
2. Concerns:
  - a. Age of system.
  - b. The current fire alarm code requires the fire alarm system to be a voice system within all educational facilities.
  - c. Does not meet current code for requirements of manual pull stations, smoke detectors, carbon monoxide detectors, audible notification devices, and visual notification devices.

Original Faraday fire alarm, standard light switch and branch panel do not meet today's code requirements.

- a. Replace system to meet the latest code requirements.

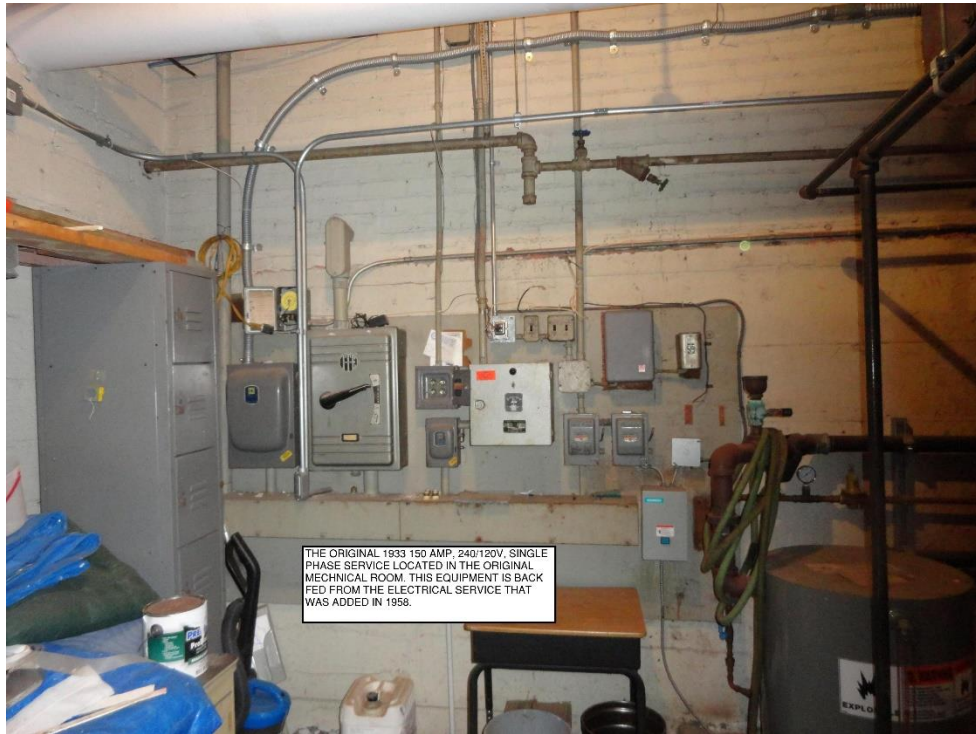
2. The original 1933 electrical distribution is back fed from the above mentioned Disconnect Switch #2. It consists of a 150 Amp, 240/120V, single phase I.T.E. disconnect switch, which feeds several 30 Amp, Edison Base plug style fused disconnects, via a metal wiring trough. This equipment is in fair to poor condition.
3. The life expectancy for electrical equipment is generally twenty-five to thirty years, depending on type and usage. The age of the equipment listed above is between 62-87 years old.
4. Concerns:
  - a. Age of the equipment and wiring.
  - b. Limited to no space capacity.
  - c. The service does not appear to be properly grounded.

Original 1933 150-amp, 240/120-volt service, back fed from the 1958 service.

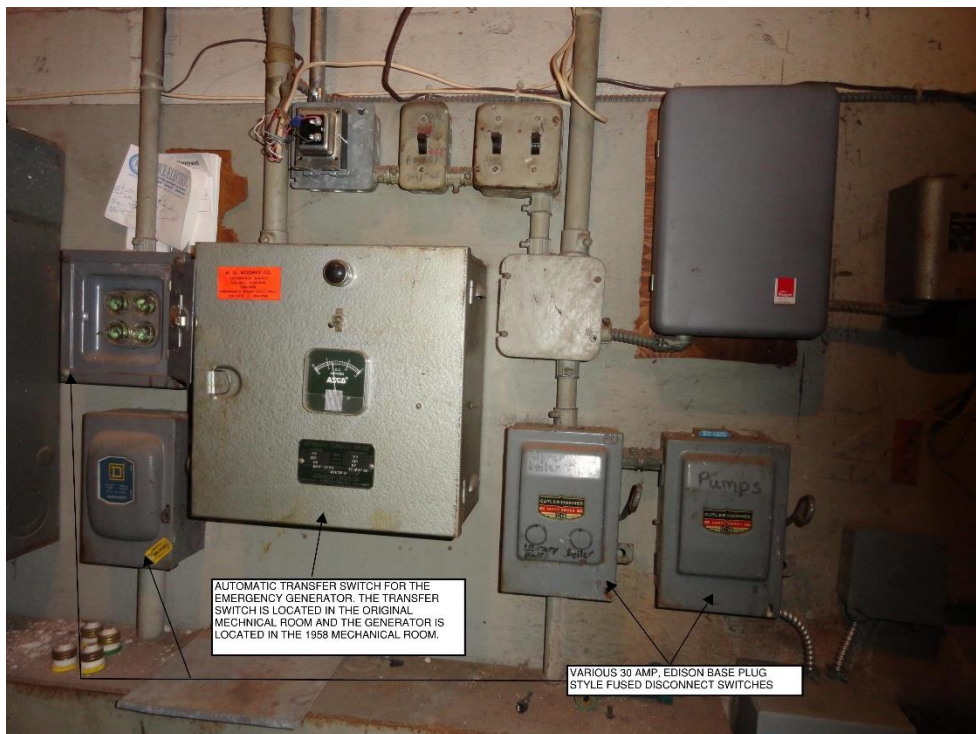
Automatic transfer and disconnect switches.

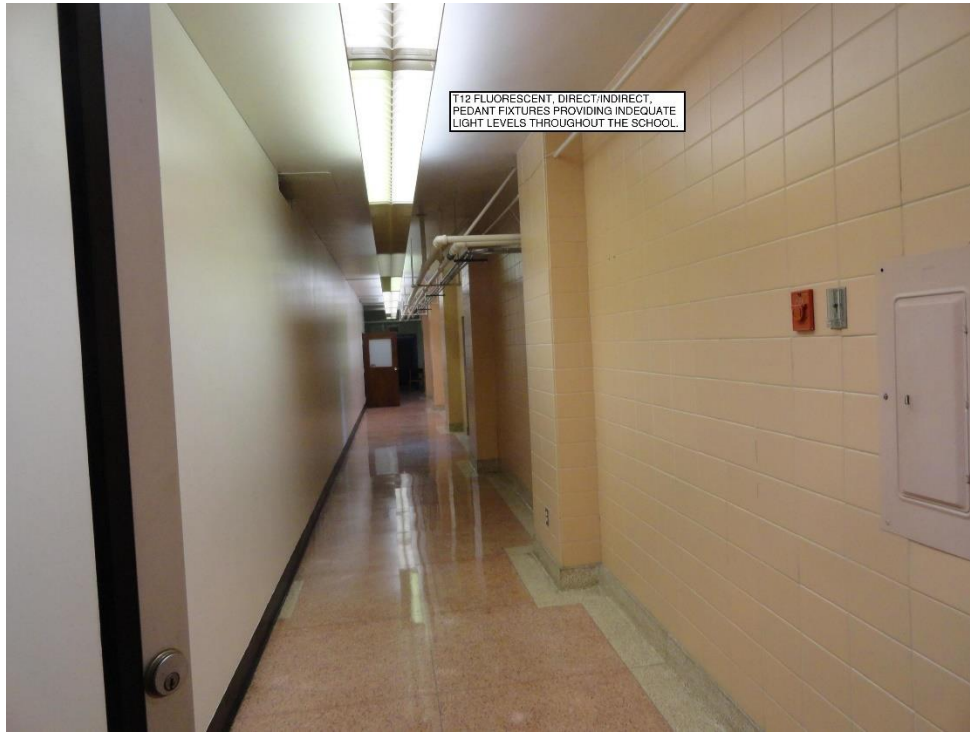
1. Much of the interior lighting consist of fluorescent fixtures with T-12 lamps and electronic ballasts. While several fixtures have medium base sockets with replacement style screw-in fluorescent bulbs. A few locations still utilize incandescent lamps. At some point the gym HID lights were replaced with fluorescent, T-8, 6-lamp, high bay fixtures. The light levels in most of the spaces appear to be inadequate per the IESNA Lighting Standards. Most of the lights are controlled by standard on/off toggle switches. The lights in the gym are controlled by the circuit breakers feeding them. Most of the exit signs are original to the building and have medium base, screw-in style sockets. Many of the fixtures are either missing or have broken or yellowed lenses. All the light fixtures are in fair to poor condition.

T12 Fluorescent lighting is providing inadequate lighting.

- a. Replace all interior light fixtures and exit signs with energy efficient LED fixtures.
- b. Replace all associated wiring and conduit.
- c. Install automatic lighting controls to meet the latest Energy Codes and to maximize cost savings.
