# Facility Study of the former Saint Sylvester School Brentwood, Pennsylvania

Performed for the  
Brentwood Borough School District

January 21, 2020  
Commission #4372

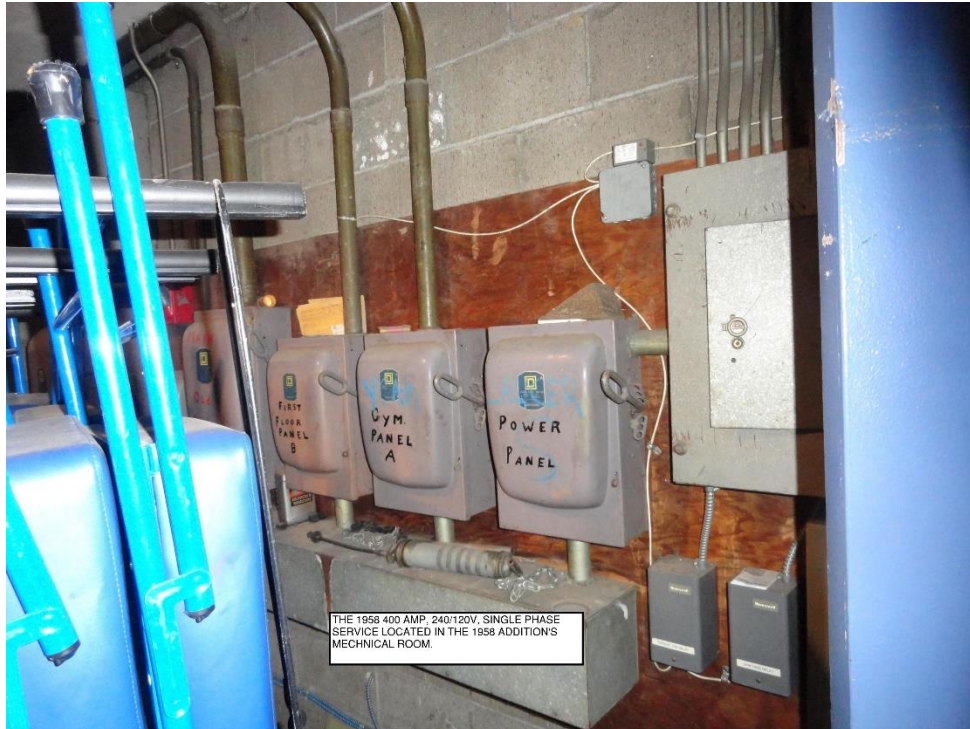
1. The main electrical service is currently located in the boiler room of the 1958 addition. It is a 400 Amp, 240/140V, single phase service that is fed from a single DLCO pole mounted transformer. The transformer is mounted on pole #186064, located on West Willock Road. From the transformer, 400 Amp underground service feeders are run to a pull box located in the 1958 boiler room. A Square D 400 Amp disconnect switch, located below the pull box, feeds (5)-disconnect switches via a metal wiring trough.

1958 400-amp 240/120-volt single phase service.

1. Replace the aged equipment and the upgrade the electrical service to a 600 Amp, 480/277V, 3 phase service to better serve the building now and in the future.

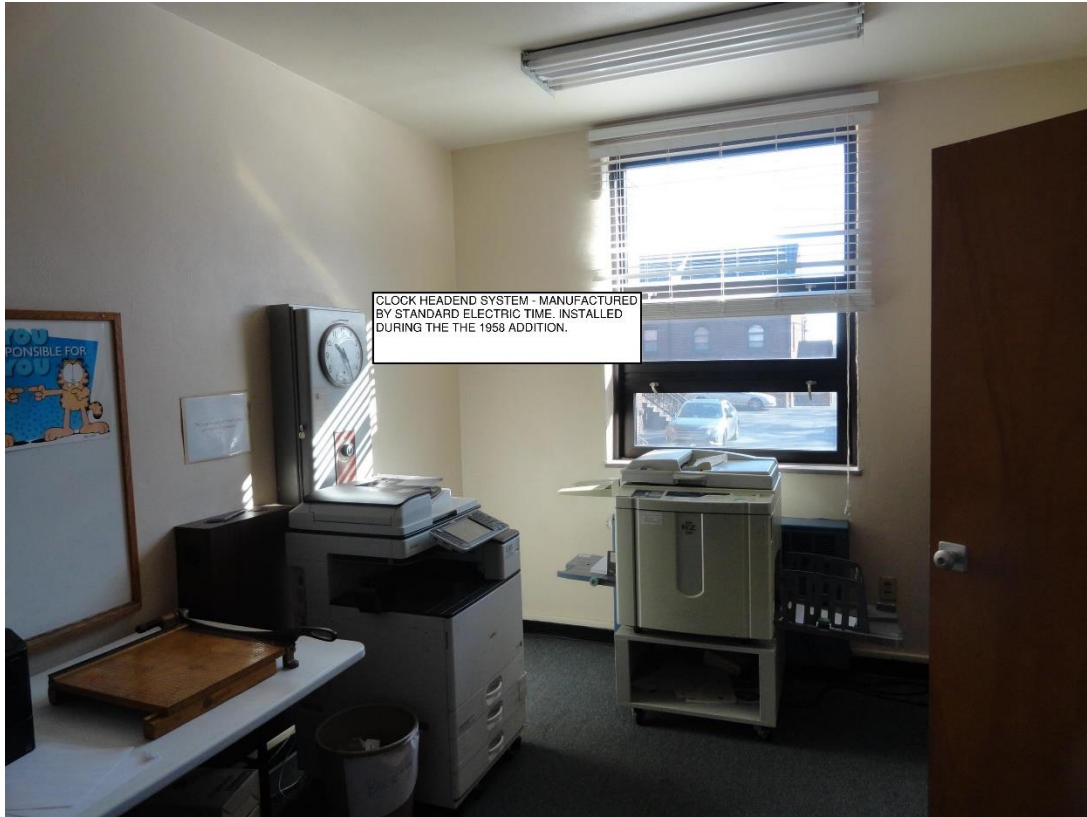
1. The clock headend system is manufactured by Standard Electric Time and appears to be original to the 1958 building. Only (3) analog secondary clocks were noted which have been upgraded to Skyscan astronomical analog clocks.

Clock head-end system installed in the 1958 addition.

- a. Replace existing system due to the age.
